# Fatigue behaviour analysis for the durability prequalification of strengthening mortars

## P Bocca, A Grazzini, D Masera

Department of Structural and Geotechnical Engineering – Politecnico di Torino, corso Duca degli Abruzzi 24, 10129 Turin (Italy)

Abstract. An innovative laboratory procedure used as a preliminary design stage for the prequalification of strengthening mortars applied to historical masonry buildings is described. In the analysis of the behaviour of masonry structures and their constituent materials, increasing importance has been assumed by the study of the long-term evolution of deformation and mechanical characteristics, which may be affected by both loading and environmental conditions. Through static and fatigue tests on mixed specimens historical brick-reinforced mortar it has been possible to investigate the durability of strengthening materials, in order to select, from a range of alternatives, the most suitable for the historical masonry. Cyclic fatigue stress has been applied to accelerate the static creep and to forecast the corresponding creep behaviour of the historical brick-strengthening mortar system under static long-time loading. This methodolo

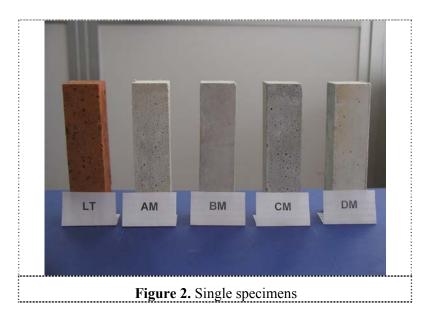
The materials are bricks, from the Royal Palace of Venaria Reale, and 4 different types of mortars produced by several firms (codified as "A", "B", "C", "D"), suitable for the following restoration techniques: reinforcement by structural plaster (A; C), joint closing (A; D), jacketing of masonry walls or reinforcement of vaults (D), consolidation by grout injection (B). The mechanical characteristics were investigated by means of 6 test pieces 40x40x160mm for each single material (figure 2), subjected to static tests. Each mortar test piece was labelled with "XM" where "X" stands for the code of the relative mortar (A, B, C, D); the brick test piece was labelled with "LT".

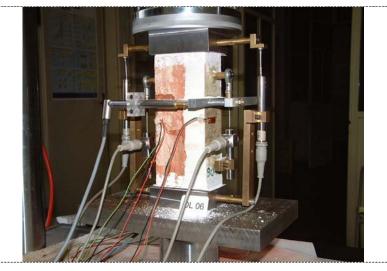
Figure 3. Instrumentation for mixed brick-mortar test pieces

Each mixed piece was labelled with "X"L, where "X" stands for the code of the relative mortar. Cyclic and static compressive tests were performed with the aid of a 250 KN model 810 MTS. The mixed pieces were instrumented with three pairs of transducers, according to the scheme shown in

figure 3: a vertical pair was anchored to the plates of the MTS and another vertical pair was applied directly to the test piece on the opposite faces of the two materials; finally, a third pair arranged horizontally was used for measuring the displacements due to bulging. Completing the system, a pair of electrical strain gauges on the opposing vertical faces of the test pieces measured transverse strains. In this manner it's possible to measure all the axial deformations (in vertical, horizontal and transverse directions), whose algebraic sum yields the volumetric deformation [3].

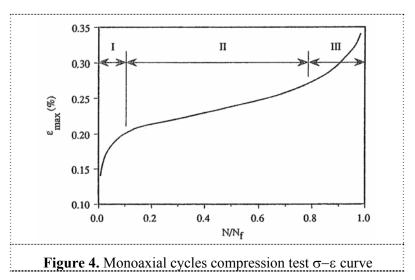
In a typical  $\sigma$ - $\varepsilon$  curve of a cyclic fatigue test (figure 4) it is possible to identify three distinct stages: stage I, where deformations are seen to increase rapidly (accounting for ca 10% of the service life of test piece); stage II, of stabilisation, where the deformations increase gradually at a virtually constant stress (10-80% of test piece life); stage III, with a rapid increase till failure [4]. Various authors [5-6] have shown that fatigue life of a material subjected to cyclic loading tests is strictly correlated to the evolution of the deformations during stage II.

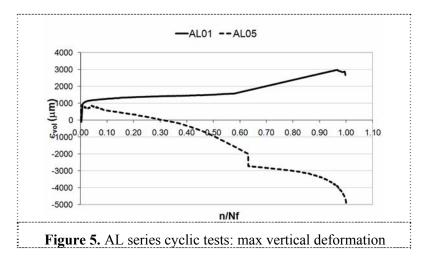
From the results of cyclic tests described above, through linear interpolation between 20% and 80% of secondary creep values (figure 9), derivatives  $\partial \epsilon_v / \partial n$  (i.e., the variations in the deformation vs. time curve during stage II) were worked out. Through a linear regression on logarithmic scale [3], it is possible to plot the data in a diagram in order to obtain an analytical relationship (1) between secondary creep variations,  $\partial \epsilon_v / \partial n$ , and the number of cycles (N) to fatigue failure:

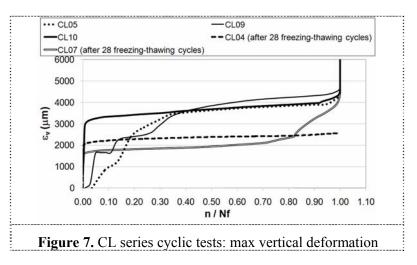
Figure 8. DL series cyclic tests: max vertical deformation

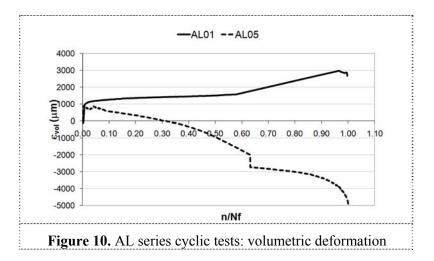
**Figure 9.** Fatigue life of mixed test pieces  $\partial \varepsilon_v / \partial n$  chart

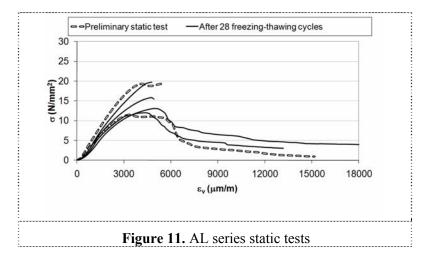
Figures 11-14 illustrate the static tests performed on mixed test pieces. The values obtained for a majority of the series remained within the average of the two preliminary tests, save for the series DL, which displayed a considerable increase in strength. In most cases, static curves after freezing-thawing revealed a more brittle behaviour. Test pieces of BL and DL series that passed 100000 cycles mark

were tested to failure: the DL series displayed a noticeable increase of their mechanical properties. Some CL and DL test pieces were subjected both to freezing-thawing test and to cycling loading: CL maintained a static behaviour similar to the weakest preliminary test result; instead in the DL series an appreciable increase of strength was mated to a lesser degree of brittleness compared to the test pieces subjected to cyclic loading only.

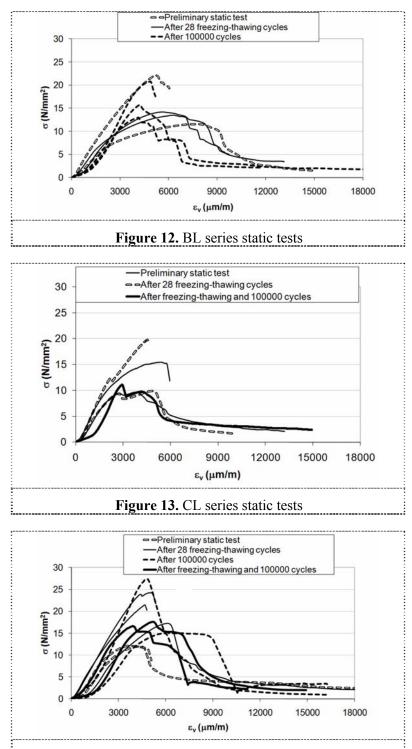
Figure 14. DL series static tests
