Building damage assessment scale tailored to remote sensing vertical imagery / Sandu, Constantin; Cotrufo, Silvana; GIULIO TONOLO, Fabio; Boccardo, Piero. - In: EUROPEAN JOURNAL OF REMOTE SENSING. - ISSN 2279-7254. - ELETTRONICO. - 51:1(2018), pp. 991-1005. [10.1080/22797254.2018.1527662]

Building damage assessment scale tailored to remote sensing vertical imagery

Silvana Cotrufo, Constantin Sandu, Fabio Giulio Tonolo & Piero Boccardo

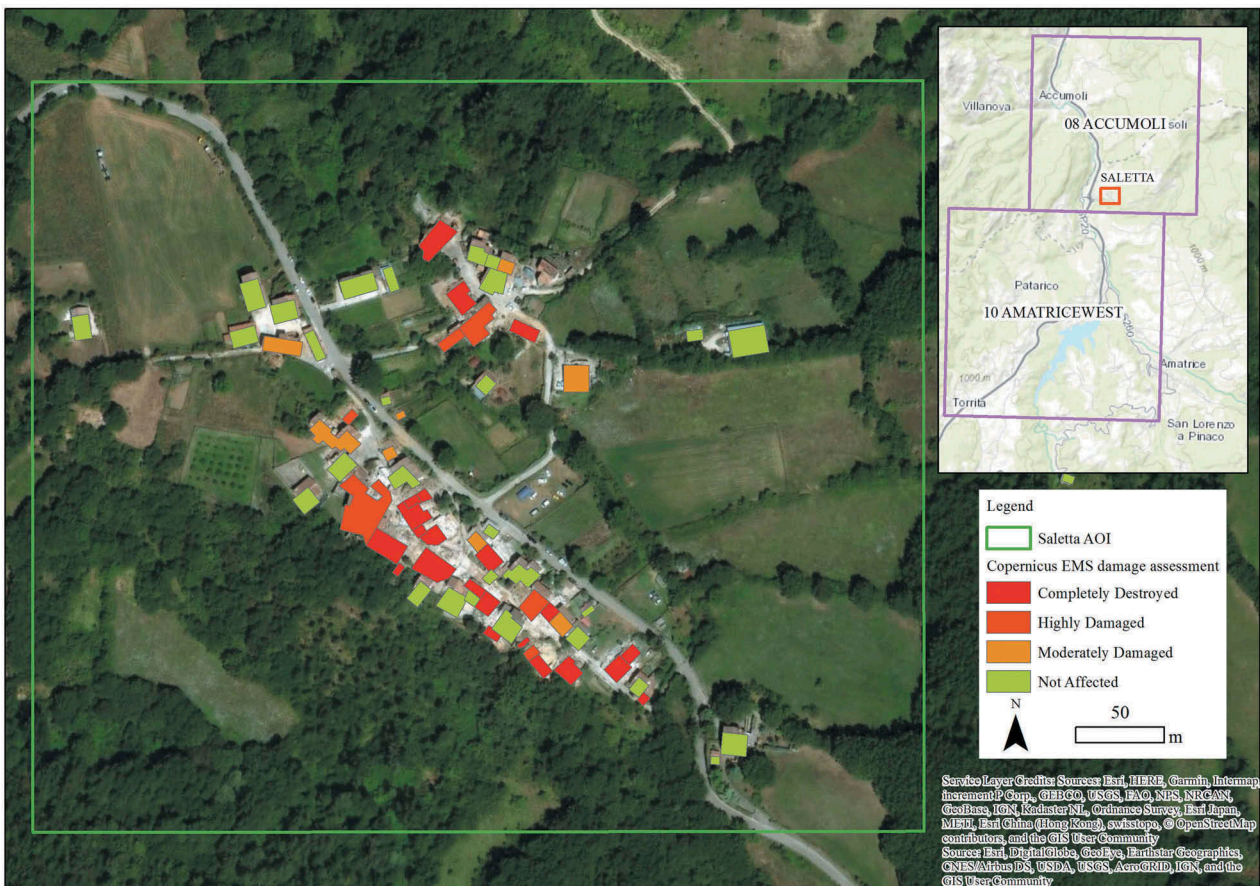
Figure 4. The building footprints over Saletta extracted from [EMSR177] Accumoli: Grading Map, Monitoring 1.

In Figure 4, as illustrative and informative purposes, the building footprints of Saletta's area of interest are displayed in a traffic light color code according to the damage scale class.
