Experimental Fatigue Test for Pre-Qualification of Repair Mortars Applied to Historical Masonry

Alessandro Grazzini

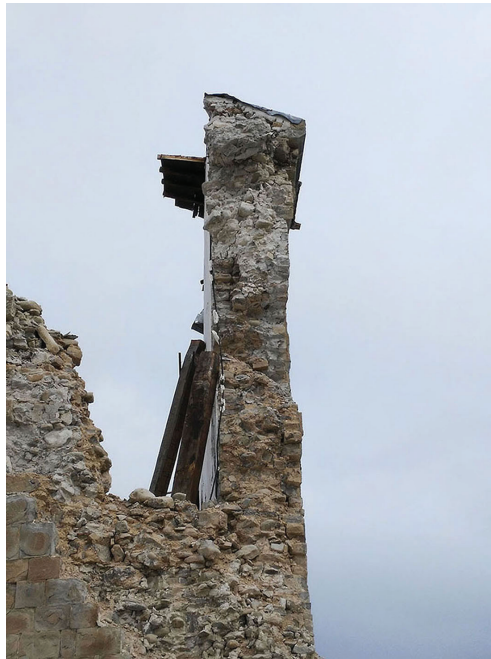
Figure 1. Collapse of the St. Agostino church in Amatrice after the Central Italy earthquake 2016 (image courtesy of the Curia of Rieti).

Recent earthquakes have shown the clear failure of restoration work performed with the use of concrete materials, the excessive stiffness of which has completely distorted the original characteristics of historical masonry buildings. **Figure 1** shows the ineffectiveness of the cementitious insertion materials inside historical walls of the St. Agostino church, collapsed during the last great Italian earthquake of Amatrice, just in correspondence with the previous stitching made by cement injections.

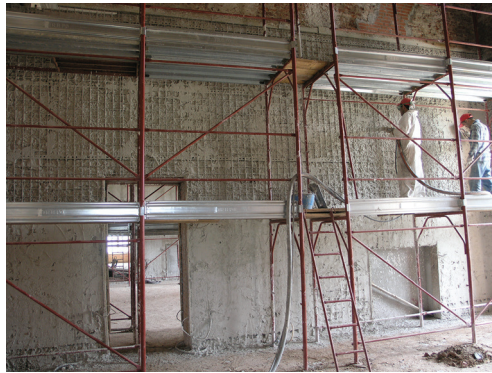
Figure 15. Application of mortar D as the reinforced plaster to Venaria's masonries.

came from the real application of mortar D as reinforced plaster retrofitting of some walls of the Royal Palace of Venaria (**Figure 15**). After 10 years, this plaster does not present any pathology of incompatibility.

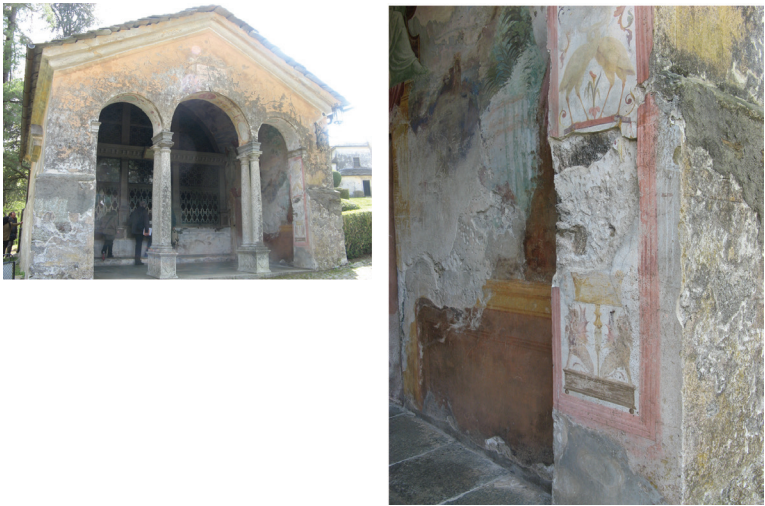
Figure 16. Decay of historical plasters because of the rain infiltrations (Sacro Monte of Varallo).

An innovative laboratory procedure, developed at the Non-Destructive Testing Laboratory of the Politecnico di Torino, is described for test mechanical adhesion of new repair mortars. Compression static tests were carried out on composite specimen stone block-repair mortar, which specific geometry can test the de-bonding process of mortar in adherence with a stone masonry structure. The methodology is being used at Sacro Monte di Varallo Special Natural Reserve. Situated at the top of the hill above the town of Varallo in Piedmont (Italy), Sacro Monte is an artistic-religious complex consisting of 45 chapels, which contain with frescoes and sculptures that tell the story of the life of Christ (**Figure 16**).

The main problem of historical plasters' preservation is linked to the rain infiltrations and to the freezing-thawing cycles that compromise their adhesion to stone masonries. Through compression static tests on stone-mortar composite specimens, it was possible to prequalify the dehumidified mortar with greater durability guarantees. Sometimes the long-term detachment determined the failure of the restoration work. The test validates the mechanical

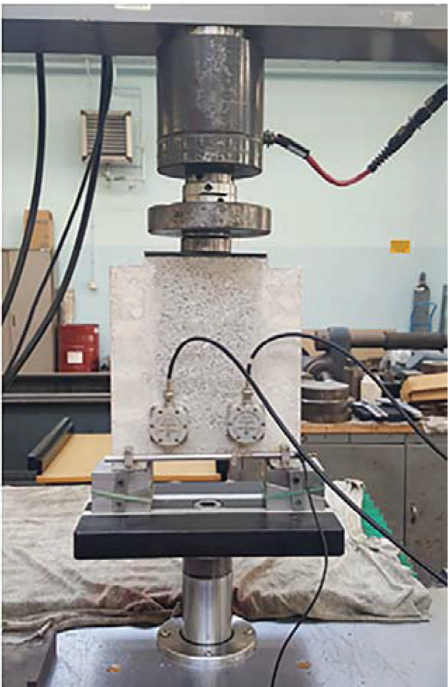
Figure 17. Geometry of composite specimen and test setup.

For carrying out tests, a particular geometry of the composite specimen has been proposed. Four mixed specimens were made, applying a 40 mm mortar layer to both shorter faces of the stone brick suitably cut with the dimensions shown in **Figure 17**. The mechanical characteristics of the repair mortar and the stone brick were chosen equivalent to those of the stone masonry at the Sacro Monte di Varallo. The experimental test can carry out also by masonry brick, if the historical walls were made by bricks. The hydraulic lime mortar was a pre-blended transpiring product, for dehumidifying repair work on historical masonry
