Experimental Fatigue Test for Pre-Qualification of Repair Mortars Applied to Historical Masonry

Alessandro Grazzini

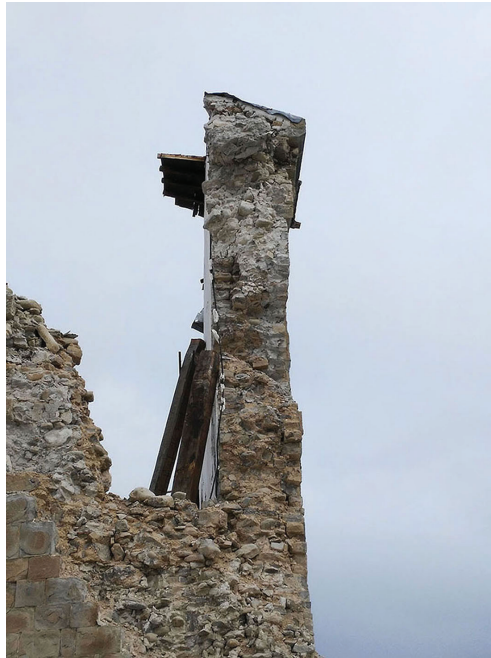
Figure 1. Collapse of the St. Agostino church in Amatrice after the Central Italy earthquake 2016 (image courtesy of the Curia of Rieti).

Recent earthquakes have shown the clear failure of restoration work performed with the use of concrete materials, the excessive stiffness of which has completely distorted the original characteristics of historical masonry buildings. **Figure 1** shows the ineffectiveness of the cementitious insertion materials inside historical walls of the St. Agostino church, collapsed during the last great Italian earthquake of Amatrice, just in correspondence with the previous stitching made by cement injections.

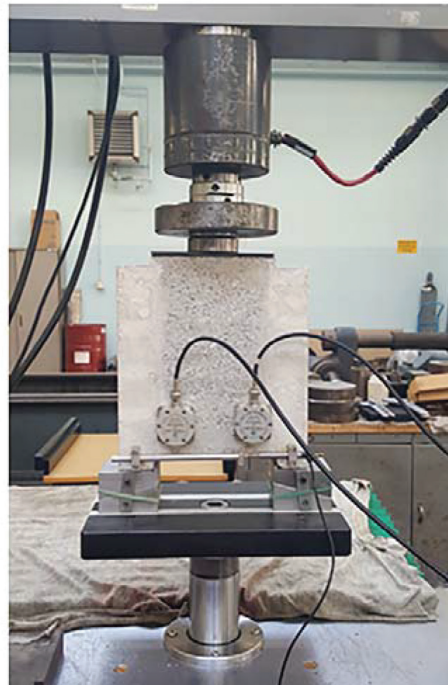
Figure 17. Geometry of composite specimen and test setup.

For carrying out tests, a particular geometry of the composite specimen has been proposed. Four mixed specimens were made, applying a 40 mm mortar layer to both shorter faces of the stone brick suitably cut with the dimensions shown in **Figure 17**. The mechanical characteristics of the repair mortar and the stone brick were chosen equivalent to those of the stone masonry at the Sacro Monte di Varallo. The experimental test can carry out also by masonry brick, if the historical walls were made by bricks. The hydraulic lime mortar was a pre-blended transpiring product, for dehumidifying repair work on historical masonry
