In Situ Analysis of Plaster Detachment by Impact Tests

# In Situ Analysis of Plaster Detachment by Impact Tests

Alessandro Grazzini

An experimental analysis of the stability of the decorated plaster covering three masonry vaults of the Birago Palace (16th century, planned by Filippo Juvarra) in the center of Turin was described by the use of the impact method test. The frescoed vaults of the Pelagi, Blu, and Giunta rooms showed some small cracks branched out in a layer of plaster that needed an evaluation regarding the risk of detachment (Figures 1–3). Surveys carried out on several points of the vaulted surfaces allowed mapping of the points of potential detachment of the de-coated plaster.

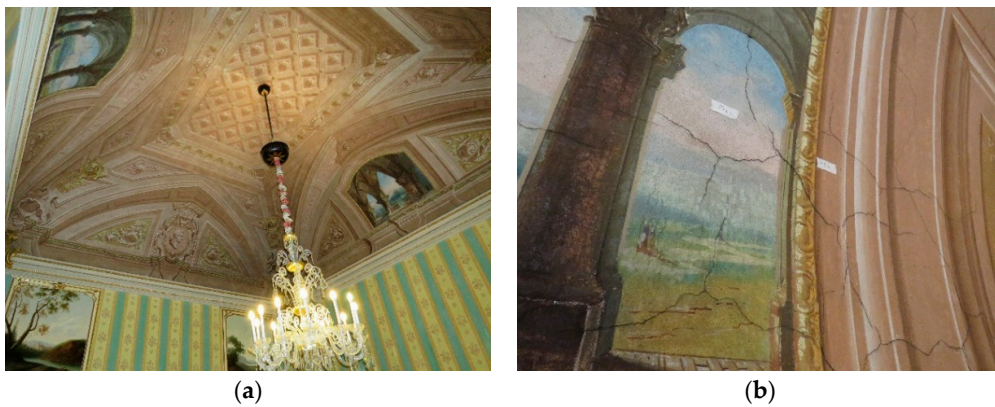
**Figure 1.** (a) Pelagi room at Birago Palace; (b) cracks branched in the decorated plaster of the masonry vault in the Pelagi room.

The decorated surfaces of the vaults therefore appeared to be in a good state of conservation. The ramified cracks present in most of the surface derive from the shrinkage effects of the historical plaster mortar, due to different reasons: climatic conditions, setting of the binders (lime and cement), binder/inert quantity ratio.

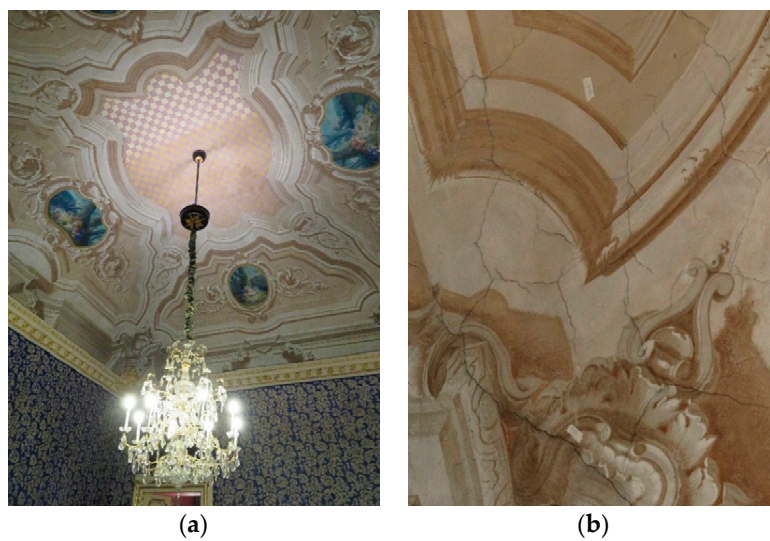
**Figure 2.** (a) Blu room at Birago Palace; (b) cracks branched in the decorated plaster of the masonry vault in the Blu room.

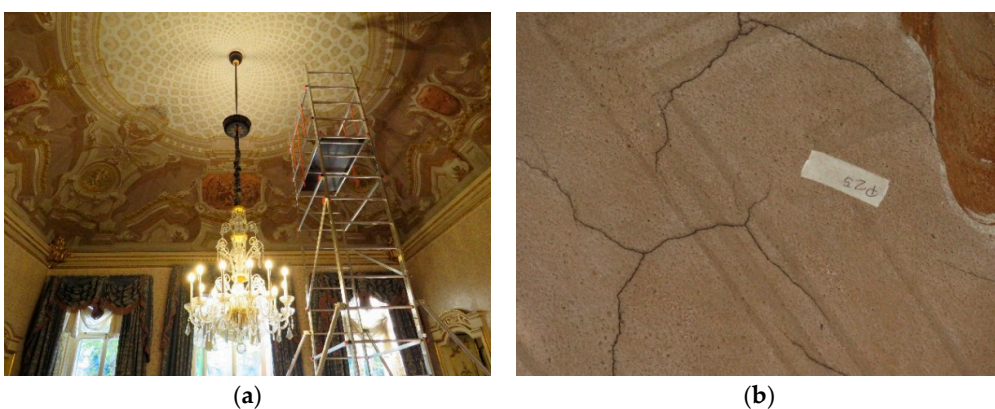
**Figure 3.** (a) Giunta room at Birago Palace; (b) cracks branched in the decorated plaster of the masonry vault in the Giunta room.

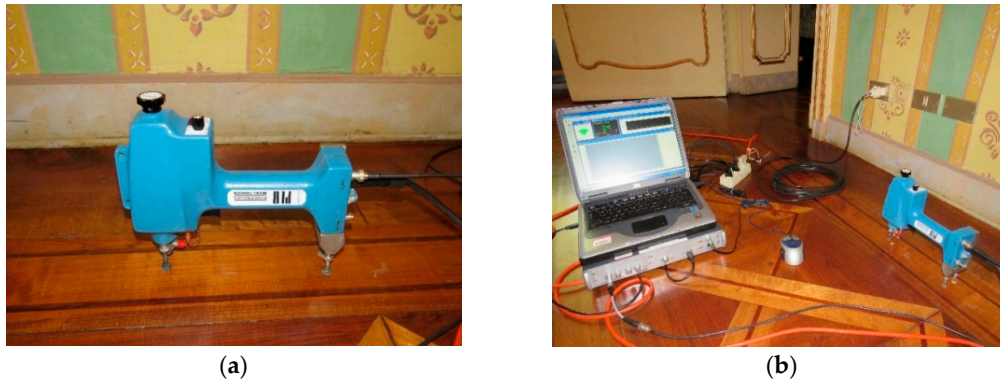
The instrumentation used to carry out the tests consisted of an impact instrumented hammer and a data analyzer. The electric impact hammer used was: PCB Piezotronics; model 086B09; force variable from 44.48 N to 4448.26 N; 208M51 model PCB force sensor; force sensor sensitivity 2.47 mV/N

(Figure 4a). The electric impact hammer was predetermined energy, characterized by the presence of one amplifier level and impedance adapter and a spherical head (10 mm diameter) in cemented steel rigidly connected to a piezoelectric impulse transducer with a total mass of 207 g.

**Figure 4.** (a) The electric impact hammer; (b) the LMS Pimento multi-channel signal analyzer.

The LMS Pimento multi-channel signal analyzer, with the “real-time” acquisition and recording function, had the following characteristics: model MSP 424; number of channels 4; input range:  $\pm 316 \text{ mV} \div \pm 31.6 \text{ mV}$ ; 24-bit ADC (analog digital converter); bandwidth greater than 20 kHz (on all channels); signal sampling rate up to 100 ksamples/second; and personal computer interface: FireWire IEEE1394—managed by its own dedicated software (Figure 4b).

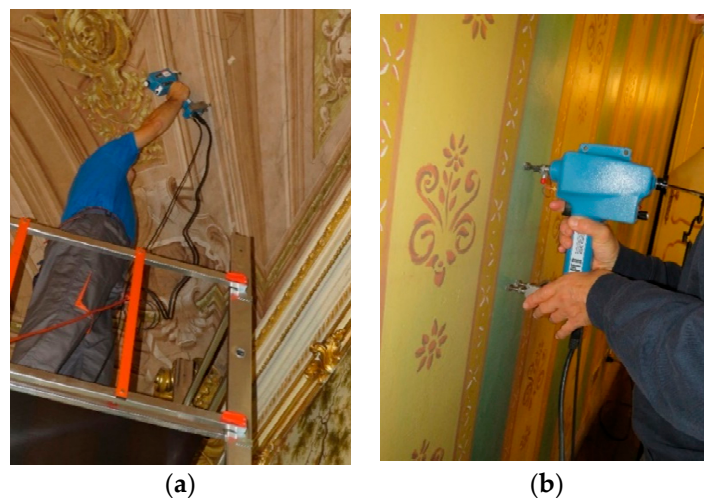
The points of the vault were randomly selected according to the logistic possibilities of movement inside the three rooms through mobile scaffolding. Most of the points chosen were found inside the cracked areas where there was a need to evaluate the adherence of the plaster on the masonry vault. Several points were also analyzed in non-cracked areas in order to compare the experimental results with the cracked points. For each point, at least three acquisitions were made to improve the statistical data (Figure 5a). For each single point test, the instrumented hammer was positioned with the impact mass perpendicular to the test surface. The perpendicularity was achieved by means of the four metallic footsies (Figure 5b). The test consisted in generating a small impact of the hammer’s mass against the test surface, with an absolutely non-destructive intensity, and therefore, also compatible with the conservation of the frescoed surfaces. The impact was triggered by a trigger control on the electric impact hammer.

**Figure 5.** (a) Use of the electric impact hammer for the adherence test of the frescoed plaster of the masonry vaults at Birago Palace; (b) calibration test where it is possible to see the positioning of the electric impact hammer on the test surface.

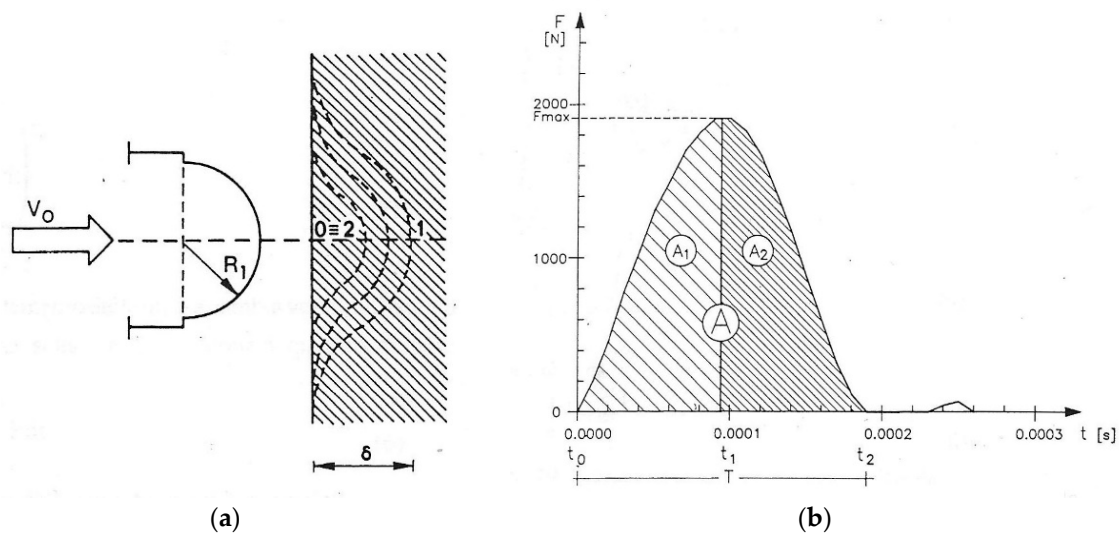
Considering the instant  $t_0$  in which the mass touches the surface and the instant  $t_1$  in which the maximum contact deformation  $\delta$  occurs and in which the velocity  $v_0$  is canceled (Figure 6a), the corresponding momentum variation results:

The force impulse is given by the area  $A_1$  subtended to the curve  $(F, t)$  obtained experimentally as shown in the Figure 6b.

Figure 6. (a) Geometry of the mobile mass; (b) force–time curve obtained from an impact test.

Figure 6b shows that the return coefficient is given by the following equation:

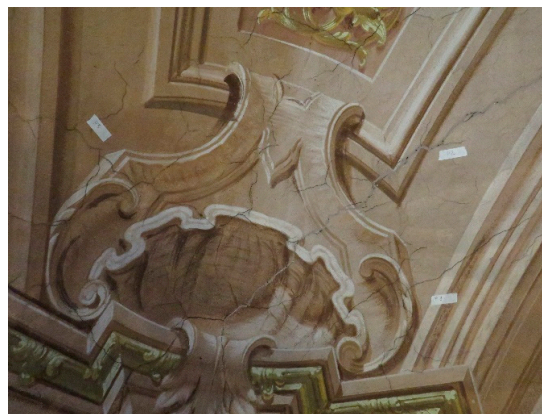
In the impact test carried out at Birago Palace in Turin (Italy), every masonry vault was divided into survey areas as shown in Figure 7, labeled with alphabet letters, within which both apparently intact and potentially damaged points were tested. For each point, at least three impacts were performed to obtain a better statistical response, and the return coefficient  $e$  was evaluated. The maps of the areas tested and the force–time curves of some tested points are shown, respectively, in the Pelagi (Figures 8 and 9), Blu (Figures 10 and 11), and Giunta rooms (Figures 12 and 13). Tables 1–3 show the coefficient averages for each point.

Figure 7. Survey area on the Pelagi room vault.

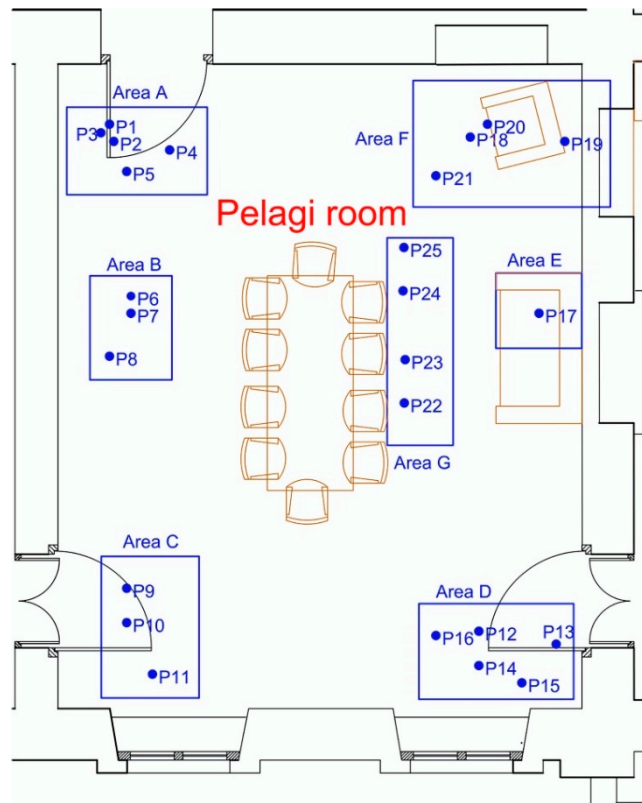
Figure 8. Map of the points and areas tested on the vault of the Pelagi room.

Area	Test Point	$e = A_2/A_1$	Notes	Adhesion Plaster
A	P1	0.77		safe
	P2	1.21	stuccoing	not safe
	P3	0.83		safe
	P4	1.08		not safe
	P5	1.33	stuccoing	not safe
B	P6	0.74		safe
	P7	0.73		safe
	P8	0.71		safe
C	P9	0.66		safe
	P10	0.91		safe
	P11	1.36		not safe
D	P12	0.66		safe
	P13	0.62		safe
	P14	0.65		safe
	P15	0.73		safe
	P16	0.75		safe
E	P17	0.91		safe
F	P18	0.69		safe
	P19	0.73		safe
	P20	1.43		not safe
	P21	0.68		safe
G	P22	0.60		safe
	P23	0.62		safe
	P24	1.19		not safe
	P25	0.69		safe

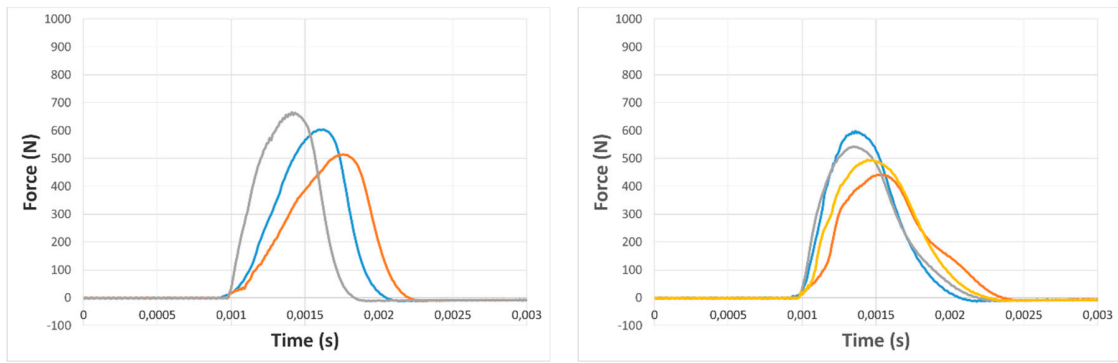
Figure 9. Impact test on Pelagi room vault: force–time curve of (a) P13 test; (b) P5 test.

The points where the plaster was still adherent to the wall surface showed more symmetrical and regular force–time curves, with higher values than the maximum impact force as the material was more compact (Figures 9a, 11a and 13a). On the contrary, in the points already covered by previous

stuccoing, lower values of the maximum force and more asymmetric curves were recorded in which the area after maximum force was greater than that which preceded it (Figures 9b, 11b and 13b).

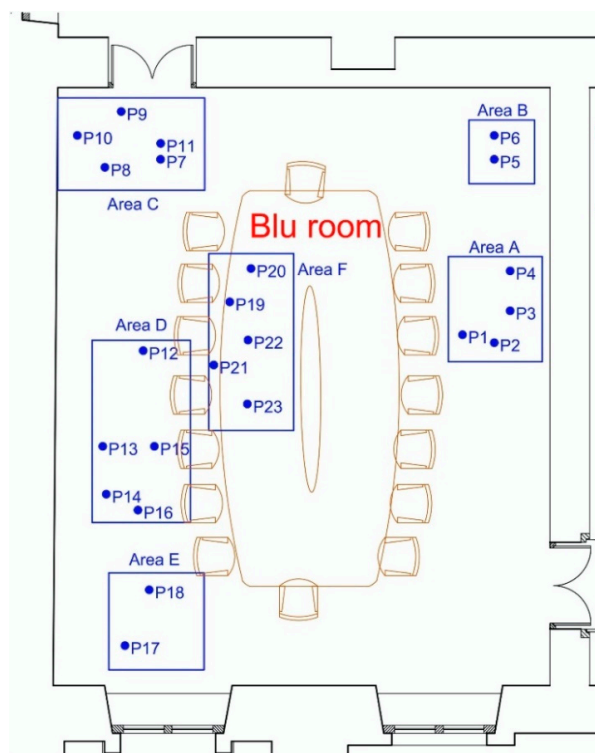
Figure 10. Map of the points and areas tested on the vault of the Blu room.

Area	Test Point	$e = A_2/A_1$	Notes	Adhesion Plaster
A	P1	0.68	Stuccoing	safe
	P2	0.75		safe
	P3	0.71		safe
	P4	1.98		not safe
B	P5	0.78		safe
	P6	0.65		safe
C	P7	0.77		safe
	P8	0.76		safe
	P9	0.84		safe
	P10	0.79		safe
	P11	0.78		safe
D	P12	0.75		safe
	P13	1.11		not safe
	P14	0.87		safe
	P15	0.70		safe
	P16	0.56		safe
E	P17	0.83		safe
	P18	0.63		safe
F	P19	0.72		safe
	P20	0.66		safe
	P21	0.66		safe
	P22	0.70		safe
	P23	0.73		safe

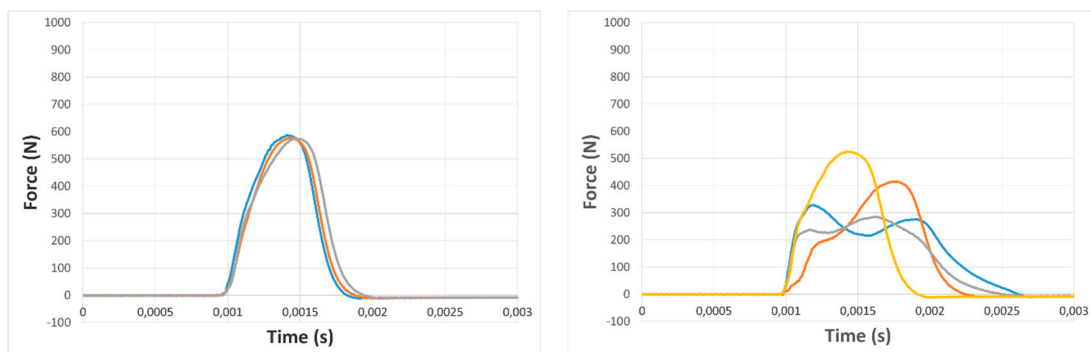
Figure 11. Impact test on Blu room vault: Force–time curve of (a) P7 test; (b) P4 test.

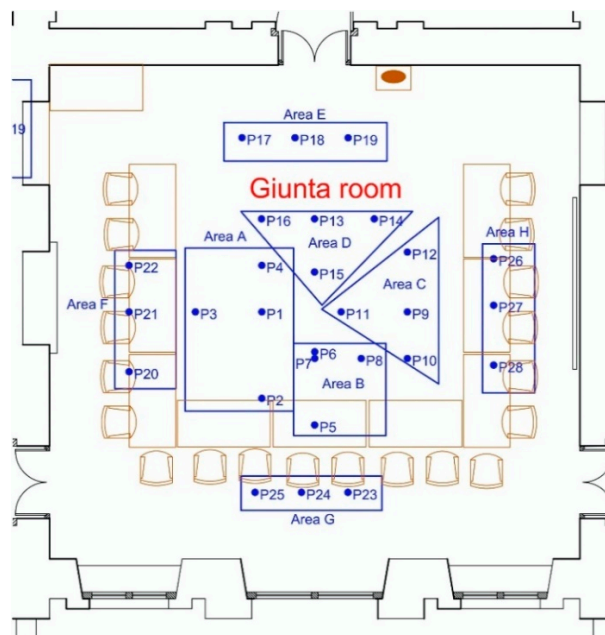
**Figure 12.** Map of the points and areas tested on the vault of the Giunta room.

Area	Test Point	$e = A_2/A_1$	Notes	Adhesion Plaster
A	P1	0.68		safe
	P2	0.74		safe
	P3	0.70		safe
	P4	0.65		safe
B	P5	0.84		safe
	P6	0.73		safe
	P7	0.72		safe
	P8	0.77		safe
C	P9	0.93		safe
	P10	0.70		safe
	P11	0.80		safe
	P12	0.72		safe
D	P13	0.65		safe
	P14	0.78		safe
	P15	1.07	Wiring channel	not safe
	P16	0.74		safe
E	P17	1.04		not safe
	P18	1.26		not safe
	P19	0.70	Stuccoing	safe
F	P20	0.74		safe
	P21	0.74		safe
	P22	0.68		safe
G	P23	0.66		safe
	P24	0.62		safe
	P25	0.77		safe
H	P26	0.75		safe
	P27	0.71		safe
	P28	0.62		safe

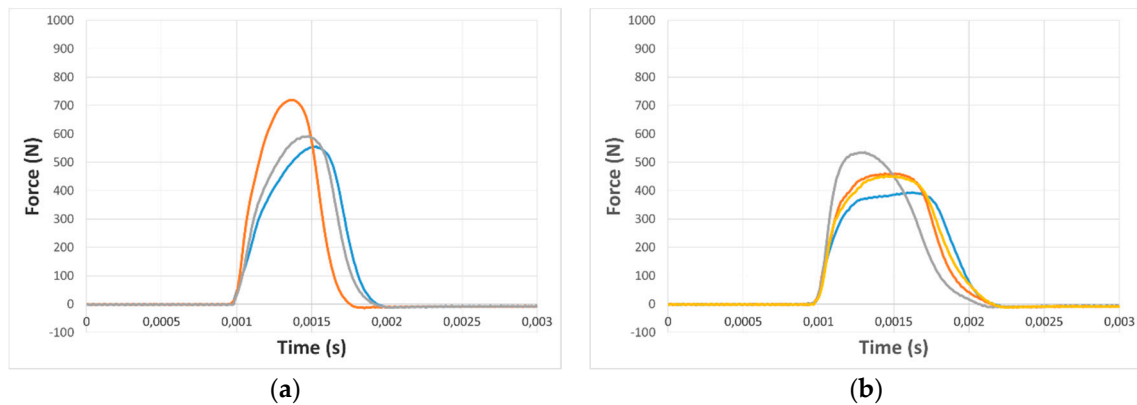
It is possible to observe that most of the points tested had a return coefficient  $e$  lower than 1. This means that the energy returned was lower than that emitted, because part of this energy was dissipated by the tested structure through sufficient bonds in the interface between the plaster and the masonry surface. On the contrary, the return coefficient  $e > 1$  showed a returned energy greater than the one emitted: in this case the material was already damaged [4,5] because it was partly or

completely disconnected and returned more energy due to the deformations and the microscopic movements active due the non-perfect adherence between plaster and masonry surface.

Figure 13. Impact test on Giunta room vault: force–time curve of (a) P4 test; (b) P15 test.

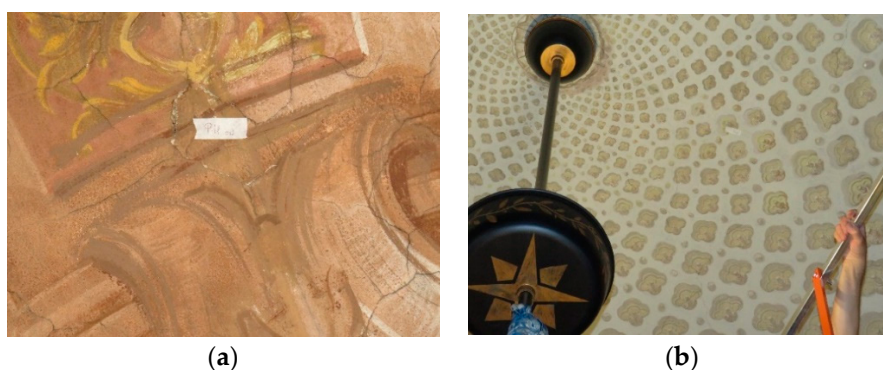
On the masonry vault of the rooms some points of potential detachment of plaster have been found, characterized by a return coefficient  $e > 1$  (Tables 1–3). These results were in agreement with what has been possible to perceive qualitatively with a simple hand knock on the point under investigation. Some of these points with a high return coefficient were stuccoed previously, a sign that some critical issues of potential detachment already existed in the past (Figure 14). In some cases, as for point P15 of the Giunta room, the impact method confirmed the presence of an installation channel that feeds the chandelier as a zone with weak adherence of the plaster (Figures 13b and 14b).

**Figure 14.** Points of potential plaster detachment: (a) P11 vault Pelagi room; (b) P15 vault Giunta room.

Overall, the impact test showed the stability and safety of the adhesion between decorated plaster and masonry surfaces of the vaults examined in the three rooms. Some points of lesser safety regarding adherence have emerged. Some of these concerns point to previously stuccoed areas only a few decades old. This point highlighted the potential critical stability of some of the plaster, which had already been the subject of micro-grouting, and for which restorations had not been perfectly carried out. On the contrary many other previously stuccoed points showed a return coefficient  $<1$ . The impact method was therefore also useful to qualify the effectiveness of previous restoration work.
