LIDAR DATA ANALYSES FOR ASSESSING THE CONSERVATION STATUS OF THE SO-CALLED BATHS-CHURCH IN HIERAPOLIS OF PHRYGIA (TR)

C. Marson¹, G. Sammartano², A. Spanò^{2*}, M.R. Valluzzi³

KEY WORDS: LiDAR Data, 3D models, feature detection, structural assessment, damages, decay, cracks detection

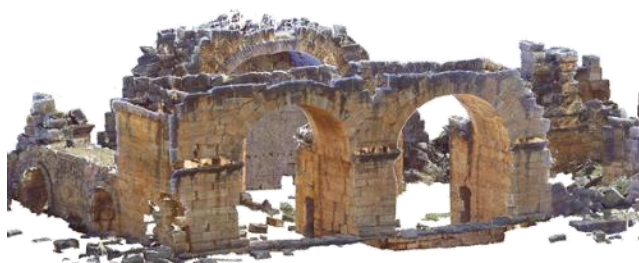
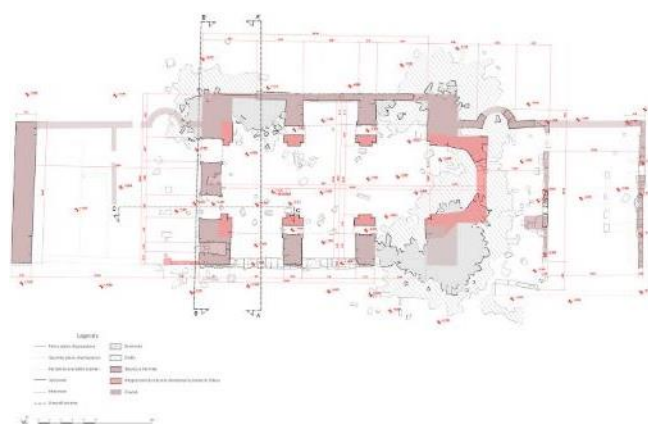
Figure 2. (a) Two general view of the overall LIDAR points cloud (b) the eastern structural system including one-barrel double rings vault, and first and second-phase pillars in some points cloud views; (c) the dimensioned architectural plan of the building. (Invernizzi, Spanò, Alferi, 2014)

Today, compared to the original configuration of the complex, the building is subdivided by three main structural parts, quite well conserved (Figure 2a):

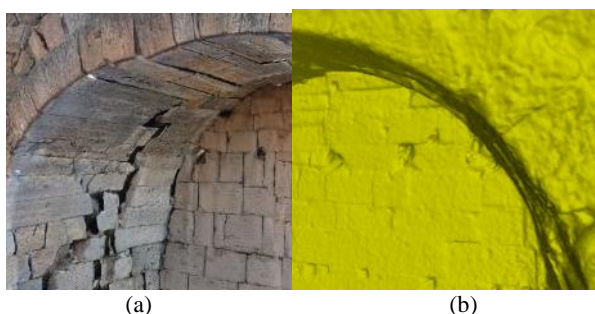
Figure 4. The travertine blocks clearly legible in the triangulated mesh (b) computed from the dense 3D point cloud generated from an oriented images block; moreover, interpretable with high quality texture (a)

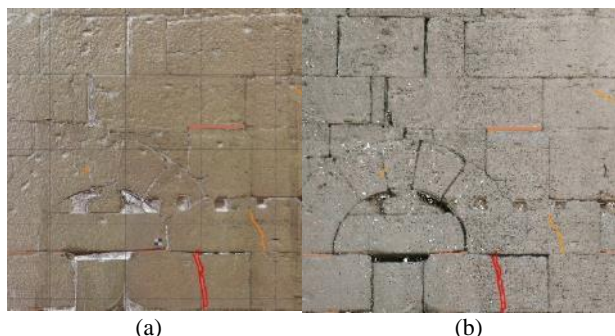
Figure 5. Degradation and cracking pattern superimposed to the different sensors orthoimages: TLS (a) and close-range image-matching (b)

Figures 5 show a well interpretable comparison between descriptive capabilities of an SfM orthoimage and a LiDAR points cloud planar view: the search and detection of details whose identification is favoured by the light/shadow component of the images is certainly easier in the orthophoto of image based approach generation.

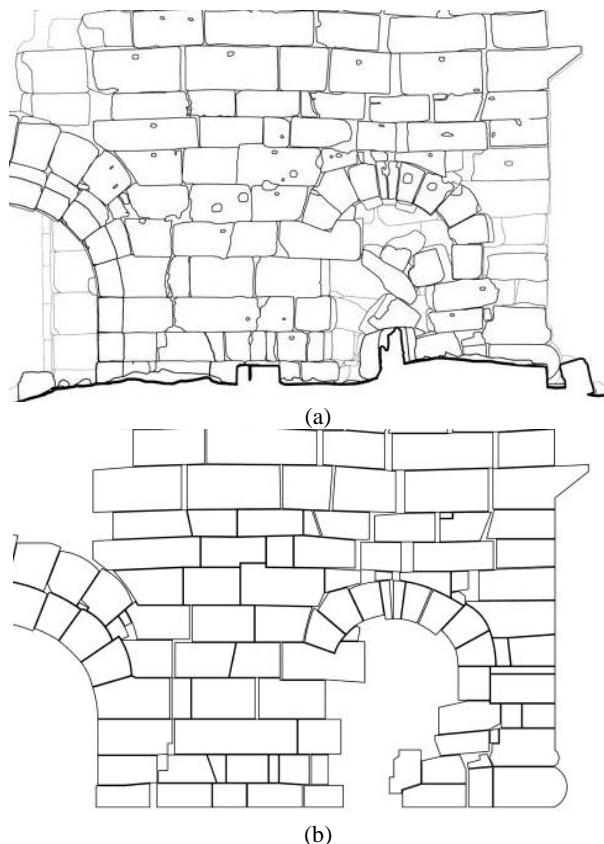
Figure 6. Different level of detail in (a) vectorialization of masonry blocks and in (b) discretized geometry for the structural analyses.

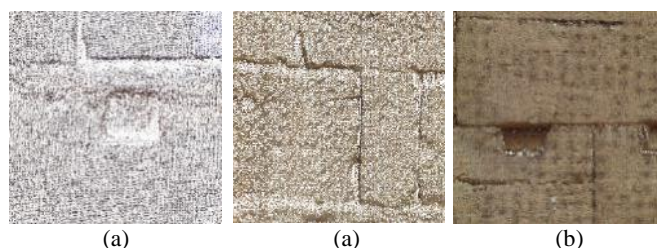
Figure 7. Digitalization of the LiDAR point cloud orthoprojection, with different rasterization resolution (*PointCab* interface): 1 mm/px 970Mb; 5mm/px, 1.3Mb; 1cm/px, 2.29Mb

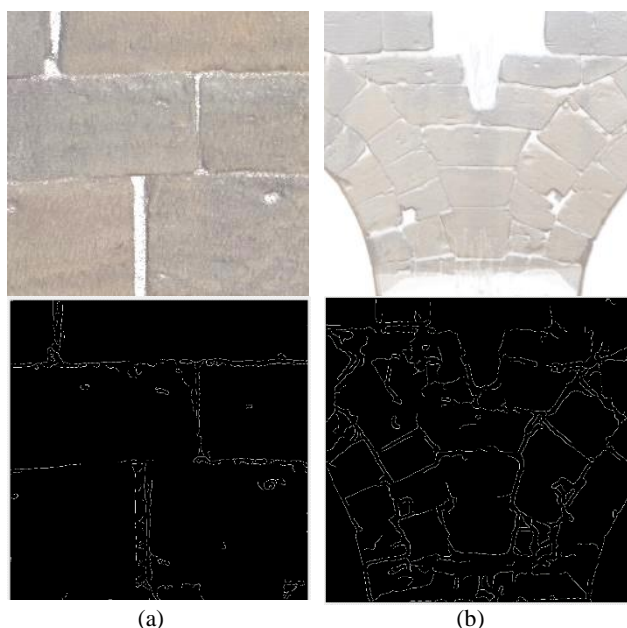
Figure 8. Test on edge detection algorithms applied on two different types of initial raster data referring to the blocks: algorithm applied to orthoimages: (a) raw and (b) processed for radiometric quality value balancing and contrast increasing.

In fact, the *Canny*, *Prewitt* and *Sobel* algorithms were tested on differently processed initial images, operating on the grayscale image and with varying threshold values of the edges extraction in terms of numbers of segments, continuity and noise values.

In figure 8, the *Canny* algorithm (Rong et al, 2014) performance was tested based on a sample of raw orthoimage (figure 8a), and on a radiometrically processed orthoimage (figure 8b) for contrast increasing.

In the first simple case, the threshold of 0.2 was associated to a standard deviation (σ) values of 3: for this kind of image, smaller values caused strong noise effects and higher values lead to loss of edge extraction and continuity. The second case portraying multiple blocks in the extracted orthoimage, originates better results by the use of threshold =0.2 and 5 sigma.

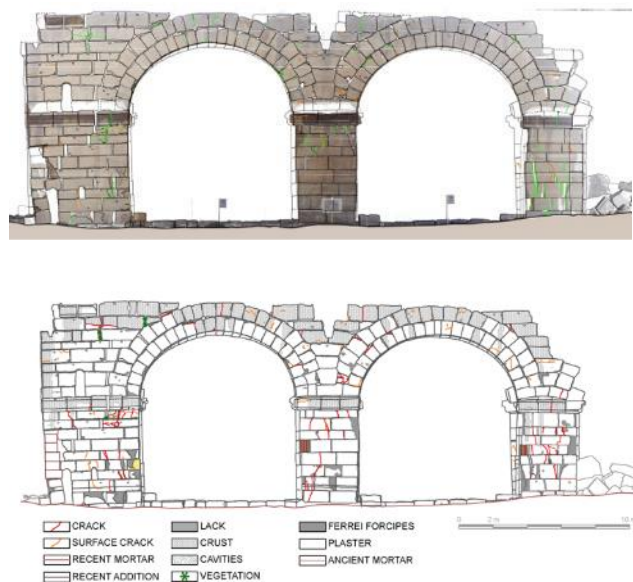
Figure 11. Deterioration map and cracking pattern of the north-western façade.

Three Roman pillars, two Byzantine pillars, two double rings Roman vaults (Figure 11) and the northern façade, compose the structural system. It is built with travertine blocks lying on mortar layers of different thicknesses (thin for Roman parts, thick for Byzantine ones) and somewhere not preserved.

The façade (Figure 11), is a Roman phase structures., the vaults overcome 9 m of span, and reach almost 4 m of height above pillars 6.50 m high.

The deterioration map and cracking pattern showed in Figure 11 outline the progression of cracks, gaps and detachments. This constitutes the starting point for identifying parts involved in mechanisms of collapse, which can be local or global, already activated or potential.

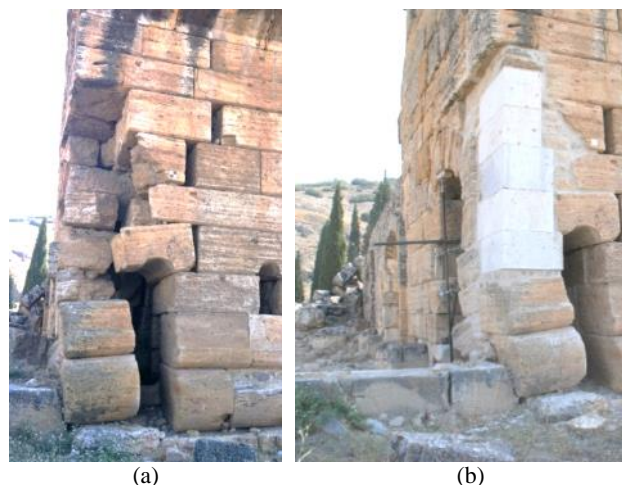
Figure 12. (a) lacks of blocks at the north-western corner and (b) more recent integration of blocks.

The interpretation of the causes that led to the current configuration cannot disregard the analysis of the construction techniques applied. The Baths-Church are composed by a system of interlocked travertine blocks. The extended overlapping, possible thanks to the great dimensions of blocks, allows the structure maintaining equilibrium also in critical condition, such as widespread lacks (Figure 12) or considerable sliding between blocks. Obviously, when a block does not have a continuous supporting surface and the force exceeds its strength, a crack develops and the system could become unstable. Figure 12 (a) represents first condition, not evolved in collapse thanks to the integration of corner blocks Figure 12 (b).

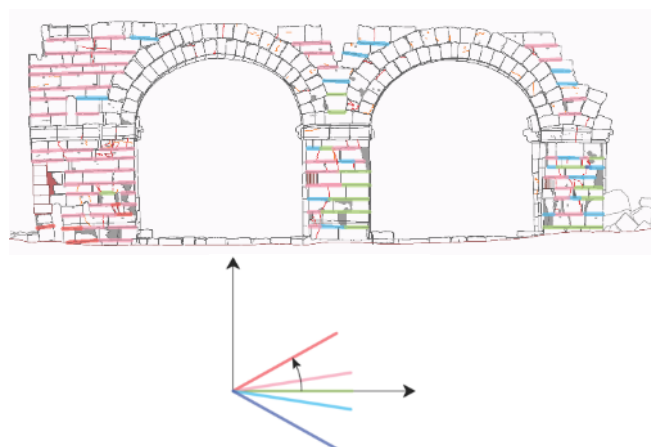
Figure 13. Deformation map. The color scale indicates the degree of inclination of the block base and its direction of possible movement.

For example, the northern pillar (left one in Figure 13) blocks present inclined plane of $+2^\circ$: the rotation of the springer caused the consequent deformation of the first vault. Moreover, the central and the right pillars present in their centre lines discordant angles and related widespread cracks.

In the north-western façade, sliding between blocks reaches 16 cm. The right spring of the southern vault has a drop of 14 cm less than the left one, causing a general deformation of its shape: the structural system is thus involved in a kinematic chain of collapse.

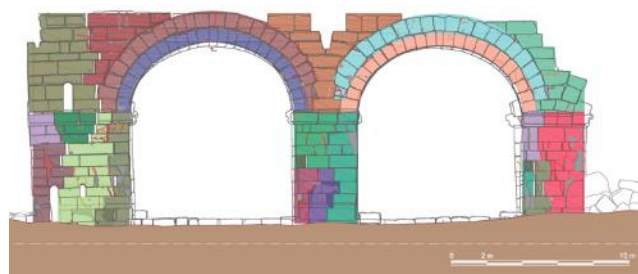
Figure 14. Identification of kinematic portion.

The integration of the evaluation of the conservation state, the crack pattern and the failure mechanisms allow for identifying kinematic portions for structural assessments of seismic vulnerability to be implemented in the calculation codes. For the façade in question, they are plotted in Figure 14.

The portions are composed by elements involved in the same structural behaviour.
