VI ITALIAN CONFERENCE OF RESEARCHERS IN GEOTECHNICAL ENGINEERING –  
Geotechnical Engineering in Multidisciplinary Research: from Microscale to Regional Scale,  
CNRIG2016

## Study of the mechanical properties of a conglomerate

This paper is devoted to the study of a conglomerate rock formation (Molare Formation) outcropping in southern Piedmont that forms a natural arch of environmental interest. Awareness with respect to the stability of this structure emerged after some intense rains which caused small collapses at the arch foot. The need for a proper characterization of the material in its natural state and its deterioration following increased water saturation is needed. A multidisciplinary approach based on the integration of both in situ and laboratory geophysical tests for the assessment of the rock structure at different scales was performed. Geological surveys together with seismic tomography and GPR have been executed on site. Petrographical and compositional studies of the matrix, ultrasonic pulse velocity measurements, electrical resistivity determinations and standard UCS test on large specimens are under development in laboratory.

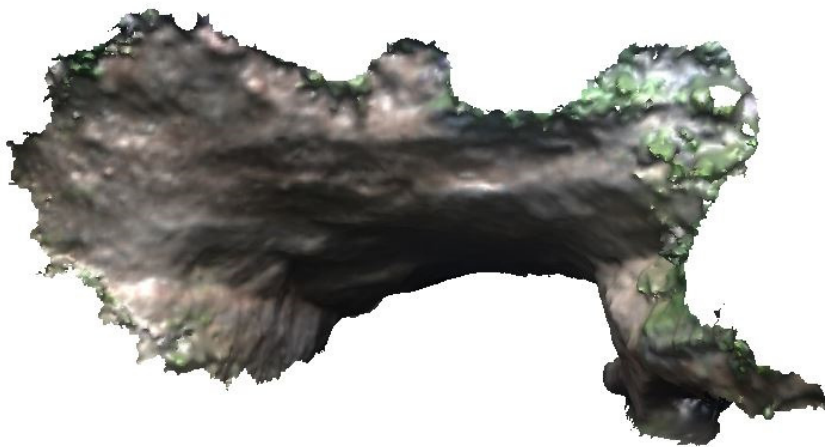
Fig. 2. View of Side 1 of the total model, after deleting vegetation and scattered points.

A photogrammetric survey has been performed on both sides of the natural bridge. It consisted in the acquisition of two sets of images covering as much as possible the arch surfaces, considering constraints due to the presence of water and vegetation. Since the aim of the survey was to create a total DSM (Digital Surface Model) of the visible surface of the arch in the easiest possible way and in a local reference system, we materialized a system suitable for unifying the models obtained from the two sides. Basically, we placed two level staffs so that they were visible from both sides of the arch; by means of the code Agisoft Photoscan we collimated, on both sets of images, at least 4 well recognizable points, two for each level staff. The vertical axis was made coincident with the level staff 1 and the origin was fixed at the base of it; the model was scaled by assigning a known distance, that is the length of a red part of the level staff, which is equal to 20 cm. The relative coordinates of the collimated points were properly assigned (e.g. the diameter of the level staff was taken into account), in order to make the reference system of the two sets of images coincide. By processing the two distinct sets of images (one for each side) by means of the code Agisoft Photoscan, two colored digital models were obtained. Since their reference system was identical, the operation to merge them was banal. The total model was then manually cleaned in order to delete vegetation and scattered points. The final model is composed by about 60'000 points, with a resolution of about 1 point every 10 cm. In Figure 2, a View of Side 1 of the total model, after deleting vegetation and scattered points is reported. This model has been adopted for the final rendering of geophysical results and the development of the bridge stability analysis.
