# Realization and Use of an IR Camera for Laboratory and On-field Electroluminescence Inspections of Silicon Photovoltaic Modules

Alessandro Ciocia<sup>1</sup>, Alessio Carullo<sup>2</sup>, Paolo Di Leo<sup>1</sup>, Gabriele Malgaroli<sup>1</sup>, and Filippo Spertino<sup>1</sup>

**Abstract** — Electroluminescence (EL) is a non-destructive technique, which detects the most common defects in Photovoltaic (PV) modules. High resolution EL images are generally obtained by infrared-sensitive cameras equipped with different semiconductors (indium gallium arsenide or silicon sensors). In the present work, a procedure is proposed to build and set up a high resolution EL camera for crystalline Si modules, equipped with a low-cost Si sensor. It can be used to perform EL test both indoor (lab) and outdoor (on-field). Experimental results from real PV plant highlight the combined use of  $I$ - $V$  curves and EL images, for determining the amount of power losses and their causes.

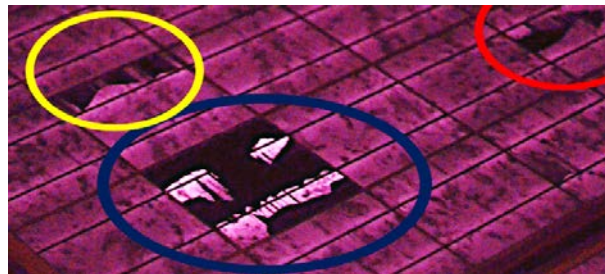
Fig. 11. EL detail of defective cells in the modules of Fig. 9.

In case of defects detection (Fig. 10), the module is analyzed more closely and details about failures are stored with high resolution (Fig. 11). The  $I$ - $V$  curve characterization shows high power deviations for all the 18 strings composing the plants, with values from -12% up to -20%. The  $I$ - $V$  and power-voltage ( $P$ - $V$ ) curves of one string are shown in Fig.12. The shape of  $I$ - $V$  curve is not smooth near the maximum power point due to broken cells. Moreover, the current starts decreasing from short circuit condition, due to a decreased shunt resistance with respect to a well working module. Thus, to recover the energy production of the plant, the replacement of the modules will start with those affected by the highest number of defects in those strings with the highest power losses.
