Post-collapse analysis of Morandi's Polcevera viaduct in Genoa Italy

Post-collapse analysis of Morandi's Polcevera viaduct in Genoa Italy / Morgese, M.; Ansari, F.; Domaneschi, M.; Cimellaro, G. P.. - In: JOURNAL OF CIVIL STRUCTURAL HEALTH MONITORING. - ISSN 2190-5452. - STAMPA. - 10:(2020), pp. 69-85. [10.1007/s13349-019-00370-7]

# Post Collapse Analysis of Morandi's Polcevera Viaduct in Genoa Italy

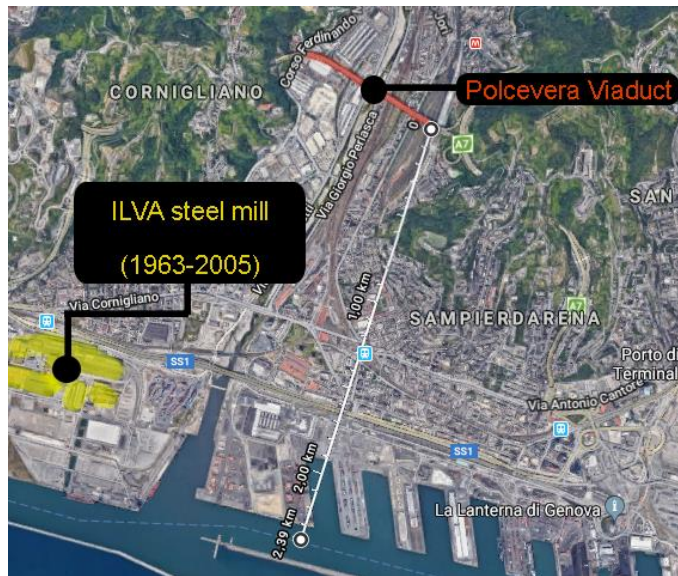
**Figure 1:** Proximity of the Polcevera viaduct to the main sources of corrosive emissions: the sea and an industrial hub

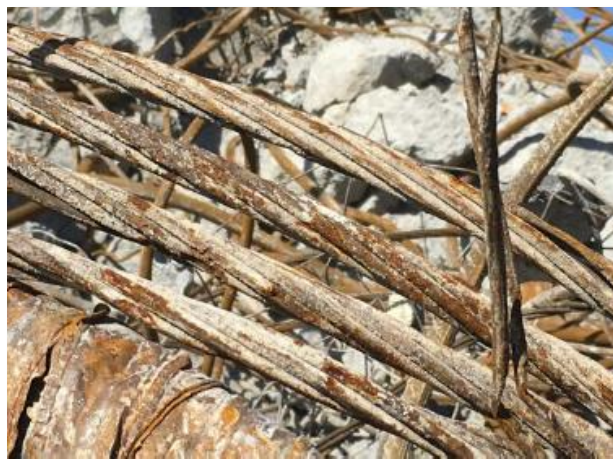
**Figure 2.** Pitting corrosion of prestressing tendons.

Transport (MIT) [16, 17]. Fig. 2 pertains to a photo of the corroded tendons, taken by Autostrade, which is the operating entity for the highway system that includes the Polcevera viaduct.

Following the failure of Polcevera viaduct, some considered the influence of bad weather and lightning on the collapse. However, degradation of the cables due to corrosion was confirmed by an investigation carried out by the inspection commission of the Ministry of Infrastructure and

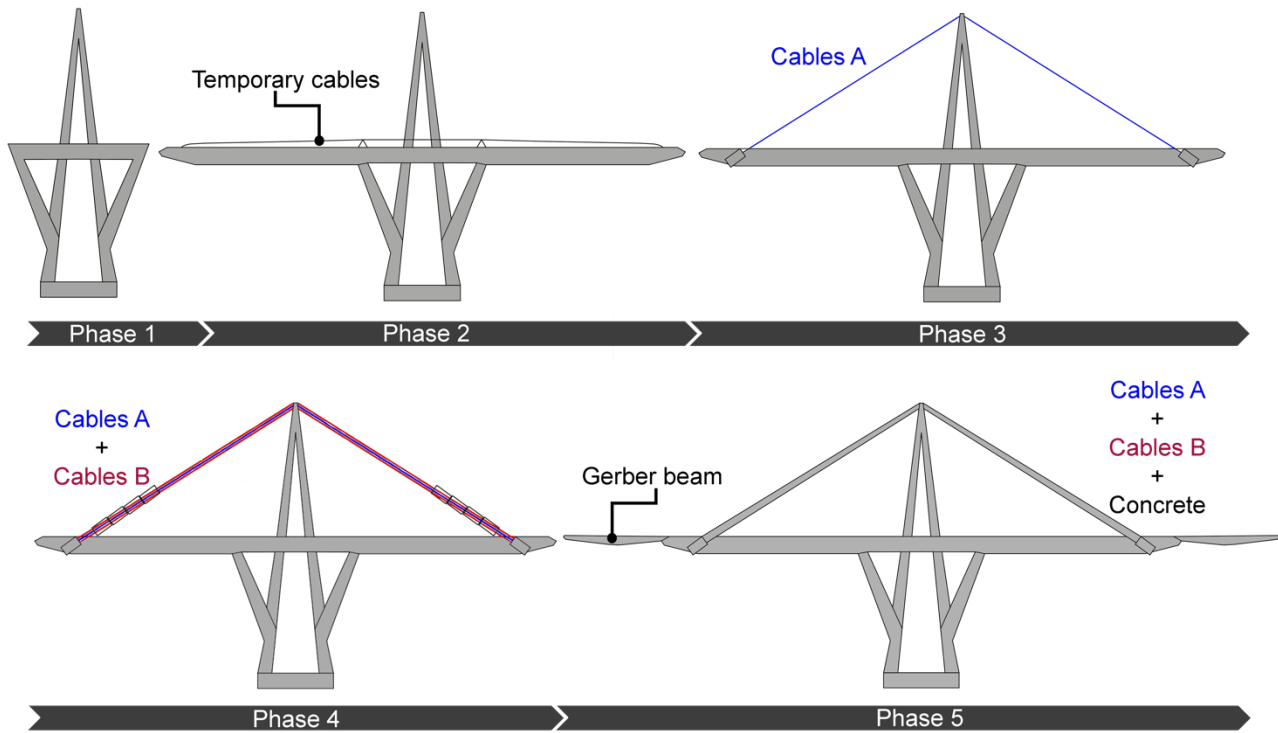
1. The pylons were constructed first, consisting of two V-shaped elements, one of them an inverted V. The V-shaped elements were connected together by transverse beams at top and mid-height, and at the base to the foundation.

under full compression due to the above-mentioned post tensioning processes. The final segment of this phase involved connecting the prestressed concrete stays to the deck girders.

5. Phase 5 involved construction of the simply supported transfer (Gerber) beams, which were employed for connecting the three sets of deck-pylon structures.

**Figure 5.** Construction phases of Polcevera Viaduct.

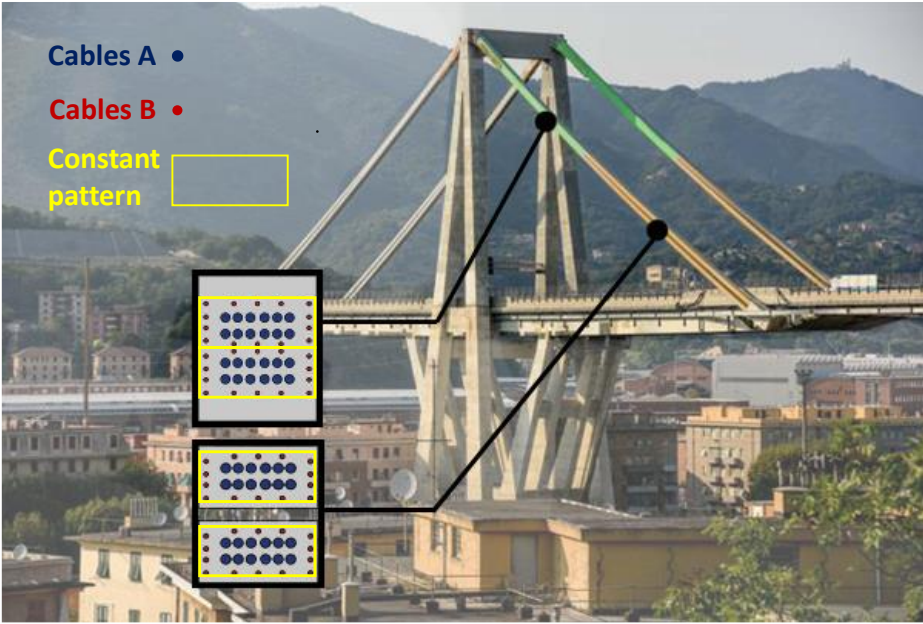
The prestressing tendon details within the cross-sections of the cable stays are shown in the photo of a typical deck-pylon structure of the bridge in Fig.6. The two different cross-sections portray the transition of the stay cable from a single cross-section on the upper portion of the stay on both sides of the saddle to double sections in the lower region, at the connecting points to the bridge deck. The larger single cross section around the saddle was necessary in order to assure smooth transition over the highly concentrated stresses at the saddle. Division of the cross section at the deck was necessary to spread the effect of the concentrated force. Despite the transition, the cross-sectional area and the number of prestressing tendons within each cross-section remained the same (Fig.6). The inner cables (Cables-A), which were installed during phase-3 of the construction

comprised of 24 tendons, each tendon with 12 strands for a total of 288 strands per cable. The external cables (Cables-B), were comprised of 28 tendons, each with 4 strands for a total of 112 strands. A typical tendon pattern signifying the positions of cables-A and B is shown in Fig. 7.

**Figure 6.** Cross-sections of the stays at Polcevera Viaduct

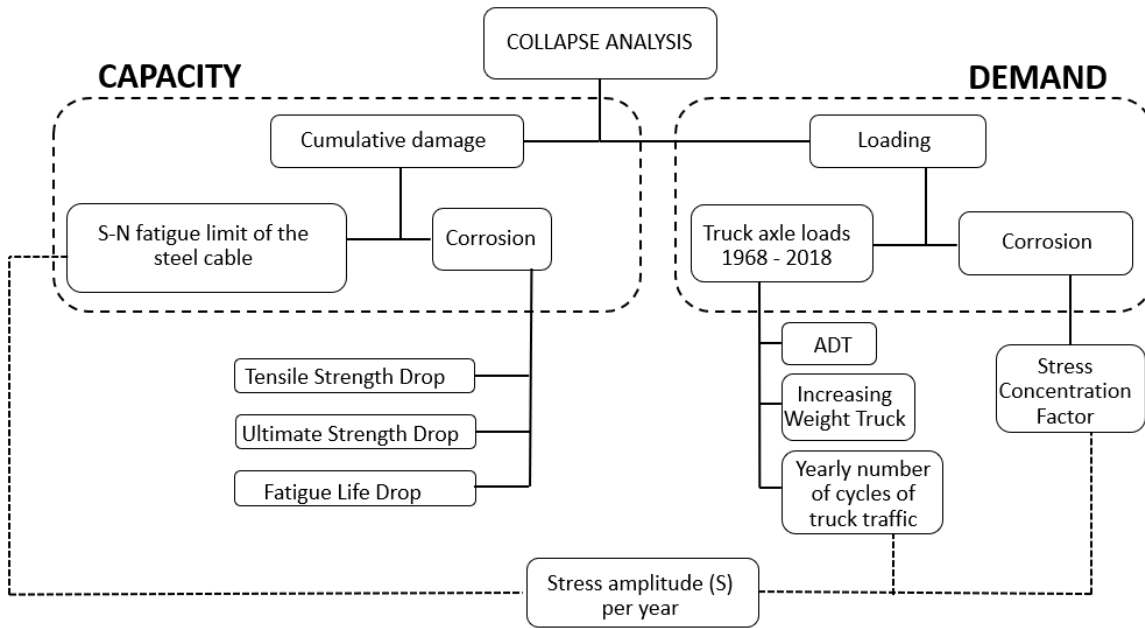
The proposed methodology for the analysis of collapse involves time-domain estimation of bridge capacity loss over the period of bridge service and increase in demand over the same period (1968 – 2018). Fig. 8 is a flowchart providing the overall capacity-demand process for post collapse analysis of the Morandi Bridge. Precursors to the analysis were the facts that: (1) the bridge lacked redundancy; (2) its design possessed unusual features, i.e. concrete cables and the saddles; and (3) the cables were not regularly inspected and or maintained, except for P11 in Fig. 3, which was replaced in 1992 as described earlier. Considering these precursors, the process follows linear analysis, both in terms of yearly decrease in capacity and increase in demand, respectively. The increase in demand was due to both the volume of traffic and the magnitude of truck axle loads over the last 50 years in Europe, and the increase in container ship and cruise ship traffic at the port of Genoa.

**Figure 8.** Flow diagram for the analysis of capacity and demand of the Polcevera Viaduct

Based on the general processes depicted in Fig. 8, post collapse analysis of the bridge requires realistic portrayal of degradation (corrosion and fatigue) and loads over the period of its service life. For estimation of capacity loss due to corrosion and fatigue, the first step in the process involved survey of technical literature for the selection of appropriate models. On the other hand, computation of demand required estimation of loads on the bridge. In addition to the self-weight as the dead load, truck traffic information was employed for the computation of the live loads. Live loads were computed as a representative set of truck axle loads typical of trucks in the Italian design standard guidelines. The number of passenger cars travelling over the bridge increased over the years. However, contribution of passenger cars to the loads were not considered in the post collapse analysis. This was a conservative assumption for the post collapse analysis. A model was also necessary to compute the corrosion related stress changes in the bridge elements over the period of its service. Once sufficient amounts of data and information became available, it was then possible to use the original design drawings of the Morandi bridge for development of a detailed 3D finite element model of the pylon-deck system (P9 in Fig. 3). Influence lines were also computed in order to identify the maximum effect of truck axle loads on internal forces at critical members. Computation of demand and capacity was repeated for each year of service until the
