Technical Note

# Investigation of a CubeSat in Orbit Anomaly through Verification on Ground

The analysis has been developed to study a practical case of interest, i.e., the investigation of an anomaly occurred during the mission of the E-st@r-II CubeSat. The project is carried out by the CubeSat Team of Politecnico di Torino and is part of the first Fly Your Satellite! Programme of the European Space Agency. The CubeSat was launched in 2016 with Soyuz VS14 from French Guyana [34]. E-st@r-II is a 1U CubeSat with the objectives of demonstrating new algorithms for attitude determination and testing in orbit miniaturized technologies for communication systems (COMSYS), on board computer (OBC), electrical power systems (EPS) and structure and mechanisms (S&M).

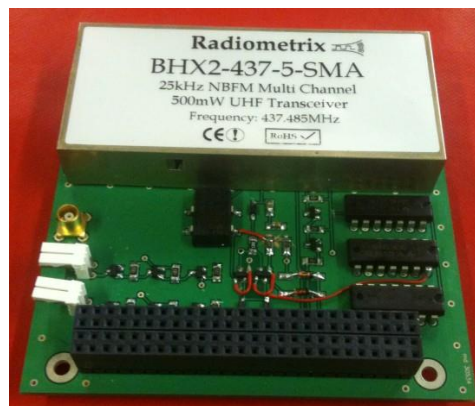
A single electronic board (Figure 5) hosts the following items: the UHF radio-transceiver from Radiometrix Ltd. (model BHX2); the Microchip PIC16F88 microprocessor that acts as a complete Terminal Node Controller (TNC), implementing all the modem functions and protocol adaptation to interface the radio and the OBC; a watch-dog electronics for fault detections; and a crystal oscillator and electrical devices to amplify and filter the signal, and to support the microcontroller operations.

**Figure 5.** COMSYS board.

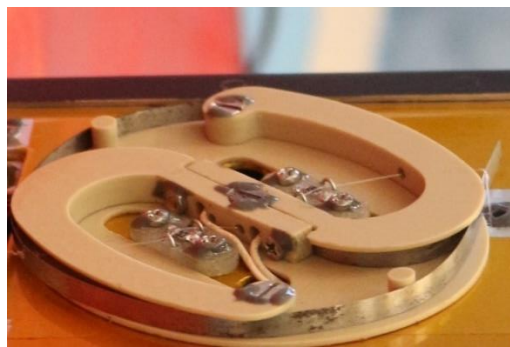
Figure 7 shows the CAD model of the antenna deployment system, and Figure 8 shows the final assembly of the antenna deployment system on the flight module.

Figure 8. Antenna deployment mechanism with the antenna folded around.
