Structural health monitoring of historical heritage in Italy: some relevant experiences

Alessandro De Stefano¹, Emiliano Matta¹, Paolo Clemente²

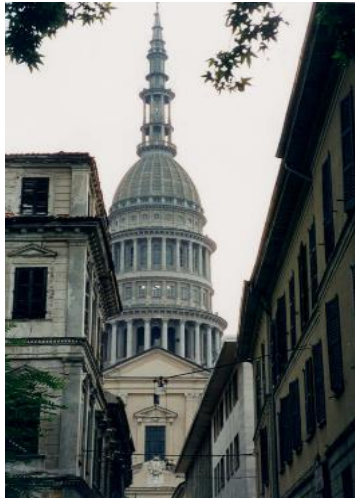
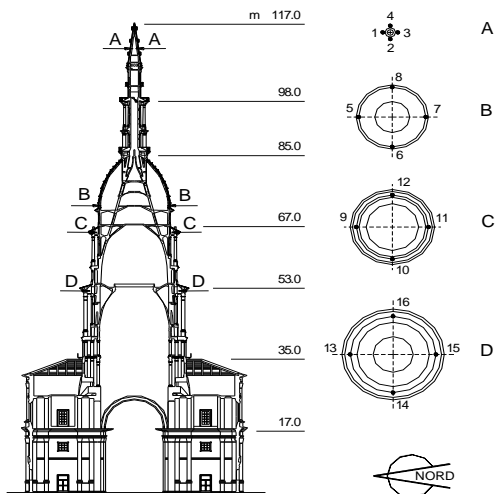
Fig. 2 The dome of S. Gaudenzio Church in Novara: (a) overall view; (b) vertical section

56 A permanent static monitoring system was installed along the dome in 2000, comprising more than one
57 hundred sensors: 52 crack displacement transducers, 16 displacement transducers, 6 load cells, 5 level gauges,
58 one pendulum (to measure the tilt angle of the dome) and several resistive temperature detectors (RTD). The
59 load cells, in particular, measure the tension force in the steel hoops encircling the dome at two different levels,
60 which can be adjusted through hydraulic jacks.
61

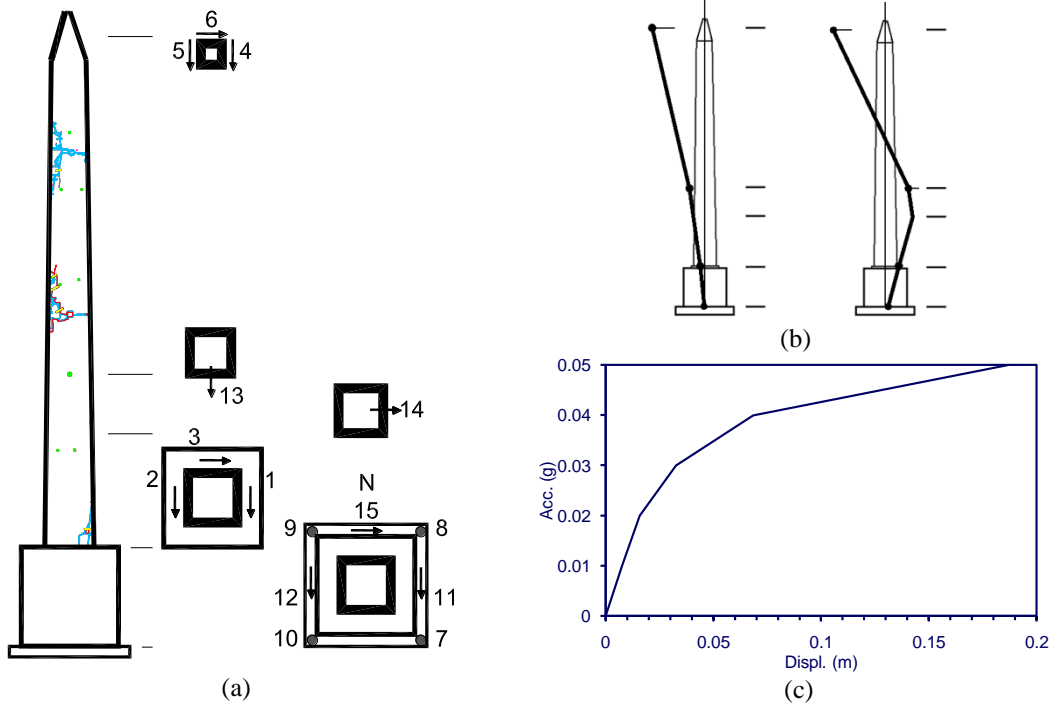
Fig. 8 The Lateran Obelisk in Rome: (a) seismometer locations; (b) N-S modal shapes; (c) acceleration-displacement diagram

1 sonic and radar measurements [48, 49]. The obelisk is 32.2 m tall and rests on a rectangular prismatic pedestal,
2 about 10 m tall, which in turn is placed on a wide stone basement, whose depth is not known as well as the
3 foundation conditions. A Christian cross is at its apex, so the total height is 45.7 m. The Obelisk itself is made of
4 three monolithic tapered red granite blocks, which exhibit various cracks particularly visible near the contact
5 surfaces between the blocks. Externally visible metallic links and small pieces of granite added during past
6 restorations connect the blocks to each other.

11 For all the recordings, time domain and frequency domain analyses were carried out. Resonance
12 frequencies were identified close to 1.27 Hz, for both the N-S and W-E first bending modes. The third and the
13 fourth modes, in the N-S and W-E directions, were associated to frequencies equal to 6.15 Hz and 6.73 Hz,
14 respectively. Modal shapes are plotted in Fig. 8b. No significant amplification effect were pointed out by the
15 HVSR, on the other hand a peculiar behaviour was observed at frequencies above 8 Hz, where the spectral
16 amplitudes of the vertical components of motion appear remarkably higher than those of the horizontal
17 components. This effect could be related to caves and ancient structures that are known to be buried below the
18 ground level.

19 The FE model was set up by using solid elements. The model was composed of four regions characterized
20 by homogeneous material properties. Their weights per unit volume were fixed according to the well-known
21 values derived from the literature, while their Young's modules were automatically updated in order for the
22 numerical first frequency and modal shape to reproduce the experimental ones. It is worth pointing out that, the
23 geometry of the foundation being unknown, also the height of the basement was changed in order to reproduce
24 the horizontal displacement on the basement.

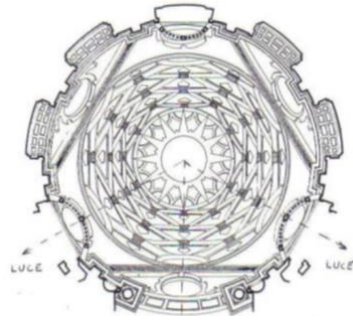
Fig. 13 The Holy Shroud Chapel: (a) photo; (b) and (c) draws; (d) FEM view

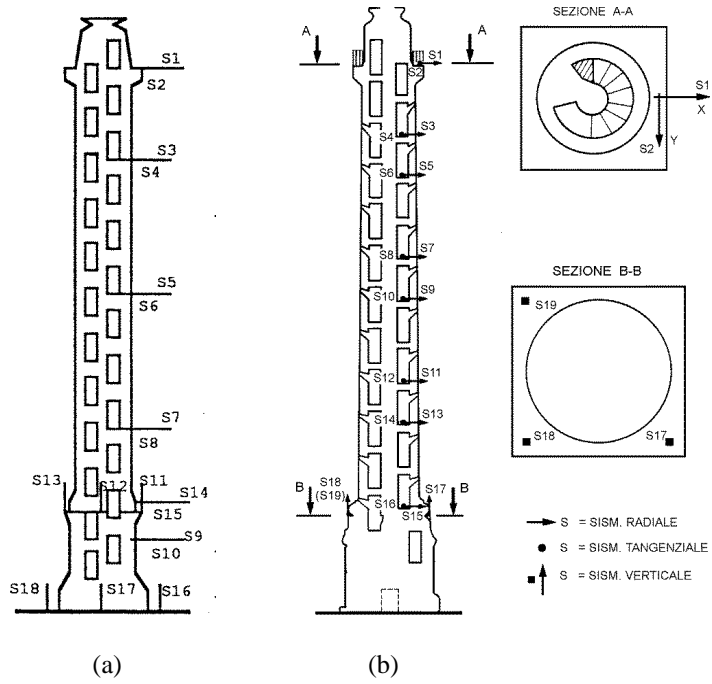
Fig. 18 Sensors deployment in the 1985 campaign: (a) the Aurelian and (b) the Trajan's Columns
