THE CONSERVATION OF GIOVANNI LABUS'S SCULPTURE OF BONAVENTURA BAVALLIERI (1844) AND ANTONIO GALLI'S SCULPTURE OF CARLO OTTAVIO CASTIGLIONE (1855)

I. Ruiz Bazán¹, V. Bresciani², A. Balloi³, A. Quarto⁴, I. Marelli⁴, M. Colella^{5*}, C. Sotgia⁶ and F. Arosio⁷

In this project a cleaning intervention of the neoclassical statues in the Brera Academy courtyard was performed with the use of living microbial cells. These living organisms, belonging to the species Desulfovibrio vulgaris, were able to remove chemical alterations, mainly caused by sulfates, from the stone surface of the statues. The method has been chosen because it is highly efficient, respectful to the original material, the environment and the restorer operating it. Thanks to the microorganism's selectiveness, it was possible to remove only the harmful alteration of the stones, respecting the so-called "noble patina" a key element in art pieces. Considering the precarious state of conservation of the hands belonging to the statue of Carlo Ottavio Castiglione, a 3D (Rilievo 3D) survey was taken.

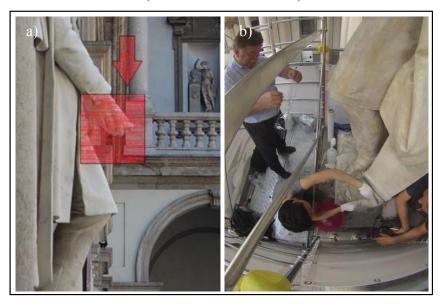
Fig. 7: a) Scheme of the consolidation system adopted (dip coating); b): Dr. Annalisa Balloi during the application of sulfate-reducing bacteria through a gelatinous medium on the areas that were altered and covered by sulfates.

With the help of Dr. Annalisa Balloi sulfate-reducing bacteria through a gelatinous medium were applied on sulfated areas that appeared altered. The gelatinous medium was left overnight on the stone surface until the desired result where obtained. The bacteria contained in the gel attack and eliminate the sulfate. Local interventions of traditional cleaning were limited to the removal of varnish drops that had fallen from above. These interventions have been performed by swabbing soluble non-polar solvents. The conservation intervention was then concluded with a mild application (4% micro-dispersed acrylic in water) with a protective patina on all the surfaces, to reduce the absorption of meteoric and condensation water (albeit for a limited time).
