Stabilitätsbewertung eines schornsteins aus mauerwerk durch schwingungsmessungen

Structural stability assessment of a masonry chimney by vibration measurements

F. Telch⁽¹⁾, G. Lacidogna⁽¹⁾, O. Rösch⁽²⁾

Keywords: tall structures; masonry chimney; structural stability; structural monitoring; vibration measurements.

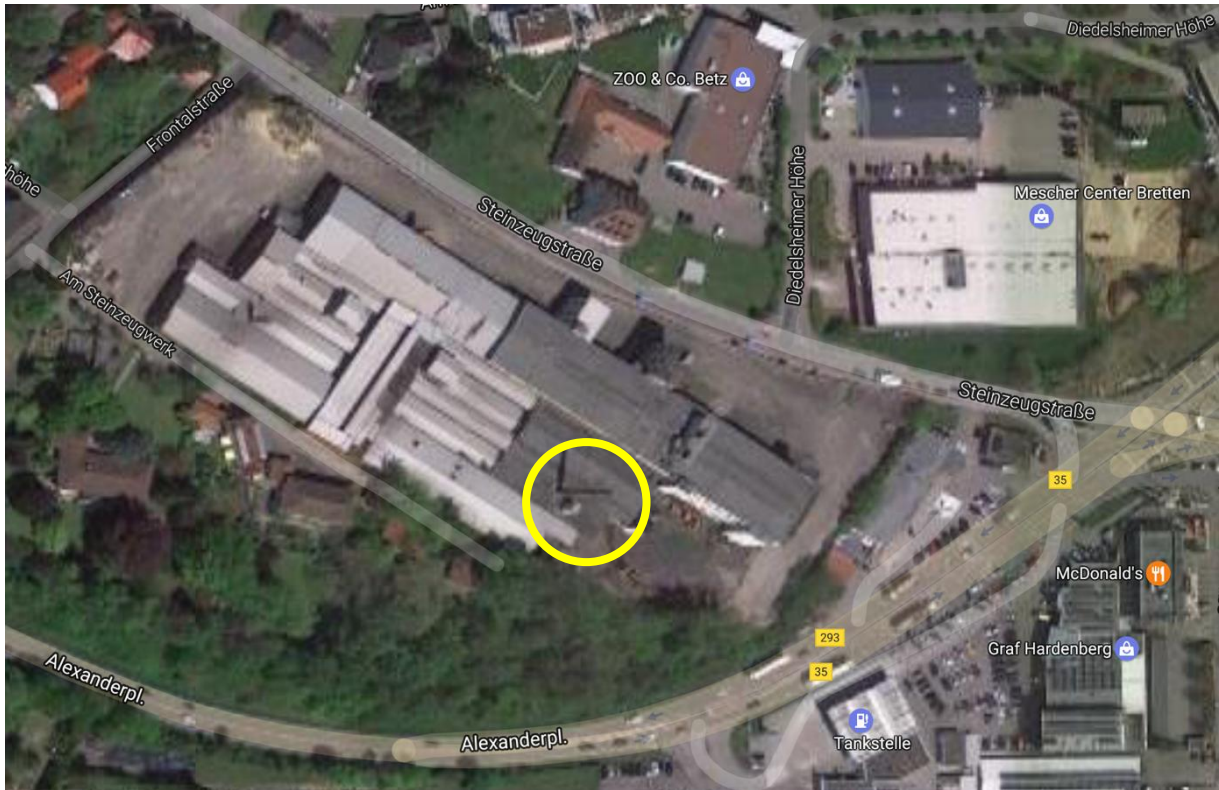
Fig. 1: Satellite image of the „Harsch-Steinzeugwerk“ with the chimney (yellow circle)

In the German town of Bretten, about 23km northeast of the city of Karlsruhe in Baden-Württemberg lies the idle Harsch-Steinzeugwerk, which was built in 1926 (Figs. 1, 2). In 2016, the owner decided to demolish the mighty Steinzeugwerk and redesign the area into a new residential and commercial space. On the 26.000 m² site, only the large masonry chimney remained to commemorate the glorious past of this company.

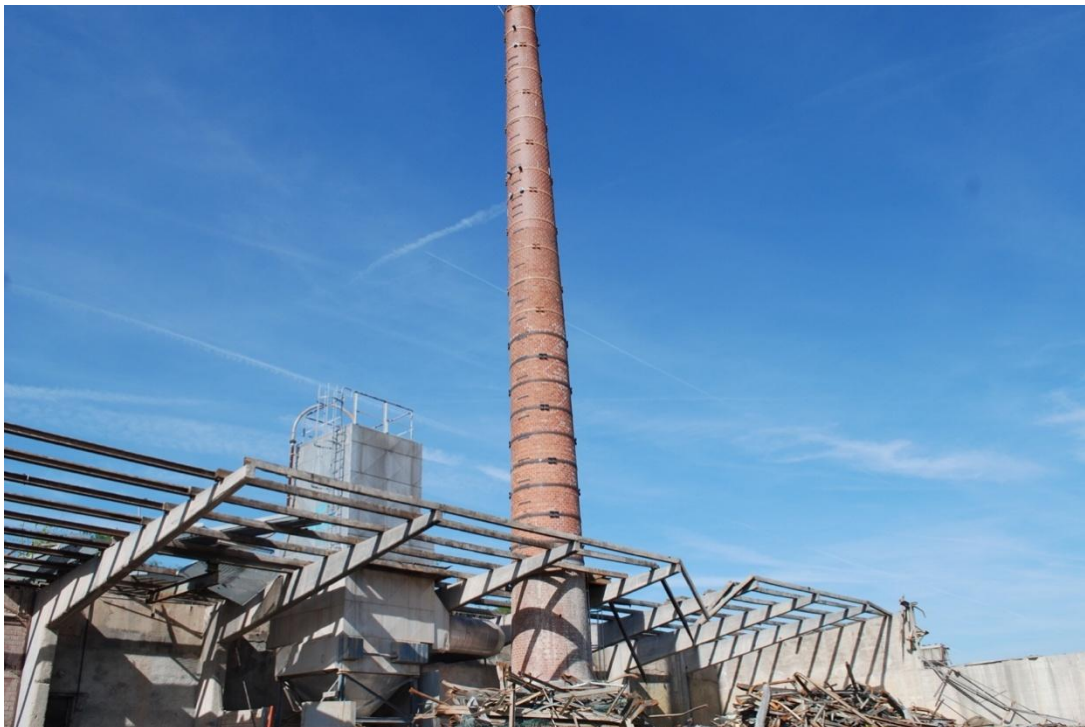
Fig. 2: The chimney

According to implementation plans [8], the 54-year-old masonry chimney protrudes 30 meters from the ground. Its diameter is 2.56 m at the bottom and 1.36 m at the top. The wall has four thickness jumps over its height. Between the jumps the thickness remains constant, it is equal to 50 cm at the bottom, and only 18 cm at the top. Table 1 shows the sections with the individual wall thicknesses.

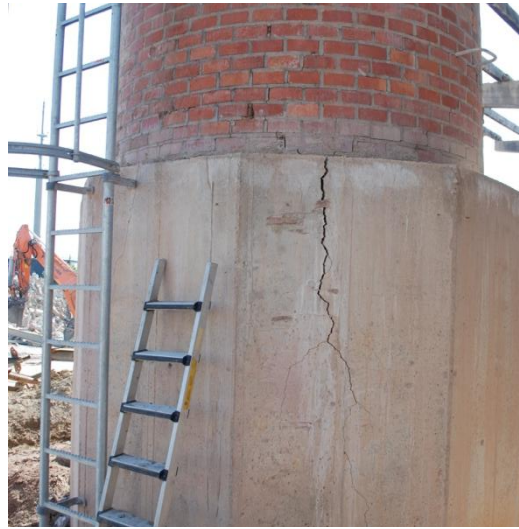
As previously described, there are several distinct cracks on the reinforced concrete cuff and at various locations above it. Striking is a pronounced vertical crack with a width of about 10 mm (Fig. 3). The cracks indicate that the ring tensile strength was exceeded at some point during the time. Evidently, the chimney also has an oblique position in the direction of the pronounced crack. Possibly, the above-mentioned mobile radio system, which was attached to this side, caused the formation of vertical cracks.

Fig. 3: Cracks in the chimney

The chimney was renovated in 1995 after cracks were formed due to storms. It is believed that the cuff described above was built after this event. From 1995, the chimney also served as a carrier of a mobile phone system, which has meanwhile been dismantled. For this reason, as reinforcement, approximately every 110 cm drawstrings were installed, which begin about 3.70 m above the cuff. Overall 23 drawstrings were used for the whole tower.
