MA-XRF measurement for corrosion assessment on bronze artefacts

MA-XRF measurement for corrosion assessment on bronze artefacts / Lins, S. A. B.; Di Francia, E.; Grassini, S.; Gigante, G. E.; Ridolfi, S.. - ELETTRONICO. - (2019), pp. 538-542. (Intervento presentato al convegno 2019 IMEKO TC4 International Conference on Metrology for Archaeology and Cultural Heritage, MetroArchaeo 2019 tenutosi a Firenze, Italy nel 4-6 December 2019).

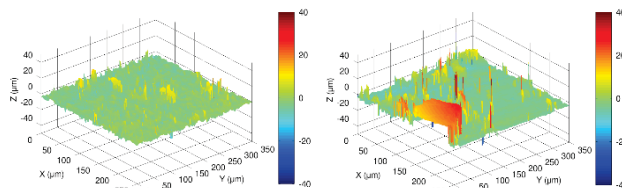
Fig. 2. Confocal microscope images of the CW (left) and sulphate (right) corroded layers.

Fig. 2 shows, as an example, the confocal microscope images acquired on some of the copper reference samples. The *CW sample* presents a quite smooth surface structure with a standard deviation of about 2.7 μm ; the *sulphate sample* instead presents a more heterogeneous morphology with surface roughness values of about 6.1 μm .

The roughness can be one of the major geometrical variables that affect the scanner performance, therefore a comparison of roughness and the sum map can show the presence of a geometrical factor that can create a sort of distortion on the scanner response. If the statistics are enough, one can hypothesize using an elemental map image as a mask to account for any roughness contribution to the final images.
