# MA-XRF measurement for corrosion assessment on bronze artefacts

**Abstract** – In this study, an innovative portable macro X-Ray Fluorescence (MA-XRF) scanner prototype has been employed in order to gain information on composition and distribution of corrosion products artificially grown on Cu-based coupons. First results have shown the importance of using artificially corroded reference samples before any assessment on archaeological artefacts. Moreover, the prototype used demonstrated to be a powerful tool for understanding complex corrosion processes which might occur on Cu-based alloys. The scanner was able to detect light elements as S and Cl, essential for studying the distribution of specific corrosion compounds. Using imaging techniques, it was possible to observe a gradient in Cu elemental maps intensity caused by the overlapping of a thicker corrosion product layer.

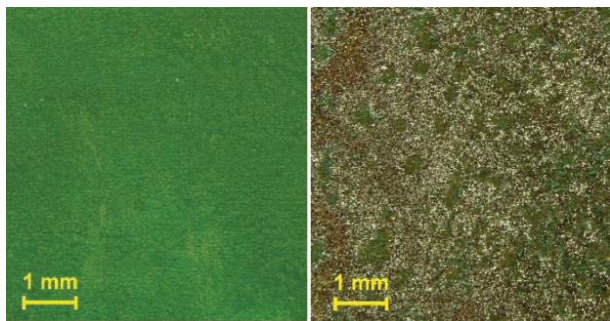
Fig. 1. Artificially corroded layers: CW (left) and sulphate (right) samples. High resolution images.

The study has been performed on Cu 99.96 wt%, reference coupons ( $45 \times 15 \times 5 \text{ mm}^3$ ). The specimens were polished with 500 to 4000 grid SiC paper, rinsed in ethanol in ultrasonic bath for 5 min, and well dried. Then, two kind of artificial corrosion layers have been produced by chemical synthesis (Fig. 1): a set of samples (*sulphate sample*) was created by immersion in a 0.1 M  $\text{Na}_2\text{SO}_4$  solution for three months at room temperature in order to obtain a sulphate corrosion layer. The other set of samples (*CW sample*) was created by immersion in a Corrosive Water solution (CW,  $2.8 \cdot 10^{-2}$  M NaCl, 0.01 M  $\text{Na}_2\text{SO}_4$ ,  $16.1 \cdot 10^{-2}$  M  $\text{NaHCO}_3$ ), that is an ASTM D1384 solution modified by Constantinides [2], for 7 months at room temperature in order to obtain a complex corroded layer. Both solutions were neither stirred nor aerated by bubbling.

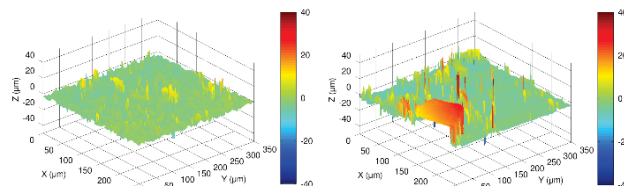
Fig. 2 shows, as an example, the confocal microscope images acquired on some of the copper reference samples. The *CW sample* presents a quite smooth surface structure with a standard deviation of about 2.7  $\mu\text{m}$ ; the *sulphate sample* instead presents a more heterogeneous morphology with surface roughness values of about 6.1  $\mu\text{m}$ .

Fig. 2. Confocal microscope images of the CW (left) and sulphate (right) corroded layers.

The roughness can be one of the major geometrical variables that affect the scanner performance, therefore a comparison of roughness and the sum map can show the presence of a geometrical factor that can create a sort of distortion on the scanner response. If the statistics are enough, one can hypothesize using an elemental map image as a mask to account for any roughness contribution to the final images.

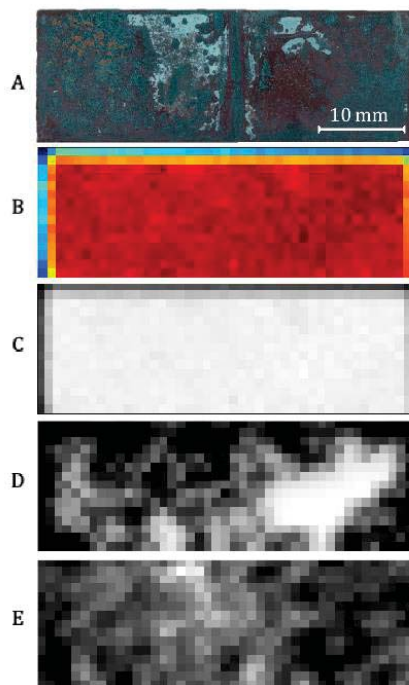
In fact, when applying an average-threshold filter to the copper maps one can observe a certain gradient in the intensity values. The reasons can be three-fold: the formation of a variable-in thickness corrosion layer which attenuates (proportionally to its thickness) the signal from the copper atoms underneath or a selective/preferential corrosion of copper atoms or lastly a distortion caused merely by the surface's roughness. Carefully inspecting the elemental maps of copper and sulphur from the sulphate sample and the sample's aspect (Fig. 3), it is reasonable that what caused a gradient in the copper intensity values in this sample is the presence of a thicker corrosion product area (lighter area, Fig. 3A) in the upper part of the sample surface.

Fig. 3. Sulphate sample surface (A) and scans: (B) sum map, (C) copper map, (D) filtered copper map and (E) sulphur map.

Nonetheless, sulphur was detected across the sulphate sample's surface (as expected) and formed a seemingly gradient that spreads from the upper-middle portion towards the lower region (Fig. 3E). Chlorine could not be detected due to its significantly lower counts and signal contamination from the sample holder (made of polyvinylchloride). Whereas for the CW sample, sulphur could not be detected, and chlorine could be mapped only when applying a low-pass filter to the elemental distribution map cutting off a portion of the contamination signal coming from the sample holder in the bottom right part (Fig. 5E).

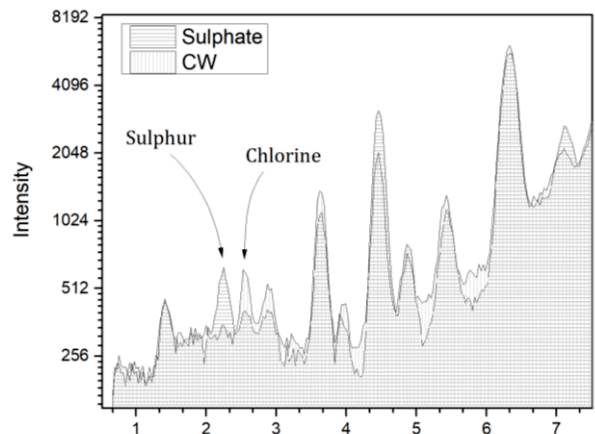
Concerning the corrosion components distribution across the sample surface, the chemical elements identified are either sulphur or chlorine (since carbon and oxygen cannot be detected by the instrument): being light (low Z) atoms, their counts statistics is considerably low (Fig. 4).

Fig. 4. Sum spectra comparison of samples sulphate and CW. Arrows point to S-K $\alpha$  and Cl-K $\alpha$  lines.

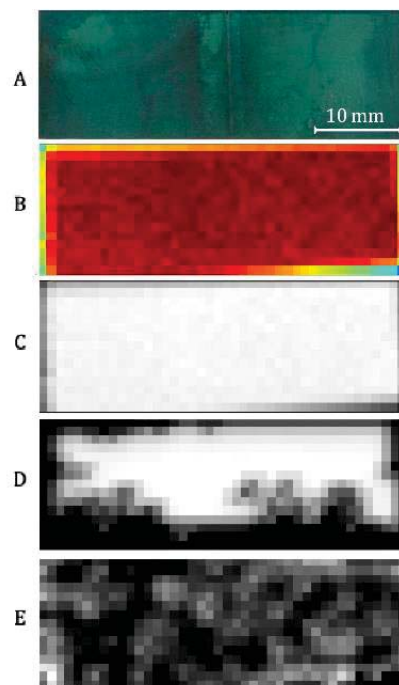
Fig. 5. CW sample surface (A) and scans: (B) sum map, (C) copper map, (D) filtered copper map and (E) chlorine map.

Differently from what was observed in the *sulphate sample*, the corrosion products distribution did not follow any specific “macro” pattern, nor did the copper distribution map shown any gradient (Fig. 5). The reason may be the distribution of chlorine and the corrosion products formation process. Constantinides et al. [2] demonstrated through artificially corroded Cu-alloys that chlorine is preferably deposited in an inner layer, in between the alloy’s bulk and the outer corrosion layer. This preferential deposition is created by a mechanism originating from mechanical stress or chemical reaction, where cracking occurs in the surface and promotes pitting corrosion. This process causes a further dissolution of the alloy, producing more  $\text{Cu}^+$  cations which reacts with  $\text{Cl}^-$  anions present in the solution, as a result  $\text{CuCl}$  and  $\text{CuCl}_2$  are formed and built up in an internal layer to the corrosion surface. Even though the formation of chlorine compounds is propelled in this mechanism, the net weight concentration of chlorine is still relatively low (when compared to the alloying elements concentration and the system detection limit), commonly about 2 wt%. Moreover, considering that chlorine is deposited underneath a Cu-oxide layer, its detection by the MA-XRF system is further hindered by attenuation effects.
