Addressing the need for standardization of test methods for self-healing concrete: an inter-laboratory study on concrete with macrocapsules

Addressing the need for standardization of test methods for self-healing concrete: an inter-laboratory study on concrete with macrocapsules / Van Mullem, Tim; Anglani, Giovanni; Dudek, Marta; Vanoutrive, Hanne; Bumanis, Girts; Litina, Chrysoula; Kwiecie, Arkadiusz; Al-Tabbaa, Abir; Bajare, Diana; Stryzewska, Teresa; Caspeepe, Robby; Van Tittelboom, Kim; Tulliani, JEAN MARC CHRISTIAN; Gruyaert, Elke; Antonaci, Paola; De Belie, Nele. - In: SCIENCE AND TECHNOLOGY OF ADVANCED MATERIALS. - ISSN 1468-6996. - ELETTRONICO. - 21:1(2020), pp. 661-682.

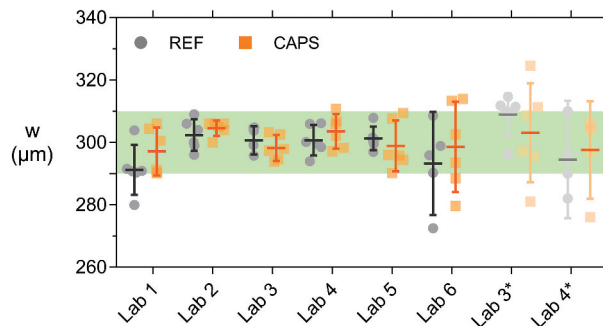
Figure 12. Crack width w of individual mortar specimens for which the mean of the series is indicated by a horizontal line and error bars give the 95% confidence interval on this mean. Most mortar specimens had a crack width w within the desired crack width range (shaded area).

After cracking the mortar specimens, they were restrained using screw jacks. The final mean crack width w measured by all labs after the active crack width restraining process is given in Figure 12. This figure shows the individual values, as well as the mean crack width of the series (horizontal lines) and the 95% confidence interval on this mean (error bars) for both REF and CAPS specimens. The green shaded band indicates the desired crack width range (290–310 μm). Lab 3 and lab 4 did a pre-test on a separately sent batch of specimens to familiarize themselves with the test technique, these are denoted by lab 3* and lab 4*. The crack width of many of these specimens fell outside of the intended range. Additionally, the screw jacks were not applying a significant pressure on the specimens, because the crack width of these specimens was rather limited after crack creation by three-point bending. In

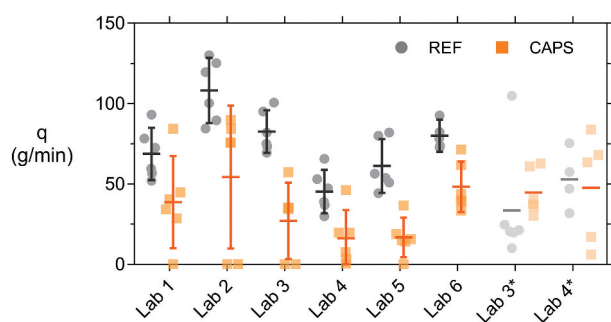
Figure 13. Individual flow rates q and the means of the different specimen batches indicated by horizontal lines. Error bars give the 95% confidence interval on the mean.

The variation on the water flow was significantly higher than for the crack width, see Table 9. It can be reasoned that for the CAPS specimens a high variation
