ARCHITECTURAL HERITAGE AT RISK: THE CASE OF THE MAGNANO HAMLET (PIEDMONT, ITALY)

F. Fratini ¹ *, M. Mattone ², S. Rescic ¹

2. THE MAGNANO HAMLET

2.1 Construction features and current state of conservation

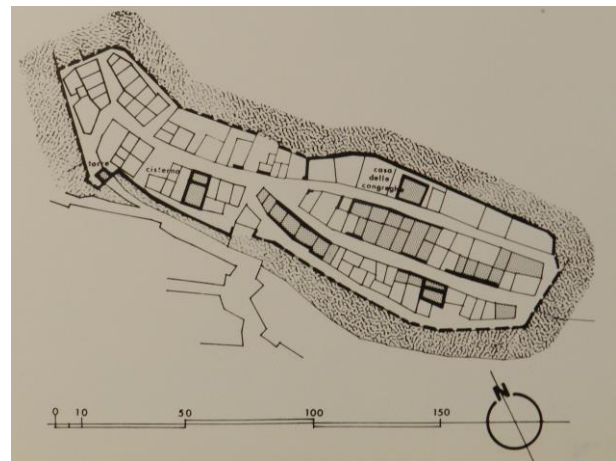
A tower-door equipped with a single arched driveway guarantees the access to the hamlet. The first part of the urban core is characterized by the presence of a single road axis on which there are few surviving buildings, mostly extensively transformed. Continuing east, the road branches off into three parallel streets, located at different altitudes (Figure 3).

Figure 3. Planimetric layout of the hamlet in 1780 (after Viglino Davico, 1978).

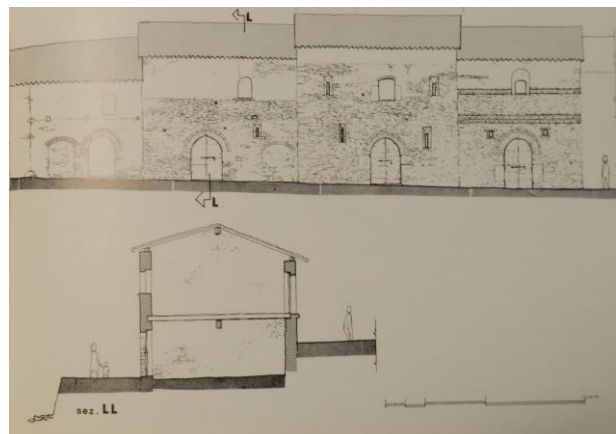
These road axes delimit compact blocks, made up of small buildings. Where the building cell is located between two parallel axes, the particular shape of the land has been exploited

to ensure direct access by road to both rooms that constitute the single construction (Figure 4).

The buildings have load-bearing walls made of stone and brick. The floors have a double wooden structure. The main beams are positioned parallel to the façade and act as a chain for the side walls.

Figure 4. Elevation and section of some building cells (after Viglino Davico, 1978).

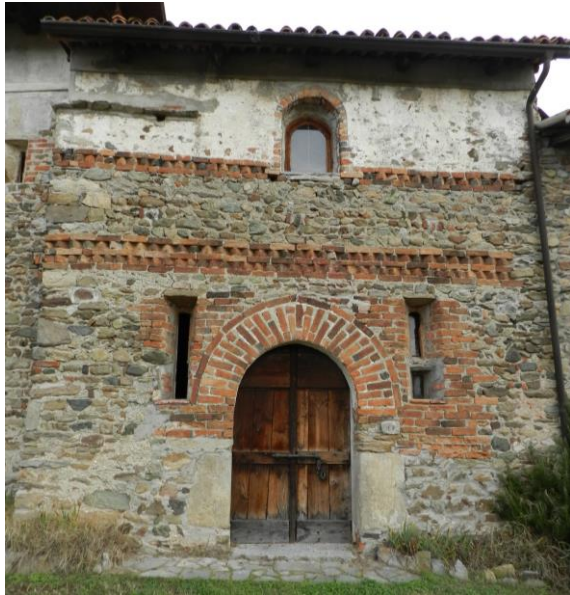
The openings are mostly delimited by fired bricks to be referred to interventions carried out in the XVth century on the existing wall structure (Viglino Davico, 1978). Sometimes, bricks are also used for decorative purposes: elements such as cornices and notches adorn some buildings' façade (Figure 5).

Figure 5. Brick decorative elements (credits Manuela Mattone).

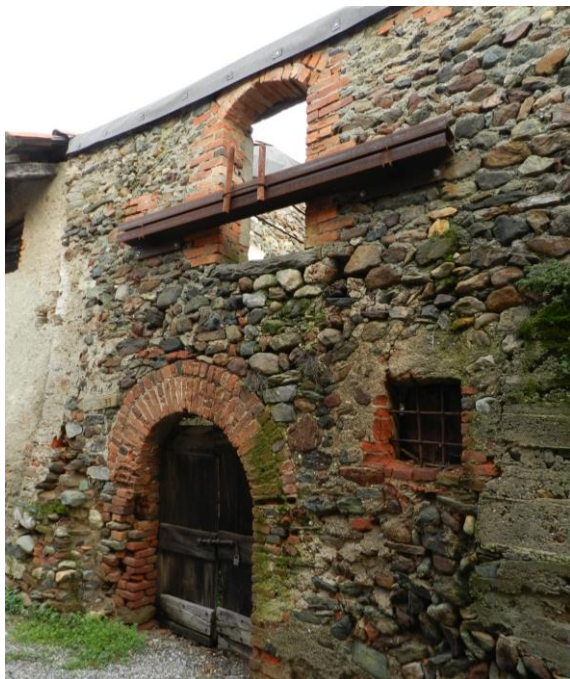
Abandoned for years, some buildings are without roof and their stability is guaranteed through temporary static aids, positioned by the municipal administration in order to avoid their collapse (Figure 6).

Figure 6. Building C - Temporary consolidation intervention carried out by the municipality (credits Manuela Mattone).

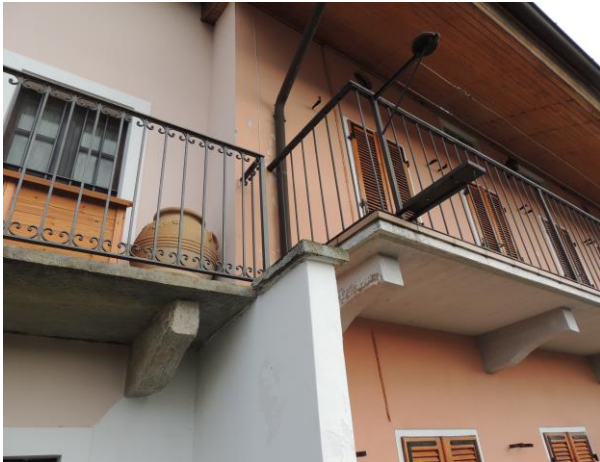
2.2.1 Adaptation of the historical built: Over time, some of the buildings of the hamlet have undergone interventions aimed at ensuring their re-use for residential purposes. They provided for the restoration of missing parts and the reshaping of the buildings in relation to aesthetic tastes and functional needs of the owners. Specific conservation requirements of the cultural heritage have not been sufficiently taken into account and interventions compromising its integrity and inherent values have been carried out. They led to a significant transformation of the buildings which often lost their specific features. The only recognised value was the use value, which lead to the adaptation of the built to changing conditions in order to make it able to suit the new needs. The insertion of balconies with reinforced concrete structure (Figure 7); the insertion of stone slab coverings along the baseboards and of ceramic tiles on the external floors (Figure 8); the addition of wooden battens in the overhang of the roof (Figure 9); the replacement of windows and the application of finishing plasters testify to the lack of attention towards the architectural heritage which is altered without paying sufficient attention to its historical-cultural as well as formal characteristics. Integrations and replacements are carried out by compromising the preservation of the architectural artefacts both at the typological and construction level and causing the irremediable loss of their identity.

Figure 7. Building E - Balcony with reinforced concrete structure (credits Fabio Fratini).

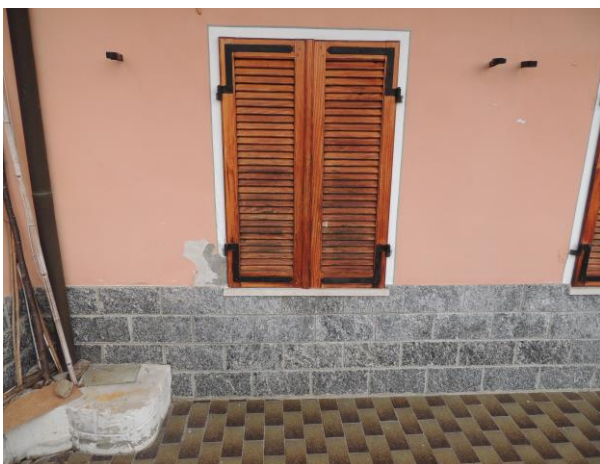
Figure 8. Building E - Baseboard in stone slabs and an external flooring in ceramic tiles, replacement of the windows and application of a new finishing layer (credits Fabio Fratini).

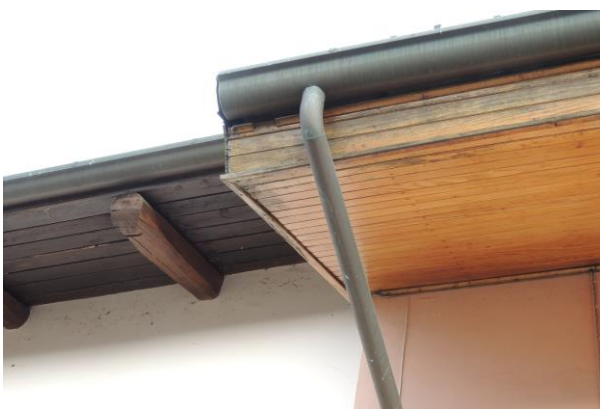
Figure 9. Building E - Wooden battens in the overhang of the roof (credits Fabio Fratini).

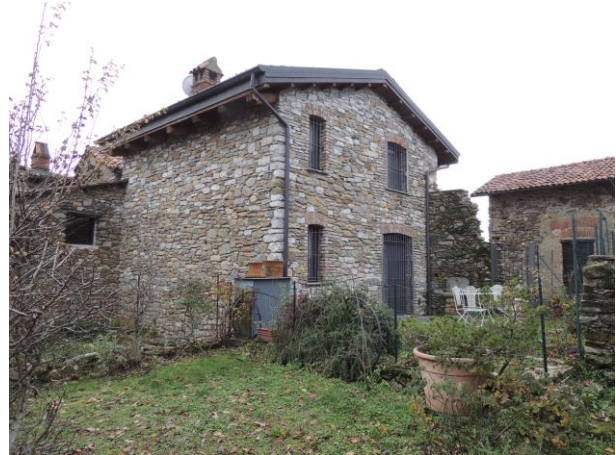
The same applies to restoration interventions that involve the reintegration of destroyed parts of the buildings such as walls, roofs, windows. Although the materials used are similar to the original ones, the treatment reserved for them is totally different. The methods of laying the stone and the bedding mortar change; the thickness of the roof is improved, presumably in relation to the desire to guarantee higher energy performances (Figure 10).

Figure 10. Building D - Reintegration of the upper part of the walls and of the roof (credits Manuela Mattone).

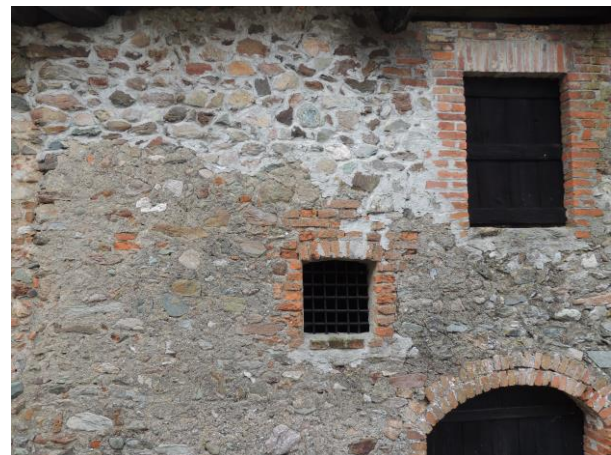
2.2.2 Incompatible materials and technique: Numerous inappropriate punctual interventions have also been done. Restoration of the walls has been often carried out using inadequate laying materials and methods. Particularly noteworthy is the widespread use of cement mortar not only for the bedding of bricks, but also for the reintegration of cracks and heavily eroded bricks (Figures 11 to 15).

Figure 11. Building B - Reintegration of the masonry adopting inappropriate materials (credits Fabio Fratini).

This intervention is incompatible not only from the mechanical point of view (elastic modulus of the whole), but also as regards the chemical (development of saline efflorescence) and physical compatibility (different behaviour towards water both in liquid and vapour form).

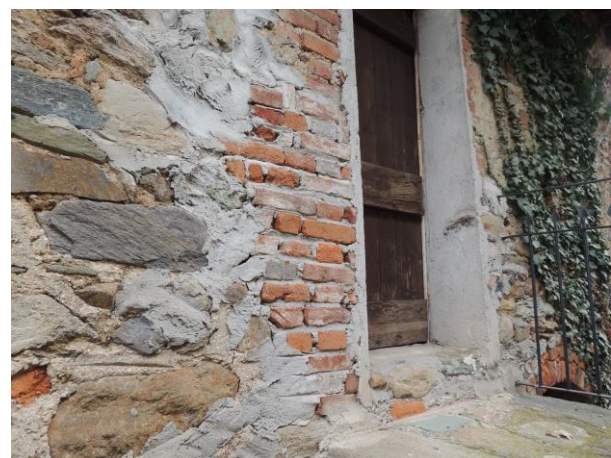
Figure 12. Building G - Improper intervention with cement mortar (credits Fabio Fratini).

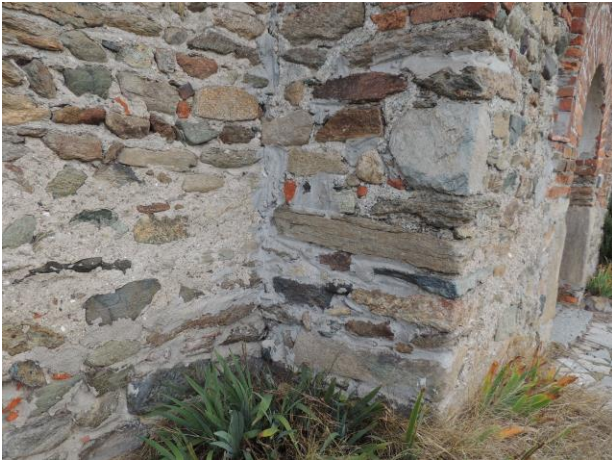
Figure 13. Building A - Grouting with cement mortar (credits Fabio Fratini).

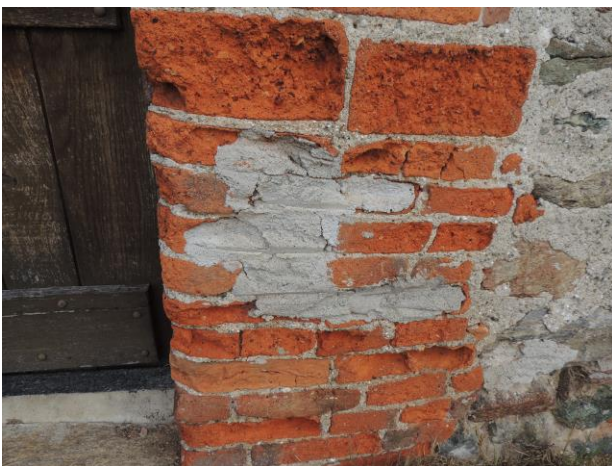
Figure 14. Building A - Reintegration of eroded bricks with cement mortar (credits Fabio Fratini).

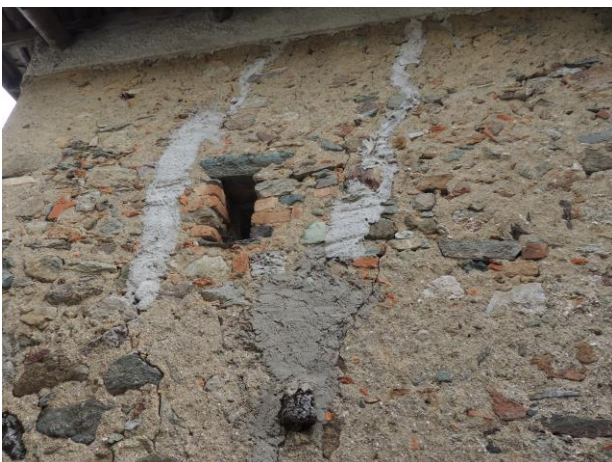
Figure 15. Building G - Filling of cracks with cement mortar (credits Fabio Fratini).

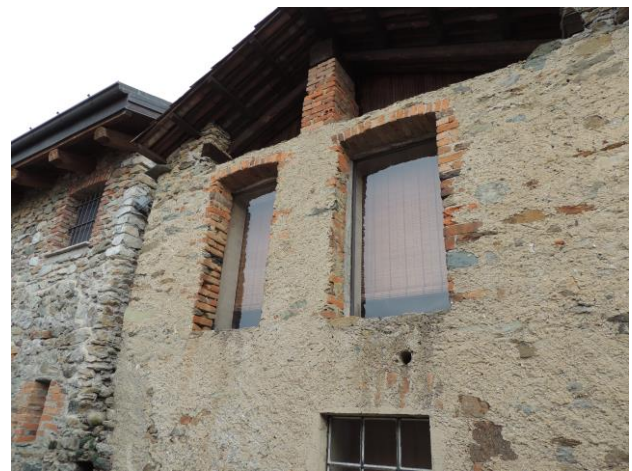
Interesting in this sense are the examples of Figures 16 and 17. In the first case, the intervention aimed at ensuring the re-use of the building was carried out without changing the characteristics of the masonry surface and of the roof, whose thickness was not altered.

In order to solve the problems due to the lack of light in the interior, windows were replaced adopting thin window frames (Figure 16).

Figure 16. Building F - Intervention preserving both the external masonry surfaces and the roof (credits Silvia Rescic).

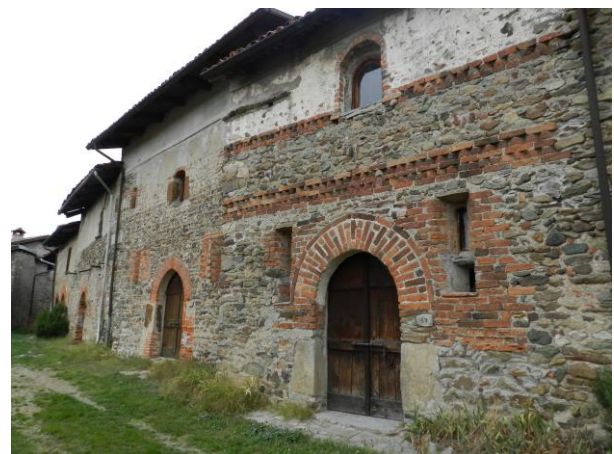
Preservation of the external wall surfaces and their stratifications, as well as of the finishing elements (such as the access portal) characterise also the intervention shown in Figure 17.

Figure 17. Building H - Preservation of the surface of the external wall and of the access portal (credits Silvia Rescic).
