ARCHITECTURAL HERITAGE AT RISK: THE CASE OF THE MAGNANO HAMLET (PIEDMONT, ITALY)

F. Fratini¹ *, M. Mattone², S. Rescic¹

KEY WORDS: Architectural heritage, Risk, Preservation, Compatibility, Identity, Re-use

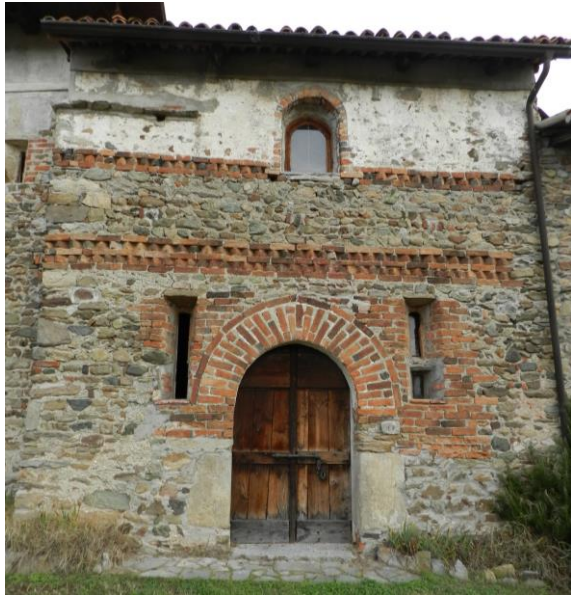
The openings are mostly delimited by fired bricks to be referred to interventions carried out in the XVth century on the existing wall structure (Vigilino Davico, 1978). Sometimes, bricks are also used for decorative purposes: elements such as cornices and notches adorn some buildings' façade (Figure 5).

Figure 5. Brick decorative elements (credits Manuela Mattone).

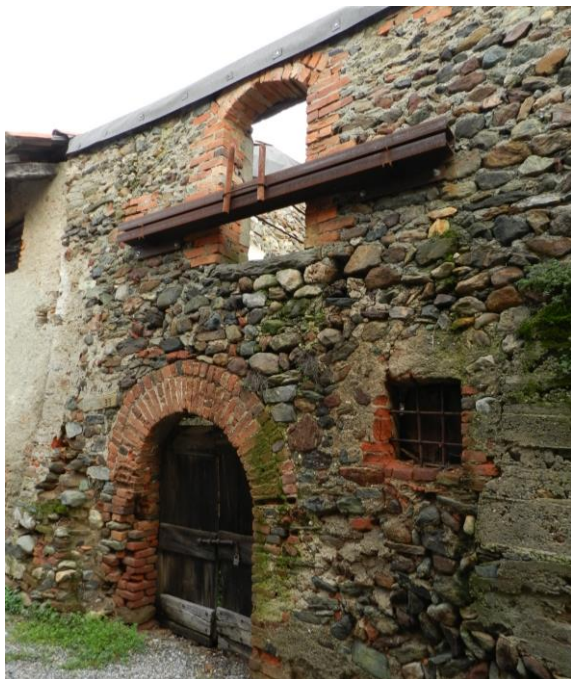
Abandoned for years, some buildings are without roof and their stability is guaranteed through temporary static aids, positioned by the municipal administration in order to avoid their collapse (Figure 6).

Figure 6. Building C - Temporary consolidation intervention carried out by the municipality (credits Manuela Mattone).

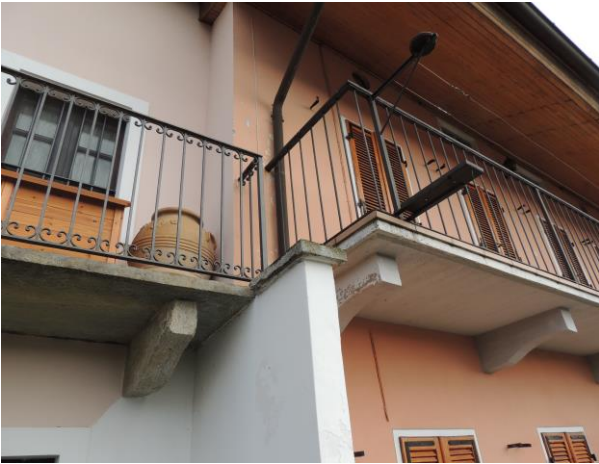
2.2.1 Adaptation of the historical built: Over time, some of the buildings of the hamlet have undergone interventions aimed at ensuring their re-use for residential purposes. They provided for the restoration of missing parts and the reshaping of the buildings in relation to aesthetic tastes and functional needs of the owners. Specific conservation requirements of the cultural heritage have not been sufficiently taken into account and interventions compromising its integrity and inherent values have been carried out. They led to a significant transformation of the buildings which often lost their specific features. The only recognised value was the use value, which led to the adaptation of the built to changing conditions in order to make it able to suit the new needs. The insertion of balconies with reinforced concrete structure (Figure 7); the insertion of stone slab coverings along the baseboards and of ceramic tiles on the external floors (Figure 8); the addition of wooden battens in the overhang of the roof (Figure 9); the replacement of windows and the application of finishing plasters testify to the lack of attention towards the architectural heritage which is altered without paying sufficient attention to its historical-cultural as well as formal characteristics. Integrations and replacements are carried out by compromising the preservation of the architectural artefacts both at the typological and construction level and causing the irremediable loss of their identity.

Figure 7. Building E - Balcony with reinforced concrete structure (credits Fabio Fratini).

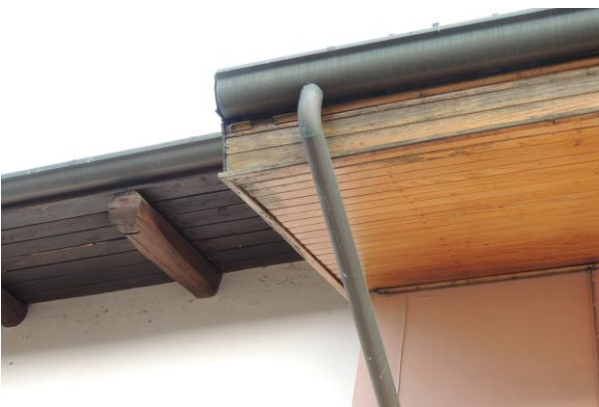
Figure 9. Building E - Wooden battens in the overhang of the roof (credits Fabio Fratini).

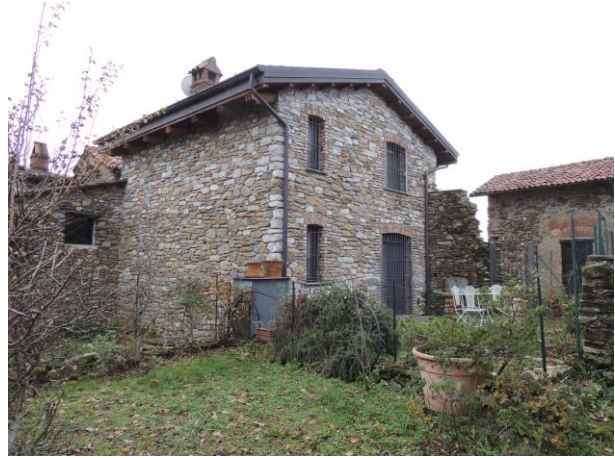
The same applies to restoration interventions that involve the reintegration of destroyed parts of the buildings such as walls, roofs, windows. Although the materials used are similar to the original ones, the treatment reserved for them is totally different. The methods of laying the stone and the bedding mortar change; the thickness of the roof is improved, presumably in relation to the desire to guarantee higher energy performances (Figure 10).

Figure 10. Building D - Reintegration of the upper part of the walls and of the roof (credits Manuela Mattone).

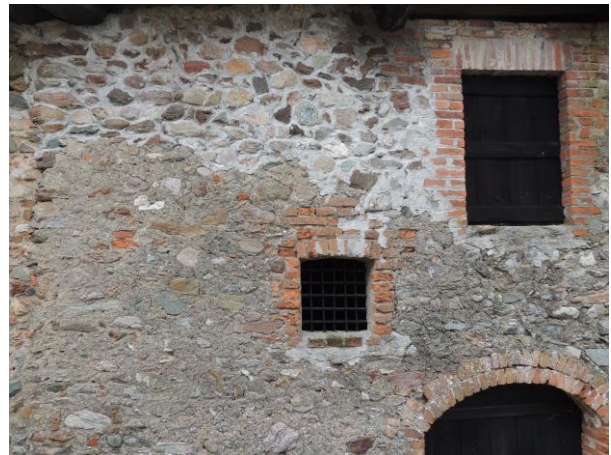
2.2.2 Incompatible materials and technique: Numerous inappropriate punctual interventions have also been done. Restoration of the walls has been often carried out using inadequate laying materials and methods. Particularly noteworthy is the widespread use of cement mortar not only for the bedding of bricks, but also for the reintegration of cracks and heavily eroded bricks (Figures 11 to 15).

Figure 11. Building B - Reintegration of the masonry adopting inappropriate materials (credits Fabio Fratini).

This intervention is incompatible not only from the mechanical point of view (elastic modulus of the whole), but also as regards the chemical (development of saline efflorescence) and physical compatibility (different behaviour towards water both in liquid and vapour form).

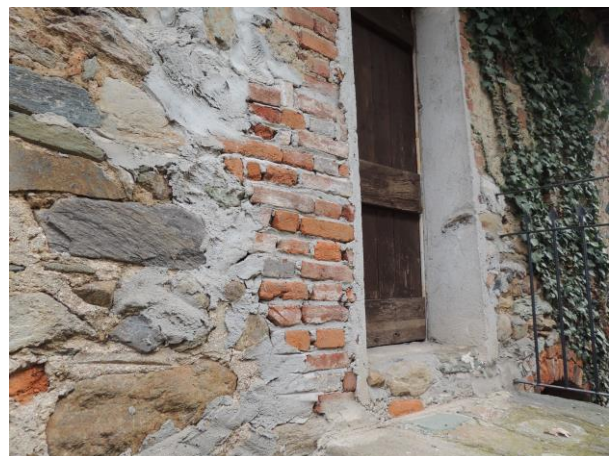
Figure 12. Building G - Improper intervention with cement mortar (credits Fabio Fratini).

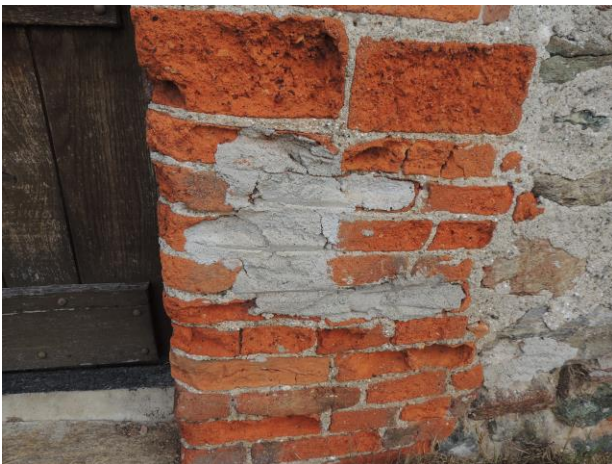
Figure 14. Building A - Reintegration of eroded bricks with cement mortar (credits Fabio Fratini).

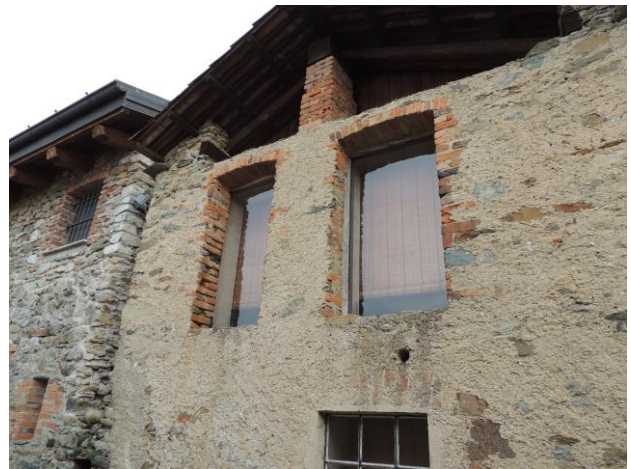
Interesting in this sense are the examples of Figures 16 and 17. In the first case, the intervention aimed at ensuring the re-use of the building was carried out without changing the characteristics of the masonry surface and of the roof, whose thickness was not altered.

In order to solve the problems due to the lack of light in the interior, windows were replaced adopting thin window frames (Figure 16).

Figure 16. Building F - Intervention preserving both the external masonry surfaces and the roof (credits Silvia Rescic).

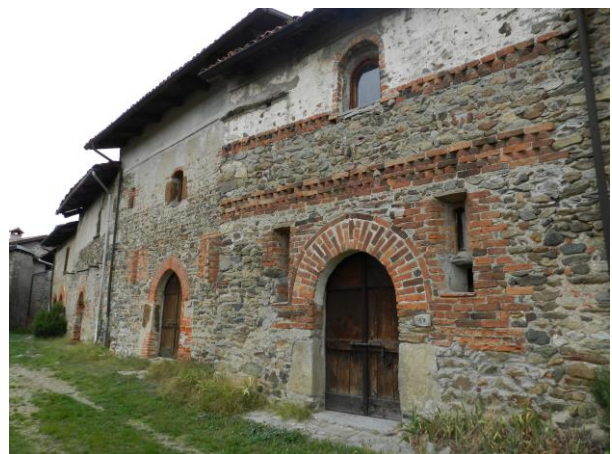
Preservation of the external wall surfaces and their stratifications, as well as of the finishing elements (such as the access portal) characterise also the intervention shown in Figure 17.

Figure 17. Building H - Preservation of the surface of the external wall and of the access portal (credits Silvia Rescic).
