TOWARDS A SUSTAINABLE AND CONTEXT-BASED APPROACH TO ANTI-SEISMIC RETROFITTING TECHNIQUES FOR VERNACULAR ADOBE BUILDINGS IN COLOMBIA.

F. De Filippi¹, R. Pennacchio^{1,*}, L. Restuccia², S. Torres¹

KEY WORDS: Colombia, Vernacular heritage, Earthen architecture, Adobe, Appropriate technologies, Seismic behaviour, Reinforcement techniques.

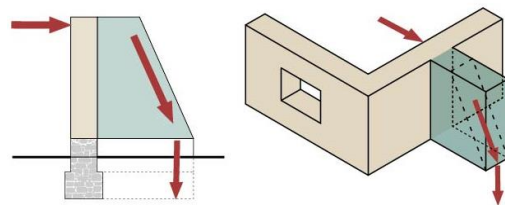
Perpendicular reinforcements reduce the bending moment in the middle of the walls, by transferring horizontal seismic loads diagonally to the foundations (Minke, 2001) (Figure 1). Horizontal and diagonal bending cracks and wall overturning are so avoided (Ojeda, 2002). Additionally, corner buttresses can increase walls vertical and horizontal load capacity in a 16% (Angulo et al., 2011).

Figure 1. Buttresses seismic load transferring into foundation. Data from Minke (2001).

On the other hand, ‘buttresses’ and ‘corner braces’ are both limited strategies. First one aims at controlling the bending stress on walls and corners, reducing flexural cracks on the wall plane and tensile stress in corners, while the second tends to increase ductility, bending and shear strength, reducing tensile and shear stress in the corners.

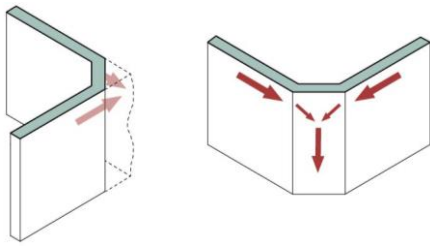
Corner chamfering helps to reduce the shear and bending stress concentration on the junction of perpendicular walls (Figure 2) (Minke, 2001; Pennacchio, Nicchia, 2013). Even if this strategy can increase by 9% the gravitational and horizontal collapse load (Angulo et al., 2011), can only be applied during new buildings design phase, and cannot be taken into consideration for retrofit interventions.

Figure 2. Rounded corners scheme. Figure from Minke, 2001.

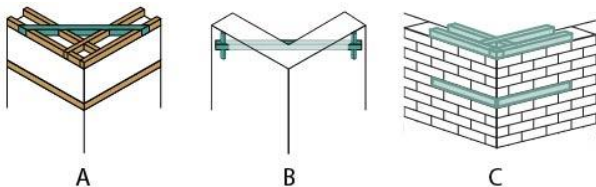
Corner braces or corner keys reinforcements otherwise, help strengthening wall-to-wall junction as shown on Figure 3 (Angulo et al. 2011; Ortega et al., 2017).

Corner timber bracing reduce tensile cracks failures, by sharing shear stress among adjacent walls, while helping the masonry to keep its box-like behaviour, by strengthening corner junctions. Additionally, timber is able to assume the bending stress before adobes are carried to failure. Furthermore, even if the adobe masonry would crack in the corners, the braces reinforcement should keep the walls together. This type of reinforcement allows to modify the seismic response of the structure: it acquires a dissipative behaviour and therefore a greater ductility, linked to the post-peak capacity to absorb energy before breaking (Ortega et al., 2017), avoiding a sudden collapse of the corner. Angulo et al. (2011), found that, under vertical and horizontal loads, in case of corner braces fixed to the ring beam, the collapse load increase in 118% (Figure 3a), in 64% using diagonal tie braces (b), while, bracing beams parallel to the walls, showed a collapse load increase of 48% (c).

Figure 3. Corner braces options. Image redraw from Ortega et al. (2017).

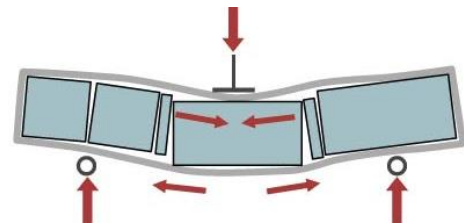
3.3.1 Plastic geogrids and synthetic ropes reinforcement: were studied for the first time in Latino America at ‘Pontificia Universidad Catolica de Perú’. An interesting proposal, in this regard, is the use of a rope grid to reduce costs and make the technology accessible to poor population (Blondet et al., 2011). The behaviour of the wall compound, under horizontal non-axial loads, is schematized in Figure 4 (Invernizzi et al. 2017). Geogrid control flexural cracks caused by the maximum bending moment, thus reducing the associated failure mechanisms and, providing tensile strength to the adobe wall (Blondet et al., 2011). Considering a deflection increase of almost 750% for the geogrids reinforced walls under non-axial loads, Invernizzi et al. (2017) specified that the reinforcement is able to redistribute the stress, bracing the wall and keeping it together, as a single element. Moreover, shear capacity of geogrid reinforced elements is increased by 180% and shear deformation is 4 times larger than the unreinforced walls (Invernizzi et al. 2017). This suggests that failure mechanisms by shear cracking in walls and corners can be reduced by geogrid reinforcements.

Figure 4. Adobe bricks kinematics and geogrid bending effect. Redrew from Invernizzi et al., 2017.

According to Invernizzi et al., (2017) and to ‘Ministerio de Vivienda, Construcción y Saneamiento de Perú’ (2017), certain aspects should be considered in geogrid reinforcement application:

- All wall surfaces, should be surrounded, by the geogrid, including openings indoor faces;
- Geogrids should be fixed by ropes passing through ring beams, basement courses and wall thickness;
- In order to control cracking and increase wall’s ductility, the reinforcement should be covered with earthen plaster.

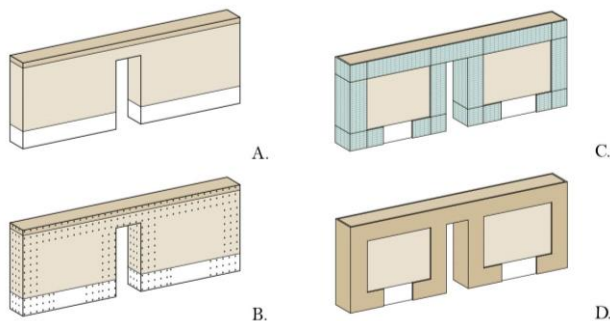
3.3.3 Rib-lath grids reinforcements: on top of the walls, on the corners and openings, create a ‘beams and columns’ additional pattern over both faces of the wall (Ruiz et al., 2012; Yamín et al., 2003). Figure 5 resumes the reinforcement implementation process; required materials are rib-laths, wire, and lime-sand mortar. The use of rib-lath reduce bending cracks in the middle of the wall and in the corners. According to Yamín et al. (2007), the reinforced walls, tested under non-axial loads, supported 43 kN without collapsing. Under earthquake shake table test, the reinforced adobe house model showed both enhanced ductility and energy dissipation of the structure (Yamín et al., 2007). Unexpectedly, the model suffered a sudden collapse (Yamin et al., 2003).

Figure 5. Rib lath reinforcement implementation. a) Adobe walls with ring beam and base course. b) Perforating wall for rib lath fixing. c) Localize rib lath d) Plastering rib lath. Redrew from Yamín et al. (2007) and Ruiz et al. (2012).

‘Rib lath grids’ reduce tensile failures in the wall plane and at the corners, by increasing ductility and bending strength; nevertheless the use of this strategy has been considered too risky, due to the sudden collapse of the walls, reported by Yamín et al. (2003).
