## TOWARDS A SUSTAINABLE AND CONTEXT-BASED APPROACH TO ANTI-SEISMIC RETROFITTING TECHNIQUES FOR VERNACULAR ADOBE BUILDINGS IN COLOMBIA.

**KEY WORDS:** Colombia, Vernacular heritage, Earthen architecture, Adobe, Appropriate technologies, Seismic behaviour, Reinforcement techniques.

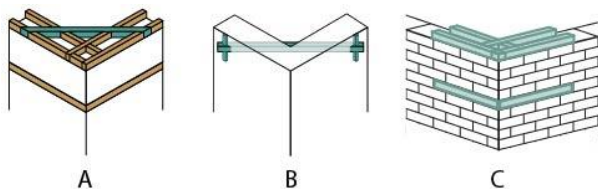
Figure 3. Corner braces options. Image redraw from Ortega et al. (2017).

Corner braces or corner keys reinforcements otherwise, help strengthening wall-to-wall junction as shown on Figure 3 (Angulo et al. 2011; Ortega et al., 2017).

Corner timber bracing reduce tensile cracks failures, by sharing shear stress among adjacent walls, while helping the masonry to keep its box-like behaviour, by strengthening corner junctions. Additionally, timber is able to assume the bending stress before adobes are carried to failure. Furthermore, even if the adobe masonry would crack in the corners, the braces reinforcement should keep the walls together. This type of reinforcement allows to modify the seismic response of the structure: it acquires a dissipative behaviour and therefore a greater ductility, linked to the post-peak capacity to absorb energy before breaking (Ortega et al., 2017), avoiding a sudden collapse of the corner. Angulo et al. (2011), found that, under vertical and horizontal loads, in case of corner braces fixed to the ring beam, the collapse load increase in 118% (Figure 3a), in 64% using diagonal tie braces (b), while, bracing beams parallel to the walls, showed a collapse load increase of 48% (c).
