# Biodegradation and Microbial Contamination of Limestone Surfaces: An Experimental Study from Batalha Monastery, Portugal

**Abstract:** An experimental study was conducted to assess the nature and extent of the biodeterioration of the limestone in the Batalha Monastery in Portugal. Stone fragments covered with microbial biofilms and lichenous crusts were investigated using Optical Microscopy (OM), Low Vacuum Scanning Electron Microscopy with Energy Dispersive Spectroscopy (LV-SEM + EDS), and X-ray micro-Diffractometry ( $\mu$ -XRD). Microbial samples were collected from the stone surface, cultured, and analyzed with NGS metagenomic DNA test to classify the bacterial communities associated with the formation of the biofilms. Particulate air pollutants collected on Pall GN-6 paper filters using a cascade impactor were characterized by SEM-EDS + NGS. The results showed that lichens play a major role in biodeterioration by promoting both physical and chemical attack on the limestone substrate via hyphae mechanical penetration along calcite inter-crystalline spaces, the dissolution/leaching of calcite minerals, and the precipitation of secondary minerals such as Ca-oxalates within the

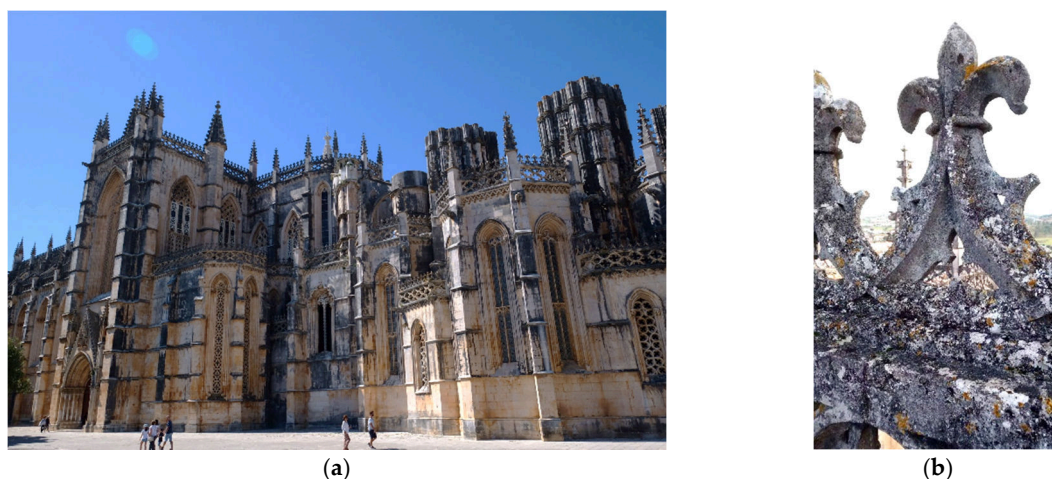
**Figure 1.** (a) The external wall of Batalha Monastery, covered by dark brown/gray biofilms and crusts; (b) Balustrade on the roof of the monastery showing thick biofilms and lichenous crusts.

The Batalha Monastery (Figure 1) is listed as a UNESCO World Heritage Site and is located in central Portugal. The monastery was built using a Middle–Late Jurassic oolitic limestone that was extracted from several ancient quarries located in sites not far from the monument itself: Pidiogo, Valinho do Rei, Carvalhos, Reguengo do Fetal, Cabeço do Roxo, and Outeiro de Sebastião [14]. The outer surfaces of the oolitic limestone in the walls of the monastery show extensive coating by biofilms and lichenous crusts leading to intense biodeterioration and aesthetical disfigurement effects. The aim of the current study was threefold: (a) assess whether microbial colonization and the formation of lichenous crusts is responsible for the decay of the limestone used in the Batalha Monastery; (b) identify the microflora colonizing the limestone surface of the Batalha Monastery, in order to provide a microbial database that could help restorers in the selection of the correct cleaning procedure to be adopted for the conservation of the Monastery; and (c) assess the relative importance of biodeterioration versus anthropogenic air pollution in the limestone weathering in Batalha.
