A Reverse Dynamical Investigation of the Catastrophic Wood-Snow Avalanche of 18 January 2017 at Rigopiano, Gran Sasso National Park, Italy

Barbara Frigo¹ · Perry Bartelt² · Bernardino Chiaia¹ · Igor Chiambretti³ · Margherita Maggioni^{4,5}

Abstract On 18 January 2017 a catastrophic avalanche destroyed the Rigopiano Gran Sasso Resort & Wellness (Rigopiano Hotel) in the Gran Sasso National Park in Italy, with 40 people trapped and a death toll of 29. This article describes the location of the disaster and the general meteorological scenario, with field investigations to provide insight on the avalanche dynamics and its interaction with the hotel buildings. The data gathered in situ suggest that the avalanche was a fluidized dry snow avalanche, which entrained a slightly warmer snow cover along the path and reached extremely long runout distances with braking effect from mountain forests. The avalanche that reached the Rigopiano area was a “wood-snow” avalanche—a mixture of snow and uprooted and crushed trees, rocks, and other debris. There were no direct eyewitnesses at the event, and a quick post-event survey used a numerical model to analyze the dynamics of the event to estimate

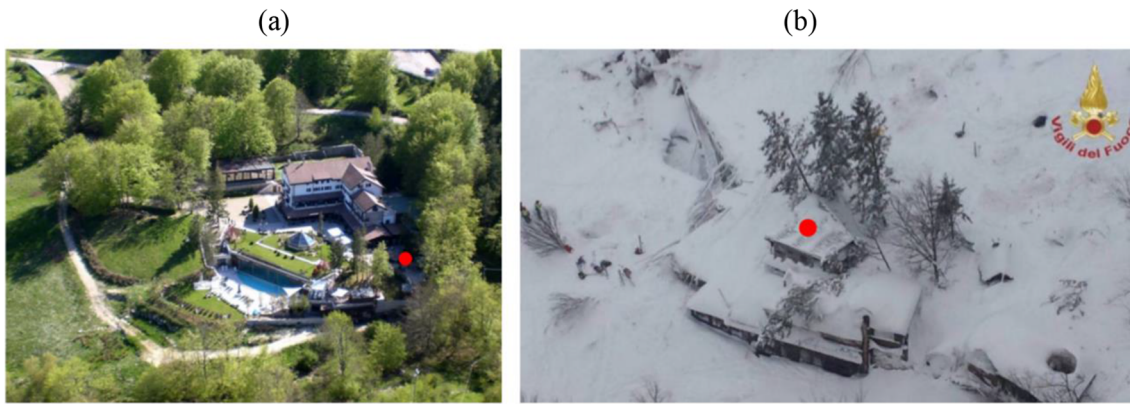
Fig. 2 Aerial view of the Rigopiano Hotel before (a) and after (b) the avalanche that occurred on 18 January 2017 in Farindola, Pescara, Italy. The red dot indicates a part of the hotel that was damaged, but not razed by the avalanche. Source a https://www.adnkronos.com/fatti/cronaca/2017/01/19/lusso-spa-ecco-com-era-hotel-rigopiano_

Located in one of the most beautiful sites of Abruzzo, the Rigopiano Hotel was a 4-star hotel. In the heart of the Gran Sasso National Park, with a view of the Adriatic Sea, the hotel stood at 1118 m asl, with a 1200 m² surface area, subdivided into 43 rooms, bar, congress center, “Il Vate” restaurant, and a 1300 m² wellness center and outdoor/indoor pool. The hotel grounds, arranged in a radial design, primarily included three communicating sections: the 4-level main structure, the lower structure attached to it (with three aboveground floors) including the original nucleus, and the underground area, devoted to the wellness center (Fig. 2).

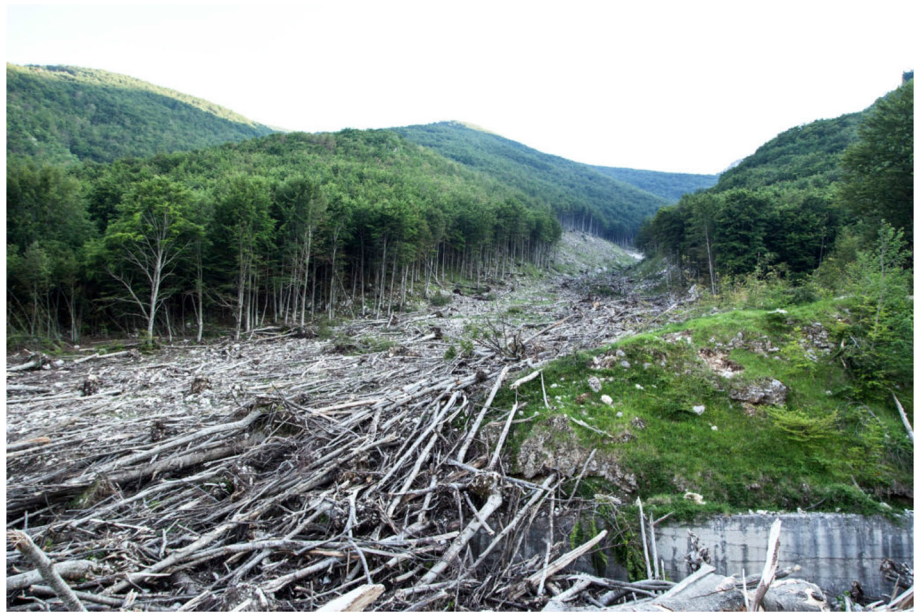
Fig. 3 The intense deforestation process caused by the 18 January 2017 avalanche in Farindola, Pescara, Italy significantly enlarged the width of the channel, uprooting and chopping beeches. Beeches uprooted and finely splintered along the track zone. View of the gully upstream of the Rigopiano Hotel. Photograph by Frigo on 12 September 2017

A number of multidisciplinary skills were needed to understand the dynamics of this complex phenomenon of a wood-snow avalanche—climatology and meteorology; snow science and engineering; geology and geomorphology; dendrochronology; and structural civil engineering. The complex survey started from field observations, but especially in the release area, the snowpack alteration phenomena made it difficult to ascertain the triggering conditions, the physical properties of the released snowpack, and the area and shape of the starting zone. Nevertheless, the avalanche flow left evident traces on the snow and by entrained debris interacting with trees and shrubs along the avalanche path, allowing the opportunity to record useful data about the direction and approximate depth of both dense and powder snow avalanche parts (Fig. 3).

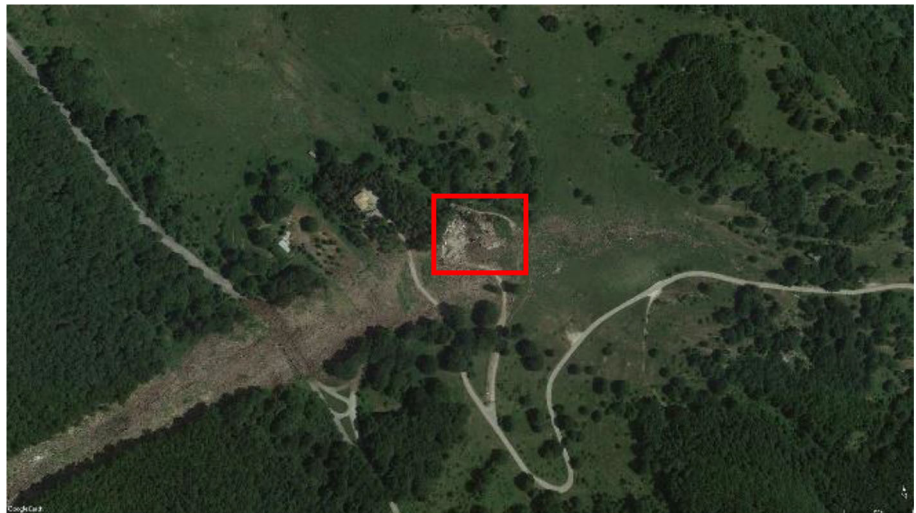
Fig. 5 High definition satellite image of the Rigopiano site in Farindola, Pescara, Italy. The avalanche track through the forest is clearly visible. At the fan apex, the flowing component expanded laterally occupying almost the entire available section without losing significant speed (in the red box, the debris of Rigopiano Hotel).
Source Google Earth Pro—image July 2017

At 450 m away from the hotel, in a flat ($< 4^\circ$) grassy plateau, the snow and debris deposition zone measured almost 4 m thick. The total runout avalanche distance reached almost 2.3 km (Fig. 5). The relatively lower deposit upslope and close to the original hotel position, along with the structural damage, indicated that at the impact point the flow still had a very high velocity, that is, it was not yet fully depositing. Most probably, at the altitude of the hotel, the avalanche was no longer accelerating but still maintained a high speed increasing its density due to the entrainment of wood, rocks, and debris (Frigo et al. 2018).

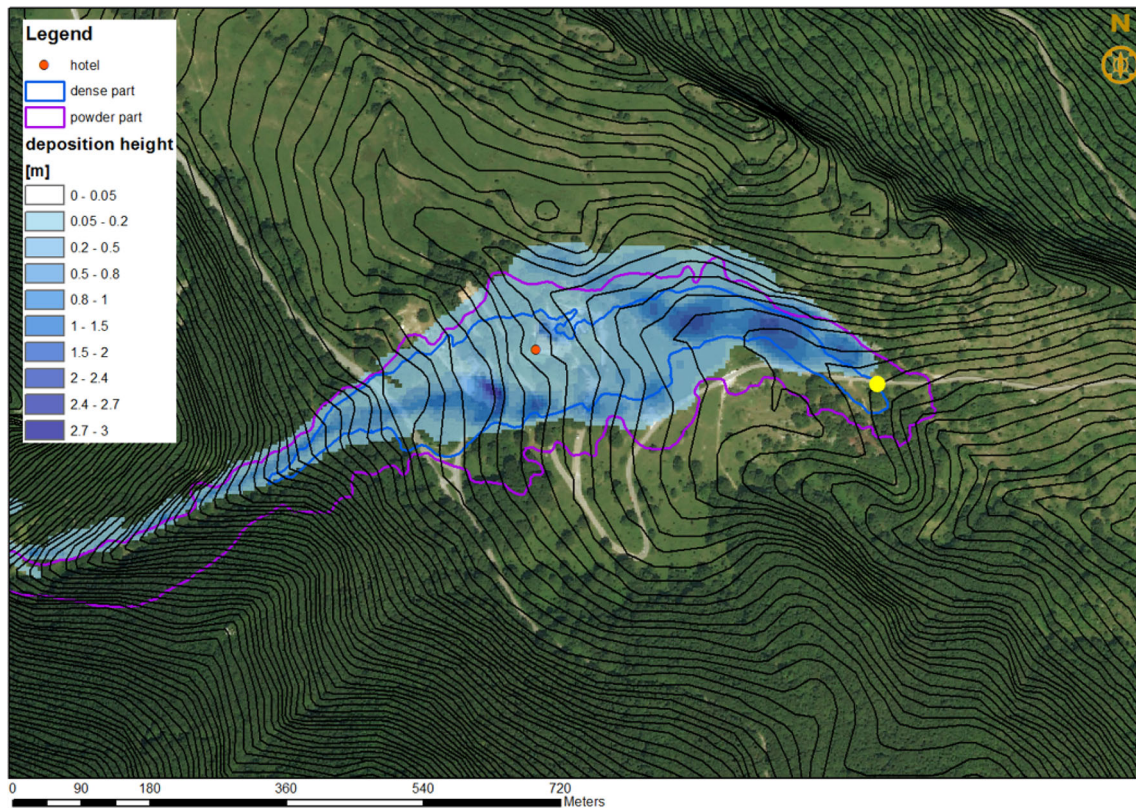
Fig. 7 Simulated deposition height of the 2017 Rigopiano avalanche in Farindola, Pescara, Italy—blue area. The blue and violet lines represent the outline of the dense and powder parts of the avalanche, as determined from the field surveys. The red dot indicates the

location of the hotel, the yellow dot, the location of the provincial road no. 8. *Source* 10 m resolution Digital Terrain Model of Abruzzo region. http://opendata.regione.abruzzo.it/opendata/Modello_digitaledel_terreno_risoluzione_10x10_metri

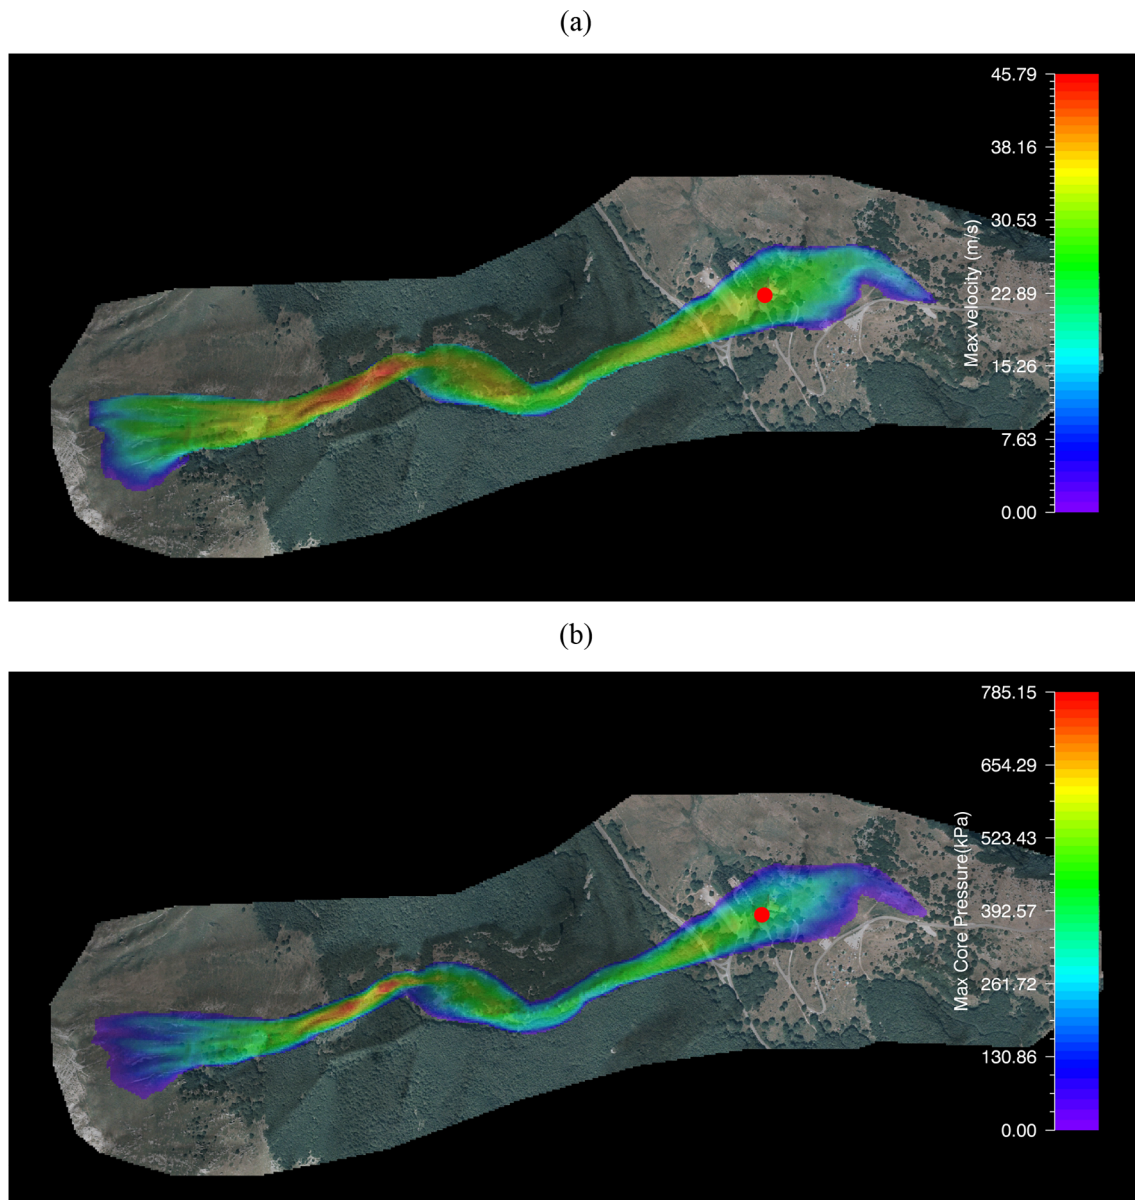
Fig. 9 Simulated variables for the 2017 Rigopiano avalanche in Farindola, Pescara, Italy: **a** the maximum velocity of the core along the avalanche track; **b** the impact pressure of the fluidized part (core)

of the avalanche that destroyed the hotel (the red dot indicates the location of the hotel)

The simulated avalanche reaches the hotel building 69 s after release, traveling with a speed of 30.6 m/s, with a slightly warmer temperature ($T = -1.1$ °C) than the avalanche in sliding phase and high flow densities (more than 400 kg/m³, given by numerical model). The simulated impact pressures reach very high values along the track (see Fig. 9b). In the area close to the hotel, the avalanche attains pressure values above 300 kPa. At the impact, the peak of the impact pressure, calculated as $\rho \times v^2$ (where ρ is density and v velocity) is estimated equal to 393 kPa. The avalanche entrained almost 103,000 m³ of snow.

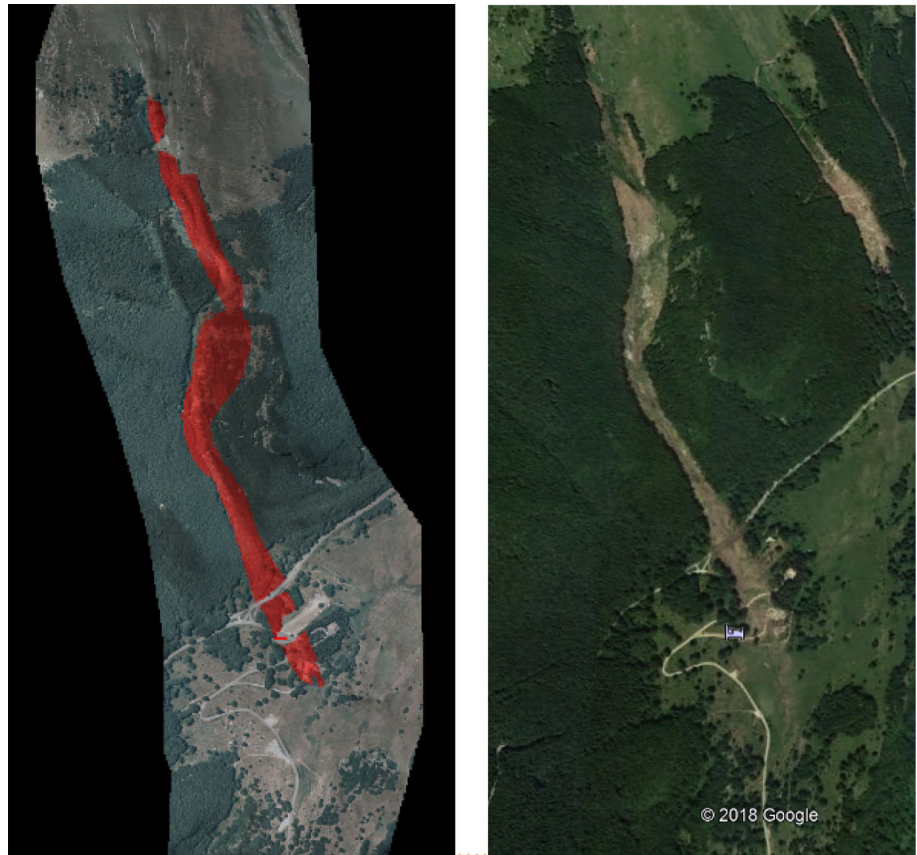
Fig. 10 Area of tree destruction caused by the 2017 avalanche in Farindola, Pescara, Italy: the modeled area (left) compared with the real deforested track in the forest (right). *Source* Google Earth

Another reliable guide to evaluating the reliability of the conducted simulation is the track of the forest devastation. The model simulated the area where the forest is destroyed in relation to the avalanche's destructive power. Usually the interaction between the avalanche flow and the forest results in a loss of mass, which is detrained from the avalanche flow by the tree trunks. Instead, in this case, the area where the trees are destroyed represents where the avalanche overcomes the resistance of the beech trees (Fig. 10).
