Stone roofing in the Aosta Valley, Italy: Technical properties and durability of traditional Lithotypes

# Stone Roofing In The Aosta Valley, Italy: Technical Properties And Durability Of Traditional Lithotypes

**Abstract:** The Aosta Valley Region has promulgated in 1990 a law to partially finance stone roofs to the owners of houses in the historic centers of the valley, provided that the stone material chosen was suitable for this use. This suitability was certified by physical, mechanical and durability tests. More than twenty years ago, roofing slabs were extracted in north-western Alps mainly from schistose rocks. In recent time instead roofing slabs, according to global market, have an international origin. All the traditional stones tested showed excellent technical features according to the local legislation on roof slates. One of these traditional stones is a phyllite whose trade name is “Porfiroide” having the best physical and mechanical properties compared to the other kinds of traditional stones, but with a high standard deviation in the results of flexural strength performed after the freeze and thaw cycles. In the roofing installed 40 years ago, despite their best t

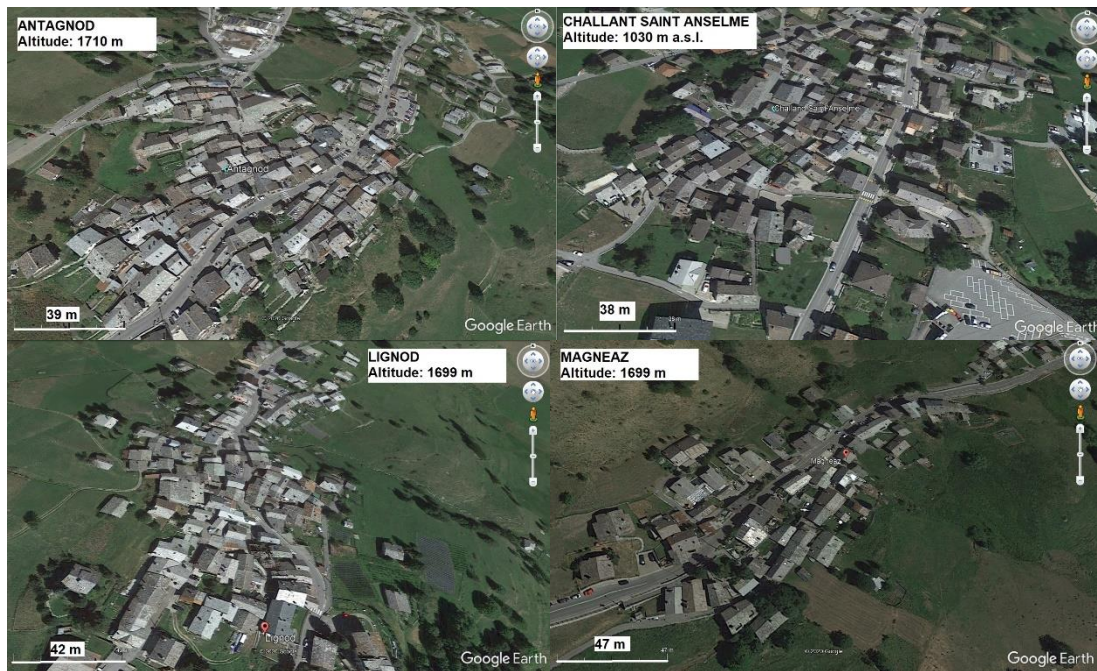
137 Figure 3. From above: Antagnod, Challant Saint Anselme, Lignod and Magneaz old town maps, with altitude.  
 138 Source: Google Earth.  
 139

131 In figure 3 the photos of the details of the historical centres of the 4 investigated municipalities are  
 132 shown, with their altitude.  
 133

140 As can be seen from figure 3, in Valle D'Aosta, all the buildings present in the historic center  
 141 have stone roofs. This is what is defined by the Regional law 1 June 2007, n. 13 [8].

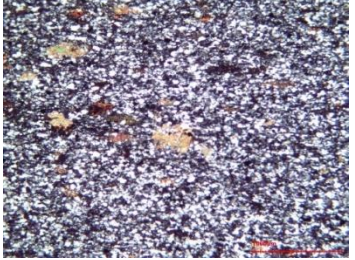
<p style="text-align: center;">100 <math>\mu\text{m}</math></p>	<p><b>QUARTZITE (China) QC:</b> Greenish, very fine-grained with schistose texture. Main minerals:</p> <ul style="list-style-type: none"> <li>- 50% quartz;</li> <li>- 40% white mica;</li> <li>- 10% biotite, opaque and chlorite.</li> </ul>

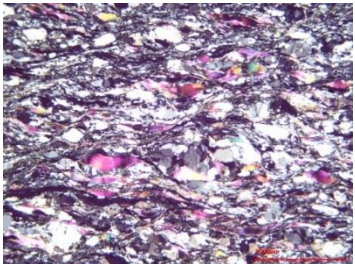
<p style="text-align: center;">100 <math>\mu\text{m}</math></p>	<p><b>QUARTZITE (Greece) QG:</b> Grey-green, fine grained and schistose texture. Main minerals:</p> <ul style="list-style-type: none"> <li>- 45% quartz;</li> <li>- 20% chlorite;</li> <li>- 25% feldspars;</li> <li>- 10% epidote; zircon and rutile.</li> </ul>

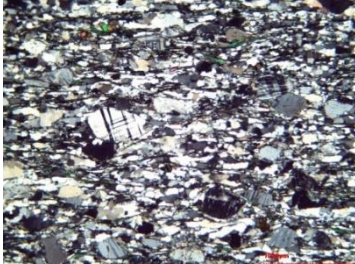
<p style="text-align: center;">100 <math>\mu\text{m}</math></p>	<p><b>QUARTZITE (Norway) QN:</b> Dark grey, medium-fine grained and schistose texture. Main minerals:</p> <ul style="list-style-type: none"> <li>- 70% quartz;</li> <li>- 20% feldspar;</li> <li>- 10% white mica; carbonates, opaque and pyroxene.</li> </ul>

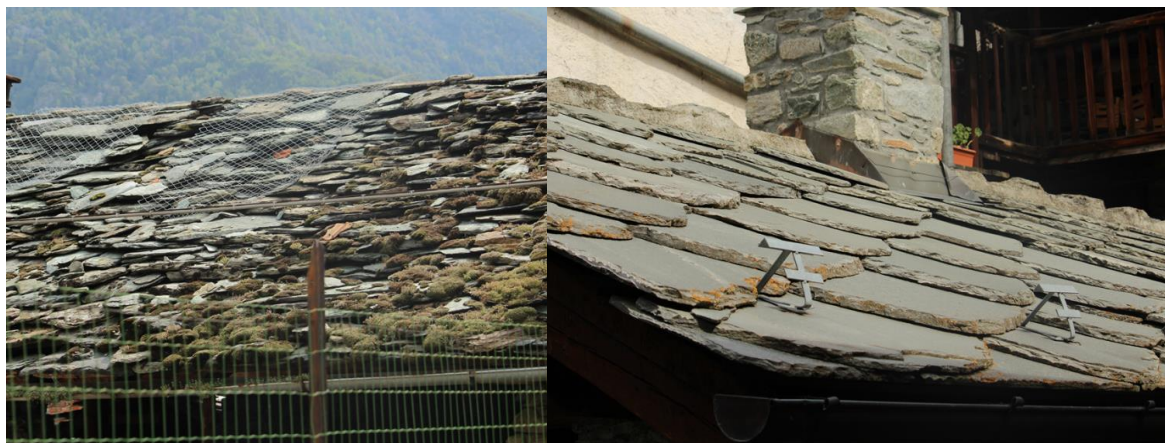
**Figure 6.** An ancient roofing in Challant Saint Anselme on the left and Norway quartzite roofing on the right.

188 In Challant Saint Anselme, from a roof slab with lichens (Fig. 6 on the right) installed in 2002  
 189 (communication of the owner) the sample 1 of Fig.10 was taken. From a quick comparison with the  
 190 sample brought from the laboratory it was assumed that the stone used was the Norway Quartzite  
 191 QN . The preservation state of quartzite slabs of this roof can be compared with the older one slabs  
 192 probably by Calcschist CM covering a nearby house (Fig.6 on the left)

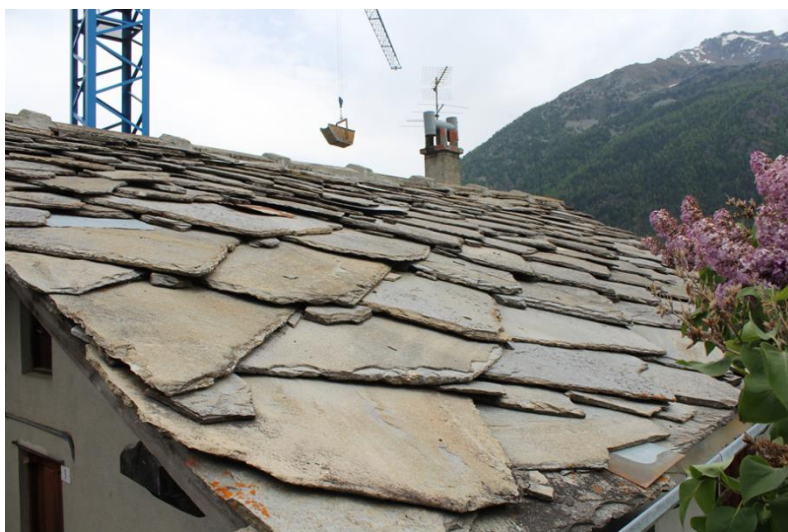
**Figure 7.** Calcschist CM roofing in Lignod after renovation.

In Ayas municipality, Lignod hamlet, the slabs of the roof in Fig. 7 have been recognized as Calcschist according to the comparison with the specimens brought by the laboratory. These slabs were similar but less weathered than those of Fig 6 on the left: the whole house was restructured in the early 2000s.

234 All the stones tested respect the threshold limits of physical and mechanical properties  
 235 requested by the Aosta Valley Region (Table 1) apart from the carbonate content of CM. However,  
 236 from table 5 and 6, Porfiroide (PO) and Calcschist (CM) show high decreasing in flexural strength  
 237 after freeze and thaw cycles (respectively -9,6% and 9,2%) despite the mechanical resistance after  
 238 artificial decay still maintain good performances (PO > 40 MPa, CM > 22 MPa). These behaviours, for  
 239 Morgex Calcschist CM, can be due surely to the high carbonate content (>5%) and mica (10%) and  
 240 for Porfiroide PO to the very high mica content (30%). From the in situ monitoring, the low  
 241 durability of PO and CM is enhanced. These are the stone roofing slabs with highest percentage of  
 242 detachment and weathering (Fig. 7, 8 and 9). The relation between mica content and resistance to

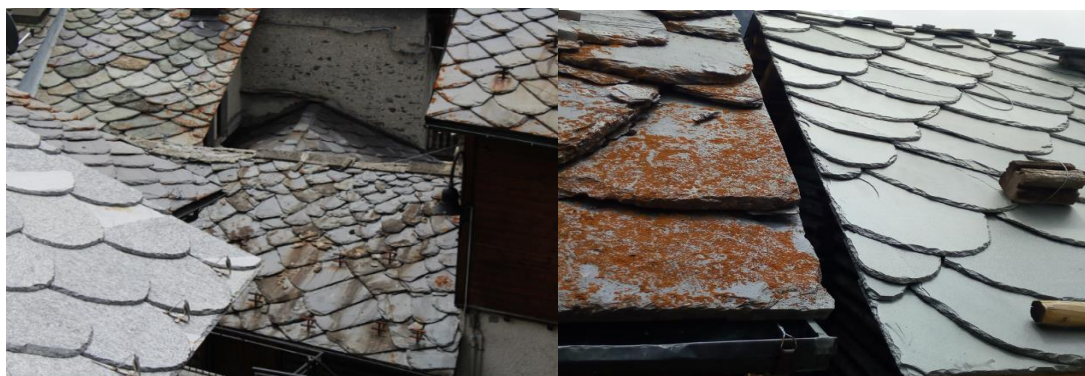
**Figure 8.** Porfiroide roofing near the new roofs of gneiss on the left and Quartzite on the right in Antagnod.

In Antagnod, it was possible to detect other varieties of ornamental stones: Prasinite in the cemetery, Quartzite and Porfiroide. In Fig. 8, the roofing in Porfiroide near new kinds of stones is shown. The Porfiroide slabs were broken therefore a sample of Porfiroide was taken (sample 2 of Fig. 10).

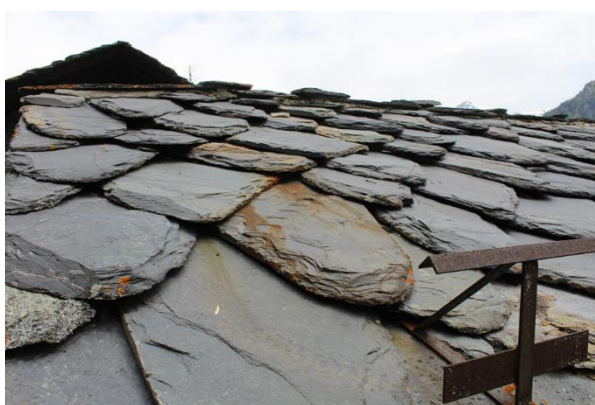
**Figure 9.** Old stone roofing in Porfiroide in Magneaz hamlet.

In Magneaz, a sample from an old roofing dated to 1980 (Fig. 9) where detachment and oxidation traces were present was taken (sample 3 of Fig.10).

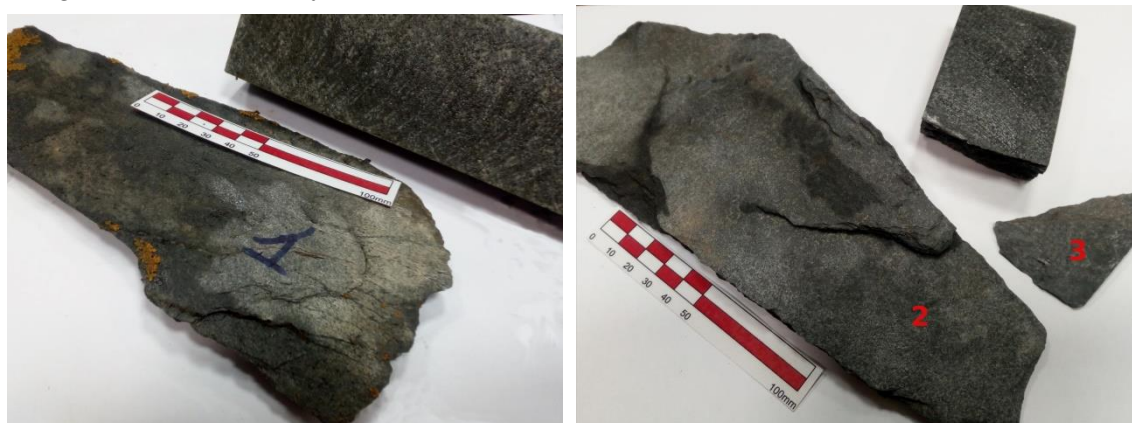
**Figure 10.** Comparison of sample from in situ and the laboratory specimens tested. On the left the sample 1 compared with Norway quartzite specimen; on the right samples 2 and 3 compared to Porfiroide specimen.

In laboratory, the macroscopic comparison of the samples taken in situ with specimens tested, confirmed that sample 1 is a Norway quartzite QN, and samples 2 and 3 are Porfiroide PO (Fig. 10).
