Vinyl-Asbestos Floor Risk Exposure in Three Different Simulations

Keywords: chrysotile asbestos; SEM analysis; vinyl-asbestos flooring; free asbestos fibers; simulation test

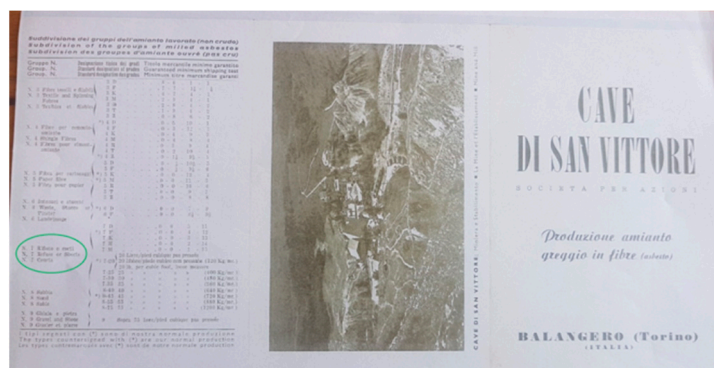
Figure 1. (a) San Vittore (Balangero, Turin, Italy) quarry, flyer extract for asbestos fiber production. Asbestos group 7 is circled in green, probably used for vinyl-asbestos floor. (b) Particularities of the subdivision of the group of milled asbestos (source: https://it.wikipedia.org/wiki/Amiantifera_di_Balangero; accessed on 10 January 2021).

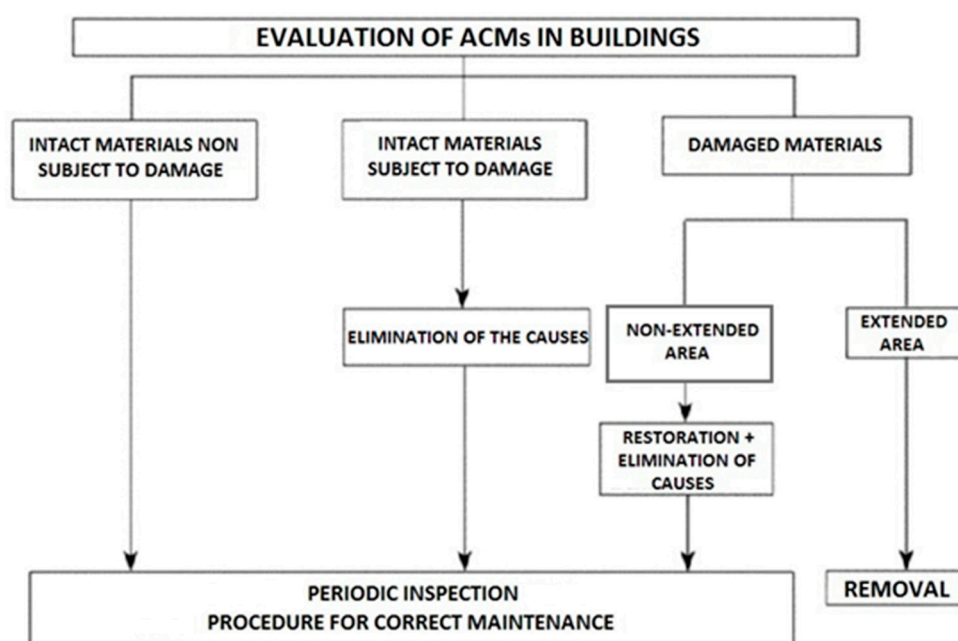
Figure 2. Evaluation scheme of asbestos-containing materials (ACMs) in building and recommendations (from Article 1, Annex: Standards and Technical Methods for Risk Assessment, Control, Maintenance and Remediation of Materials Containing Asbestos Present in Building Structure, Risk Assessment, Table 2 of M.D. 6/9/94 [4]).

Figure 2 describes the different situations that can occur during the evaluation of ACMs in buildings and the related recommendations in these different cases required by M.D. 6/9/94 [4].

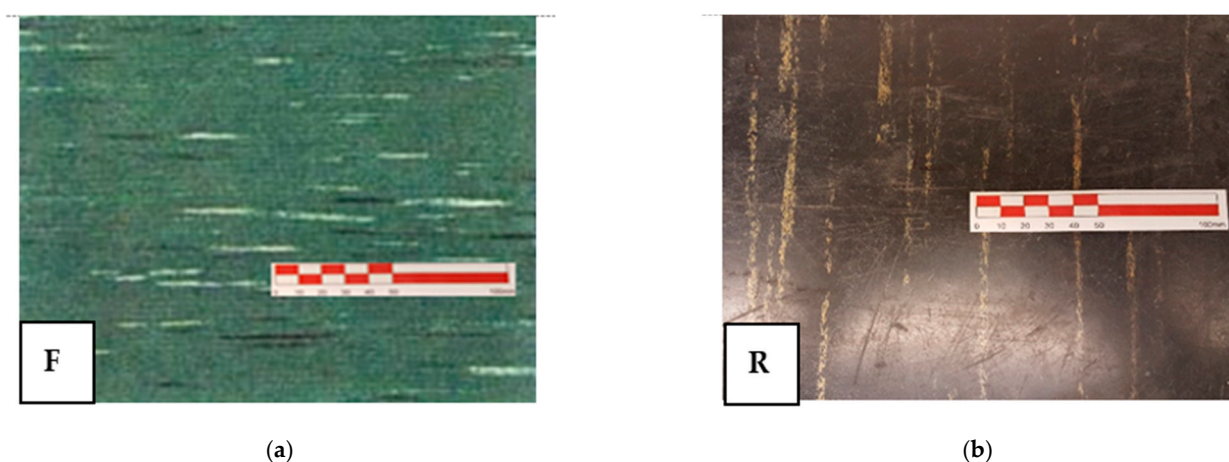
Figure 3. (a) Sample F—squared floor green tiles with white and black stripes, more flexible and in good condition (b) Sample R—squared floor black tiles with beige stripes, quite rigid and in fairly good condition.

The prevalent use of vinyl floors containing asbestos was in public buildings and popular housing. In this context, two types of vinyl from public buildings have been considered. In Figure 3, they are shown macroscopically. The green vinyl (F) on the left was laid in the 1990s and shows a flexible structure. The black vinyl (R) on the right was laid in the 1980s and shows a more rigid structure.

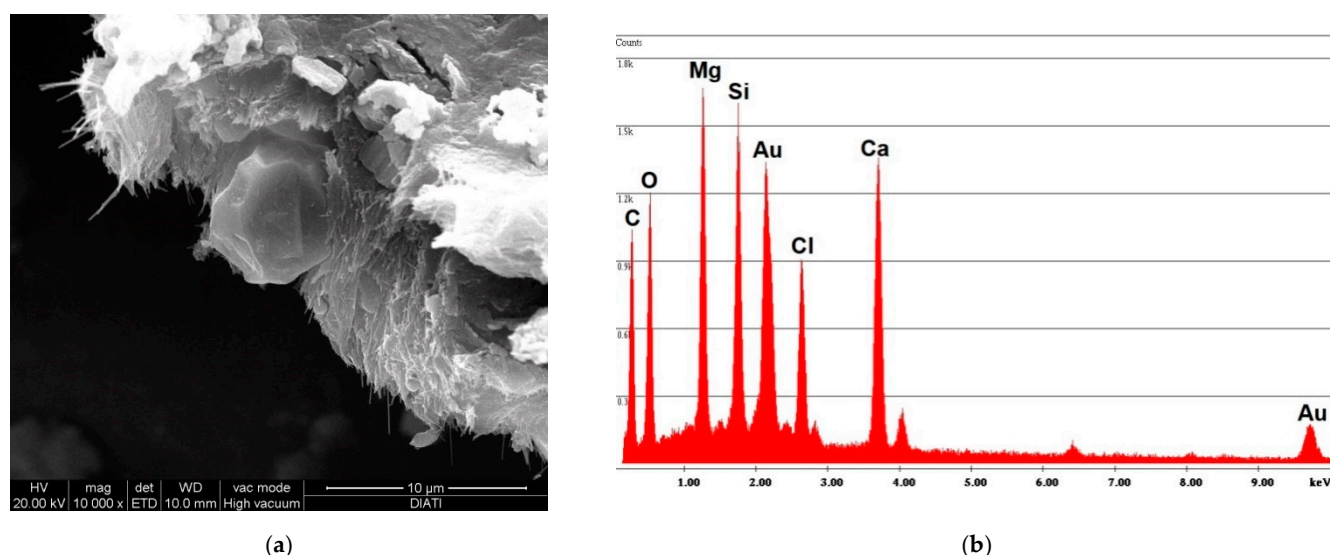
Figure 4. F sample SEM analysis. (a) Photo of incorporated fibers of chrysotile; (b) spectrum of chrysotile and vinyl chloride composition.

The simple abrasion of surface tile powder was analyzed with SEM/EDS; Figure 4 shows the spectrum obtained by analyzing the powder from vinyl F. The photo on the left shows how the fibers are completely incorporated within the vinyl matrix. The spectrum shows both of the elements that compose chrysotile, Mg and Si, where the Mg peak is greater than the Si peak; the spectrum also reports the elements that compose the vinyl matrix, Cl and Ca.

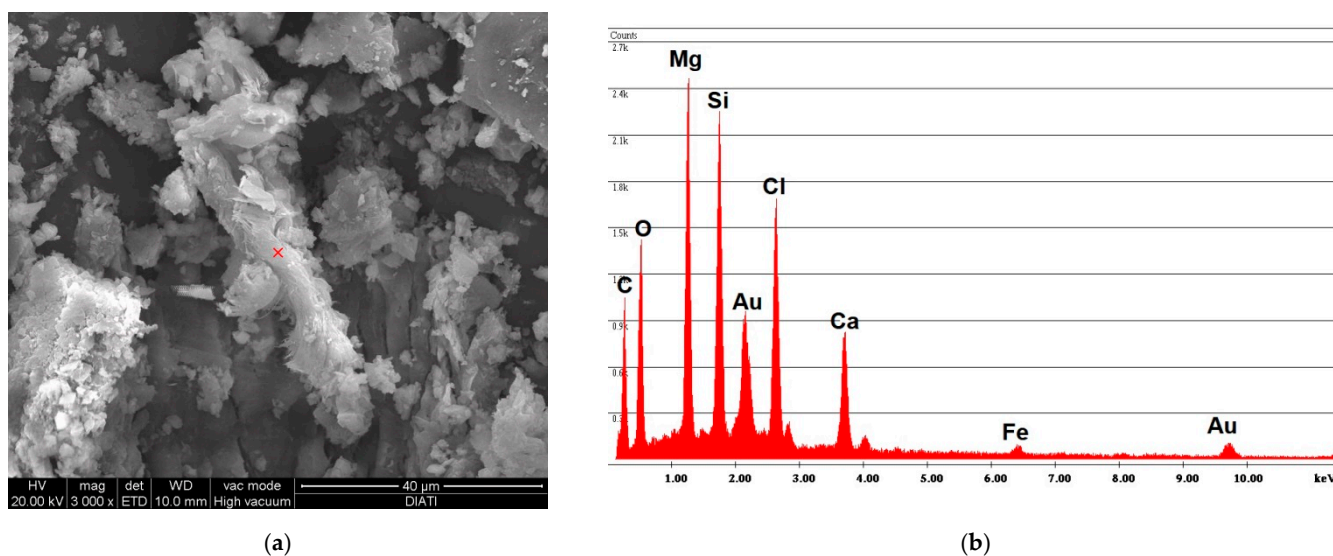
Figure 5. R sample SEM analysis. (a) Photo of incorporated fibers of chrysotile; (b) spectrum of chrysotile and vinyl chloride composition.

Figure 5 shows the same analysis, performed on the powder obtained from the vinyl sample R. In addition, in this case, the fibers are incorporated in the vinyl matrix; the spectrum confirms this aspect due to the presence of Mg and Si components of the chrysotile.

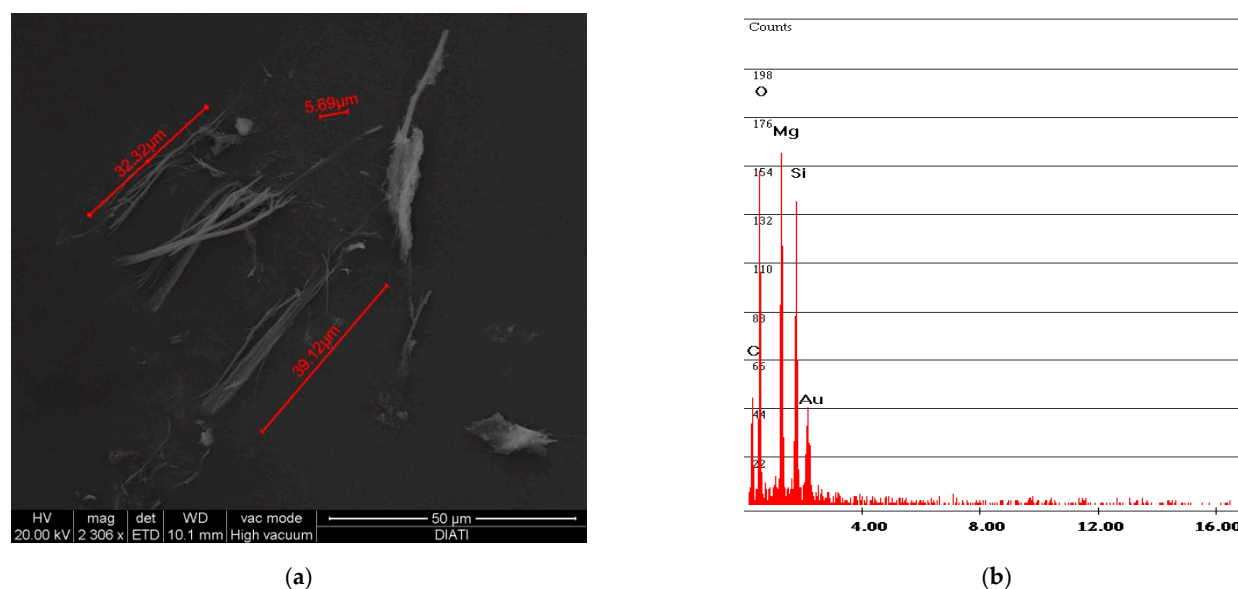
Figure 6. F sample SEM analysis. (a) Photo of free fibers of chrysotile with measurement values; (b) spectrum of chrysotile.

Figures 6 and 7 show the free fibers obtained, respectively, from samples F and R. The measurements of the fibers of both samples are in line with the particle size dimension declared by Petry US Patent [2], that is, below 2 μm . A difference can also be observed between the particle size dimension of sample R and sample F: the older and more rigid sample R has smaller fiber sizes than sample F.

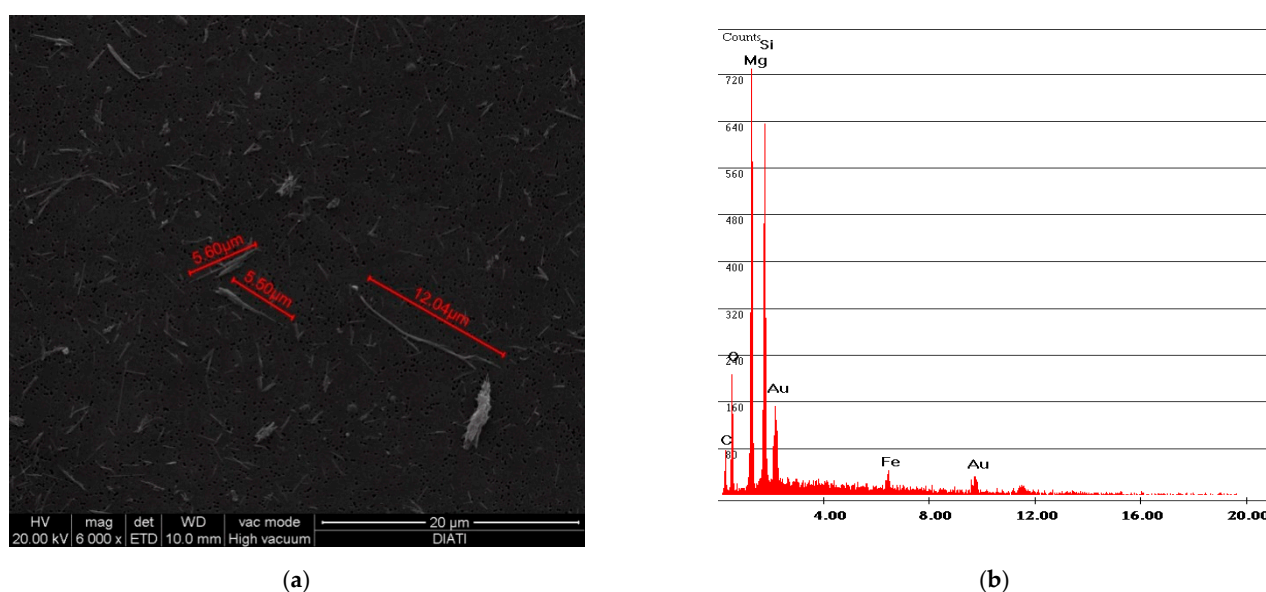
Figure 7. R sample SEM analysis. (a) Photo of free fibers of chrysotile with measurement values; (b) spectrum of chrysotile.

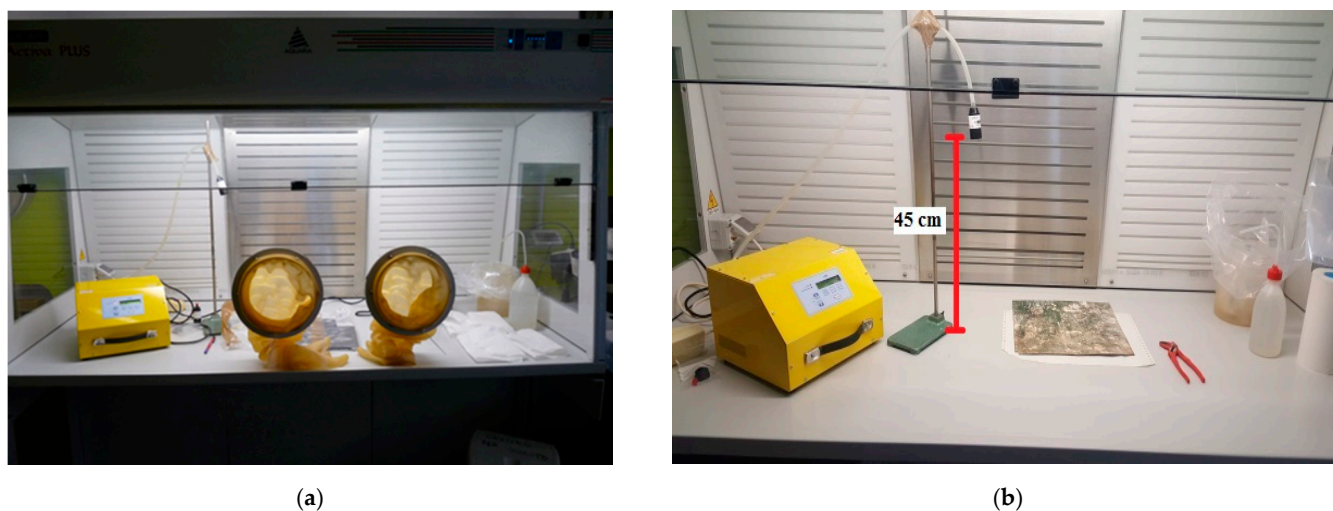
Figure 8. (a) Confined hood with gloves for simulation tests. (b) The airborne retrieval through a polycarbonate membrane.

During the sampling phase for the ACM mapping, a piece of tile is detached manually. This procedure must normally be carried out wet. The purpose of this test, however, was to check whether there is a release of fibers during this ACM sampling phase. In this case, the test was carried out in a confined environment, with multigrip pliers in dry condition (Figure 9). The duration time of the test was 15'. The airborne samples were then analyzed with SEM/EDS.

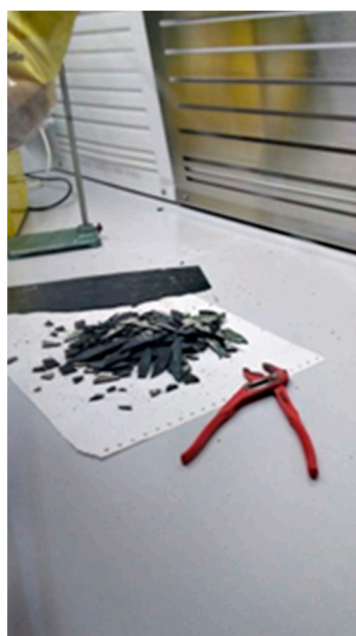
Figure 9. Multigrip plier breakage test.

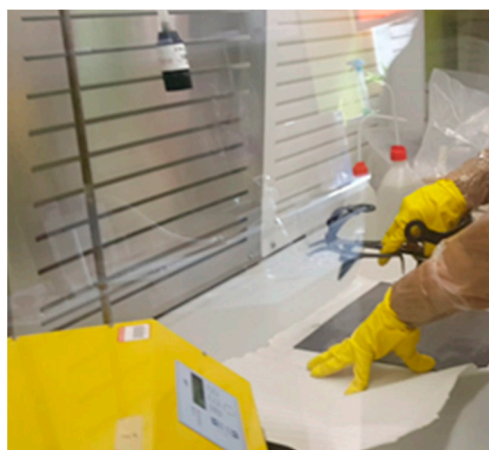
Figure 10. Vinyl tile crampon test inside the confined hood.

A vinyl floor is subject to pedestrian traffic. This test was carried out using NiCrMo steel crampons (Camp_Cassin brand (Premana, Italy)) with Hardness HRC (Rockwell scale) $53 \div 58$, to simulate the pedestrian traffic with impact and drag. The test was performed with 100 crampon shots (impact and drag) by the same operator in ten minutes. This test was performed manually from about 40 cm in height by letting the crampon fall without applying force. The number of shots could underestimate the wear carried out over time by the pedestrian traffic, but the hardness of steel is greater than any shoe worn, therefore, a possible release of fibers during the test can be representative. Figure 10 shows the performed test.

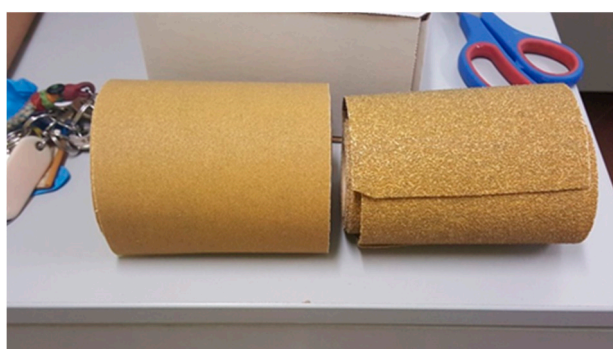
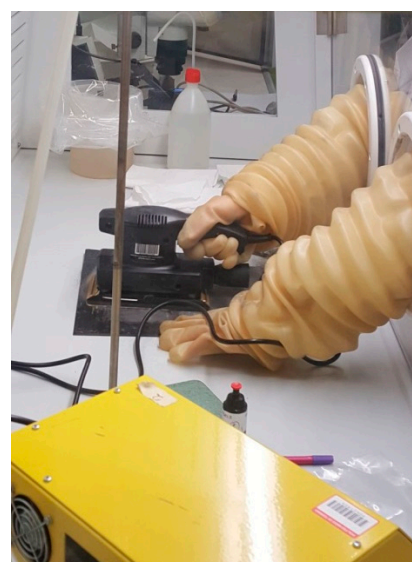
Figure 11. (a) Sandpaper used for the test. Left: fine sandpaper (dimensions: P120). Right: coarse sandpaper (dimensions: P40). (b) Performed mechanical abrasion test inside the confined hood.

In the present study, a strong mechanical abrasion of R and F vinyl tile samples was carried out using two types of sandpapers, one with a fine grain of P120 and one with a coarse grain of P40 (Figure 11). The abrasion time for each sample was 5 min.

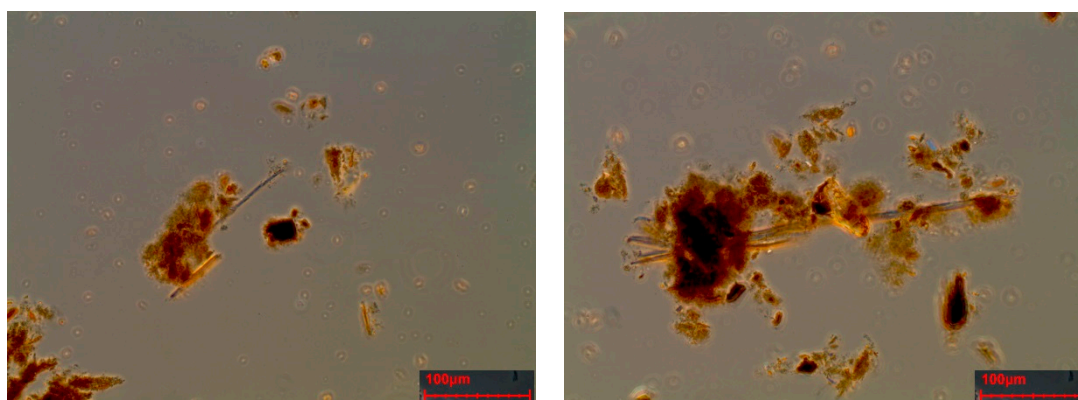
**Figure 12.** Phase-contrast microscope (PCOM) photos of the powder obtained by means of abrasion test. Chrysotile fiber with part of the vinyl glue remain attached.

The simulation tests performed on the two vinyl floor samples provided the airborne analysis for a quantitative evaluation of any release of asbestos fibers (free asbestos content). The release of free fibers into the powder, obtained from abrasion test was also quantitatively assessed (last column Table 5). The values obtained confirm, as shown in the D.M., that the percentage of chrysotile present in the vinyl flooring is in a range between 10% and 12% [3,4]. In Figure 12, two PCOM photos of the powder obtained by means of the abrasion test are reported; the presence of Chrysotile fibers is evident.

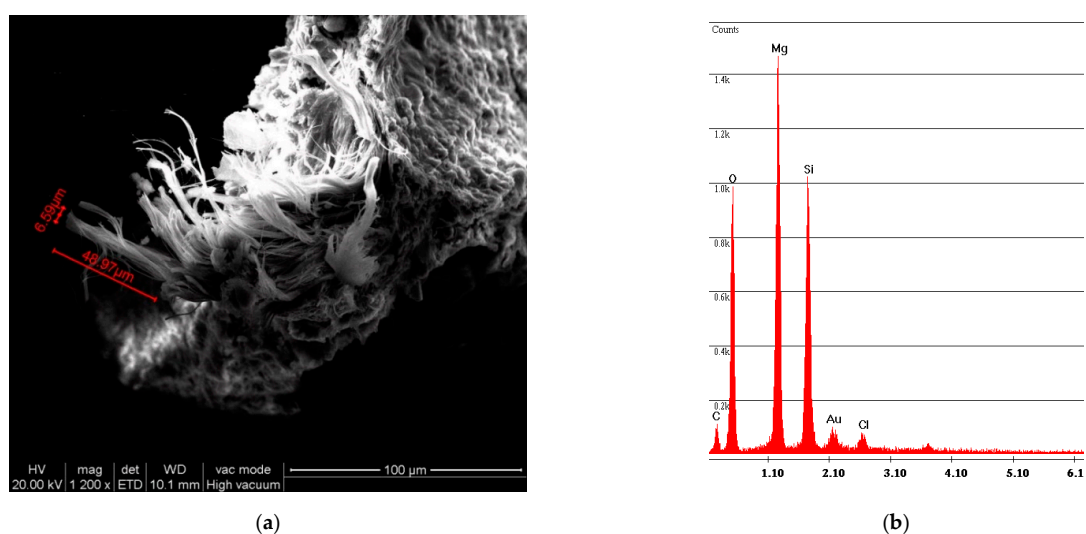
Figure 13. Sample F airborne sample of multigrip plier breakage simulation. (a) SEM photo; (b) spectrum with Mg and Si peaks indicating Chrysotile presence.

The simulation of the sampling was carried out by an operator to verify the presence of asbestos in the artefacts by mapping the areas containing asbestos; this simulation found a release of fibers that exceeds the limits of 2 fibers/liter only for sample R. The asbestos fiber concentration is $C = 3.05$ fibers/liter for sample R and $C = 1.53$ fibers/liter for sample F, indicating that sampling of asbestos-vinyl floors must be carried out avoiding asbestos fibers contamination for operators by adopting preventive and protective measures while operating in wet conditions [4]. Figures 12 and 13 show two examples of SEM photos and spectrum of airborne samples.

Figure 13 shows that in sample F, many fibers remain incorporated in the adhesive matrix of the vinyl, while the fibers found for the sample R (Figure 14) are free fibers.

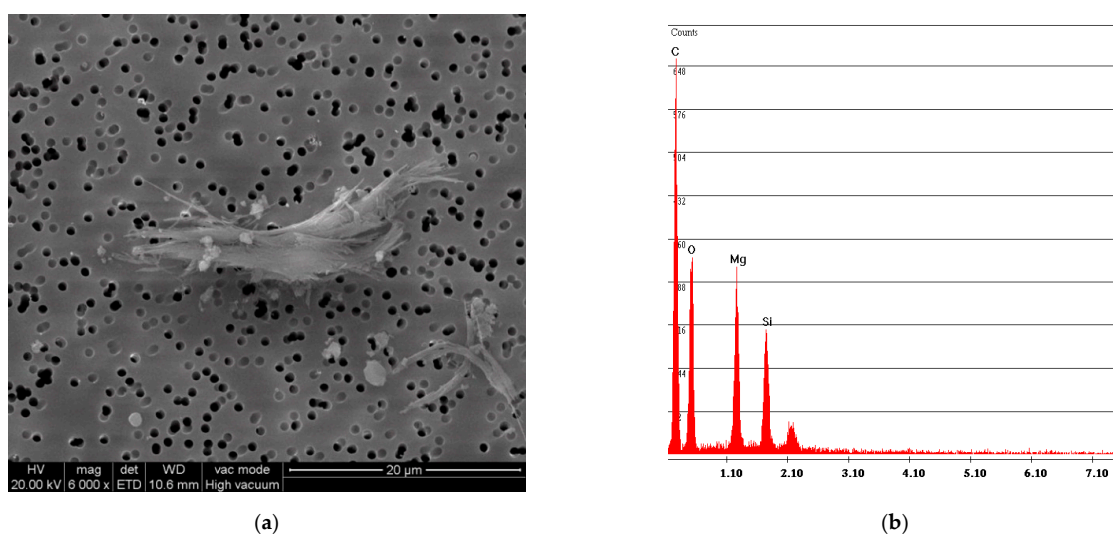
Figure 14. R airborne sample of multigrip plier breakage simulation. (a) SEM photo; (b) spectrum with Mg and Si peaks indicating Chrysotile presence.

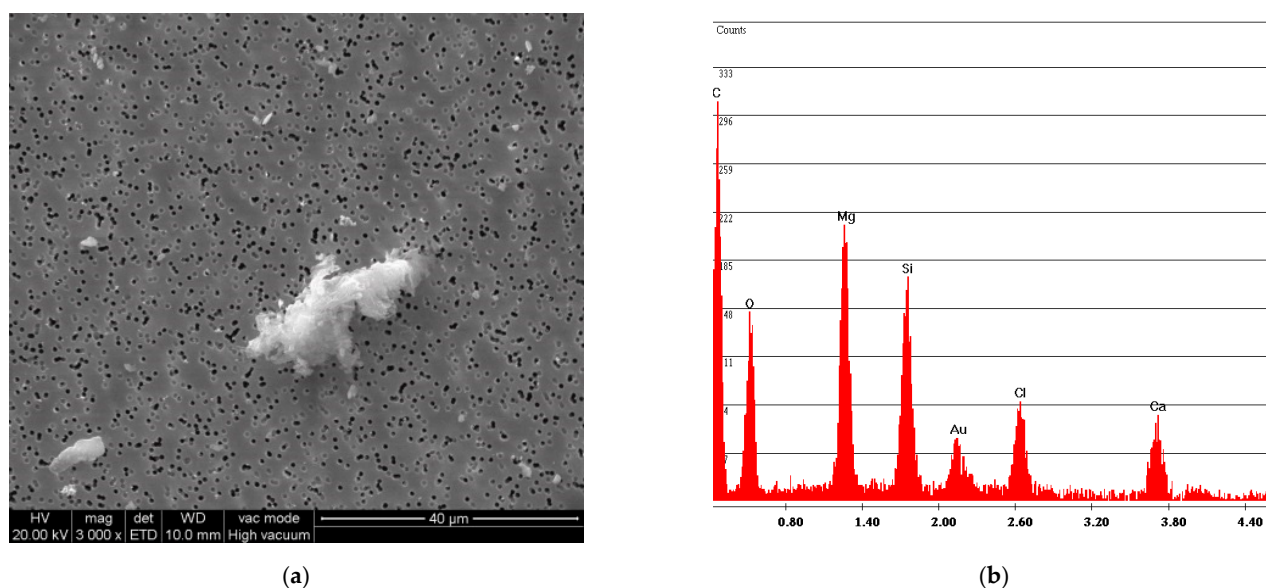
Figure 15. Sample R airborne sample of simulation for impact and drag with crampons. (a) SEM photo of incorporated asbestos fibers in the vinyl-adhesive matrix. (b) Spectrum with Mg and Si Chrysotile peaks and Cl and Ca adhesive matrix peaks.

This test was carried out with impacts and drag that simulate the trampling of the vinyl floor; this simulation did not produce fiber release. The test did not produce powder. The results obtained with Equation (1) are $C = 0$ fibers/liter for both samples. This confirms the indications given by the Italian Ministerial Decree 06/09/1994 [4], which states that there is a release of fibers only in the case of abrasion, perforation, brushing or if the vinyl floor is very deteriorated (Table 3). Figure 15 shows incorporated asbestos fibers in adhesive vinyl matrix. Figure 16 shows a piece of the adhesive matrix of the vinyl floor.

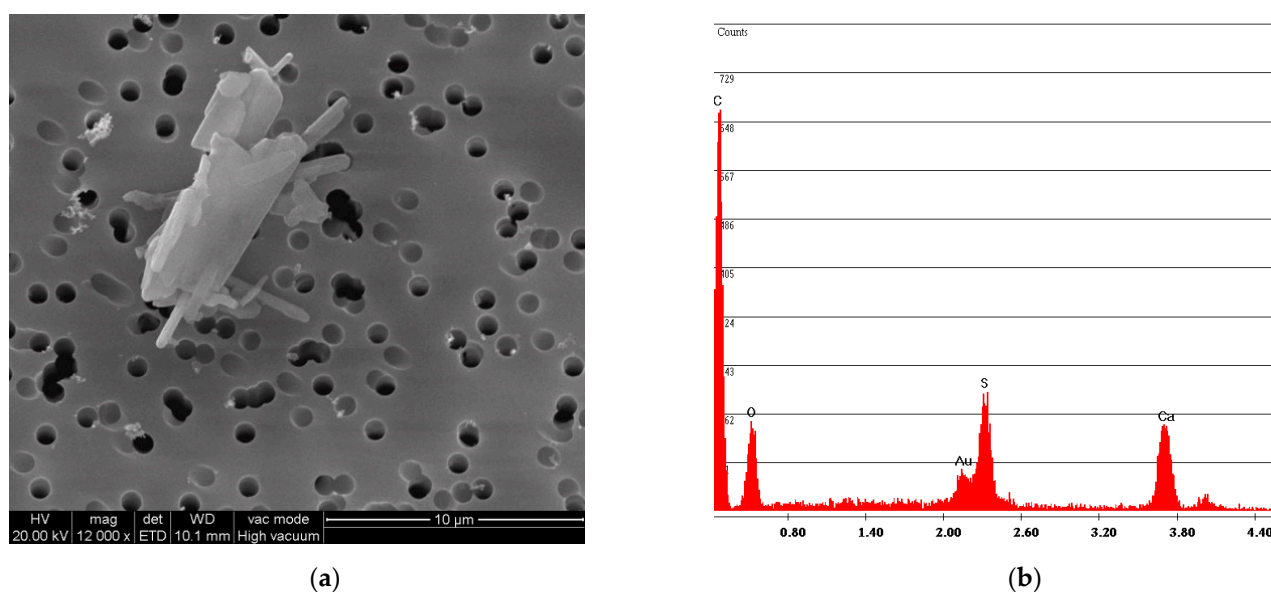
Figure 16. Sample F airborne sample of simulation for impact and drag with crampons. (a) SEM photo of part of the matrix without asbestos fibers. (b) Spectrum of the adhesive matrix.

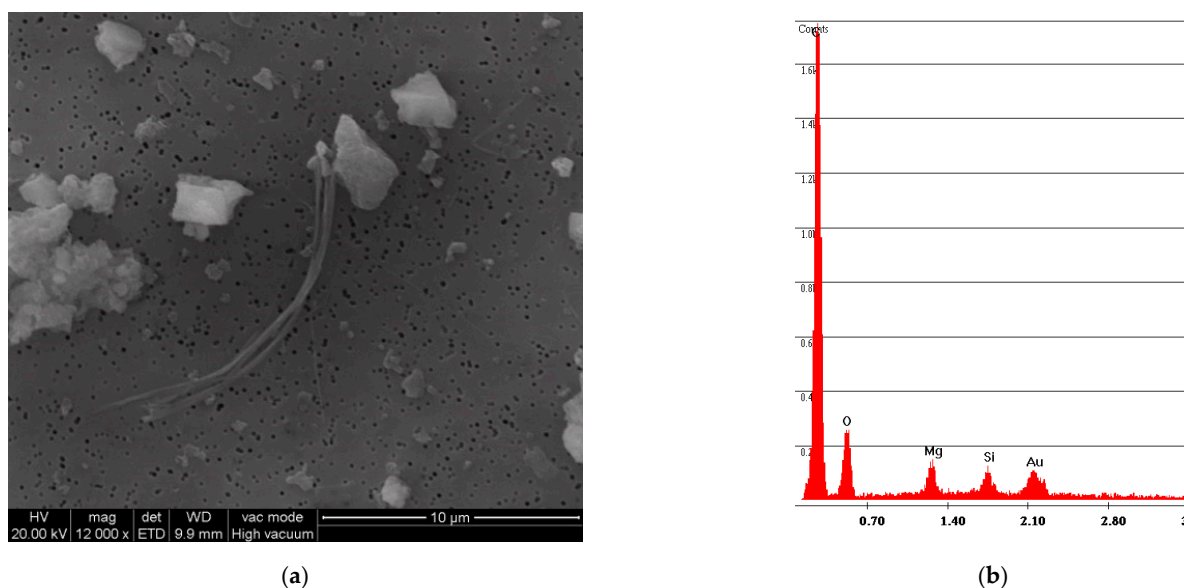
Figure 17. F airborne sample of abrasion simulation test with fine-grained sandpaper. (a) SEM photo of Chrysotile bundle. (b) Spectrum of Chrysotile with typical Mg and Si peaks.

The results obtained for abrasion with fine-grained sandpaper are $C = 12.97$ fibers/liter for sample F and $C = 24.42$ fibers/liter for sample R. The abrasion of sample R produced more longer and free fibers compared to the ones of sample F. This particular aspect is shown in Figures 17 and 18. The smaller fiber dimension of sample R had already been observed during the vinyl characterization test (Figures 6 and 7).

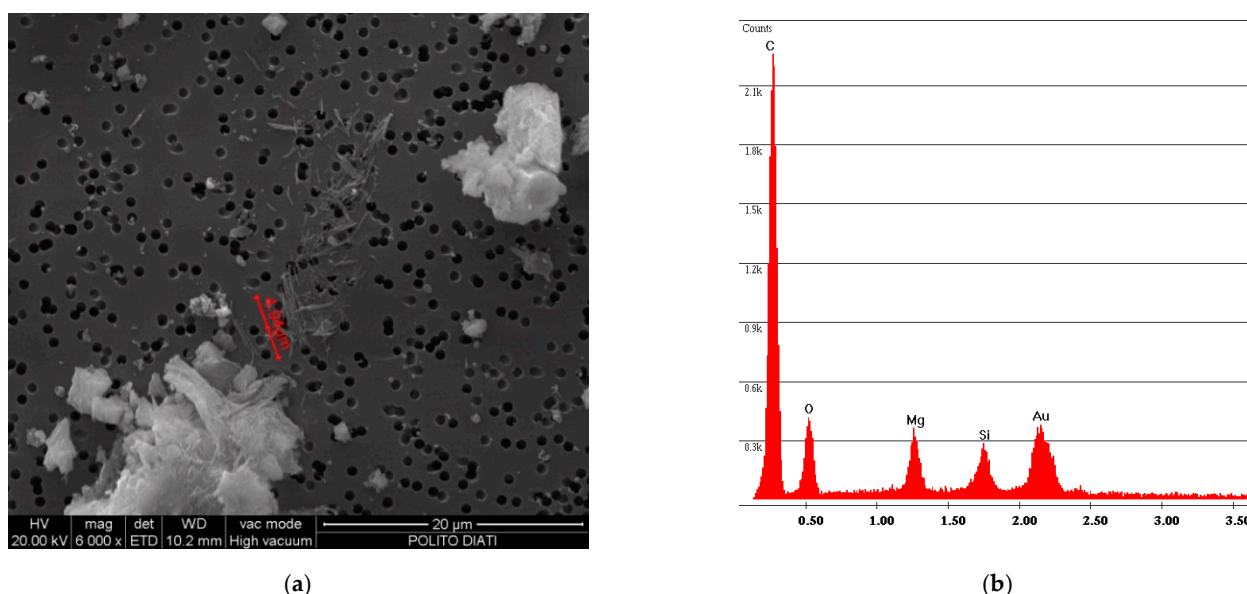
Figure 18. R airborne sample of abrasion simulation test with fine-grained sandpaper. (a) SEM photo of little Chrysotile free fibers; (b) spectrum of Chrysotile with typical Mg and Si peaks.

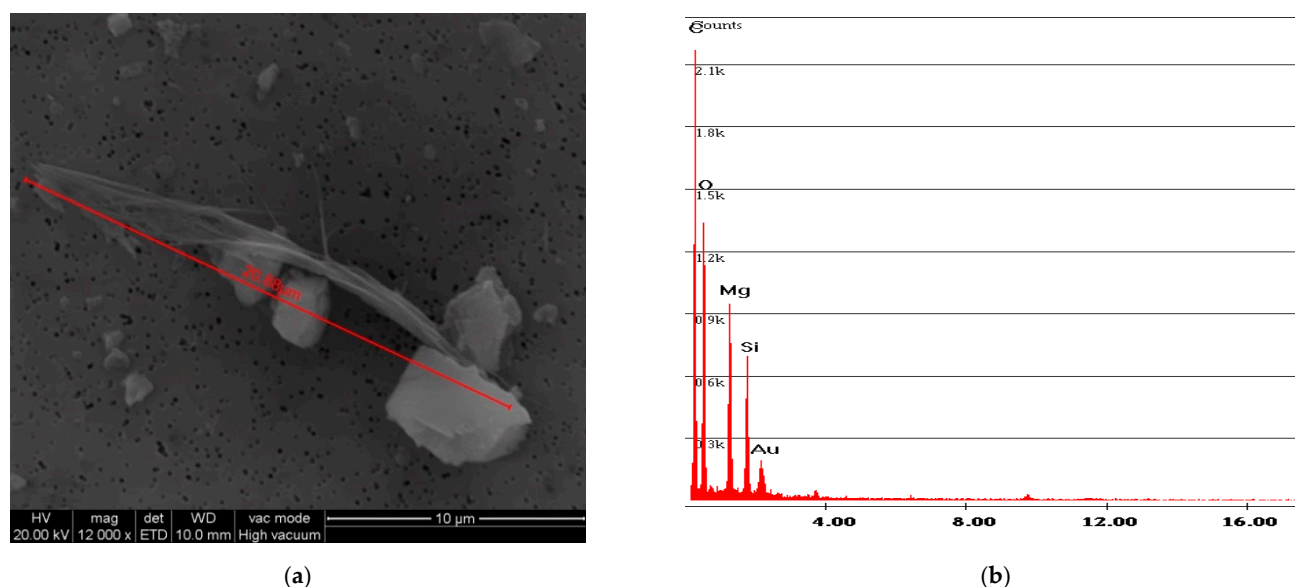
Figure 19. F airborne sample of abrasion simulation test with coarse-grained sandpaper. (a) SEM photo of Chrysotile bundle; (b) spectrum of Chrysotile with typical Mg and Si peaks.

The results obtained with abrasion simulation test using coarse-grained sandpaper were $C = 9.16$ fibers/liter for sample F and $C = 7.63$ fibers/liter for sample R. The free

fibers obtained with coarse-grained sandpaper were larger than the free fibers obtained with fine-grained abrasive sandpaper for both samples. Furthermore, the same trend that was observed for fine-grained abrasive sandpaper can also be observed for coarse-grained abrasive sandpaper, i.e., the fiber sizes from sample F were larger than the fiber sizes of sample R (Figures 19 and 20).

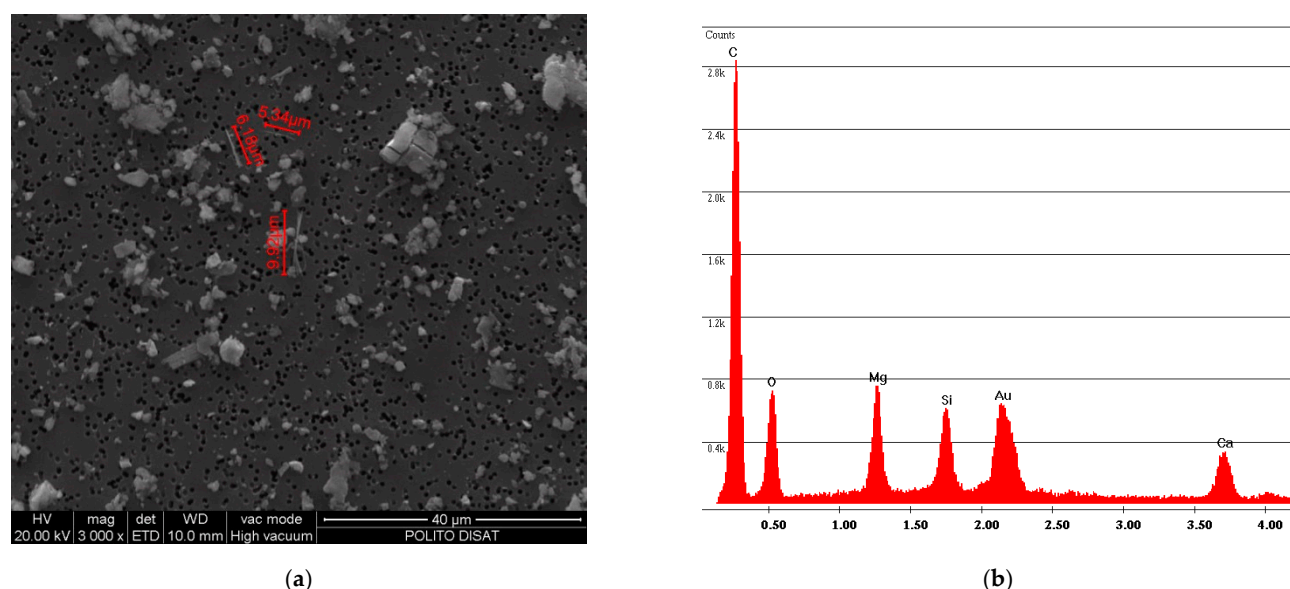
Figure 20. R airborne sample of abrasion simulation test with coarse-grained sandpaper. (a) SEM photo of Chrysotile free fiber bundle; (b) spectrum of Chrysotile with typical Mg and Si peaks.

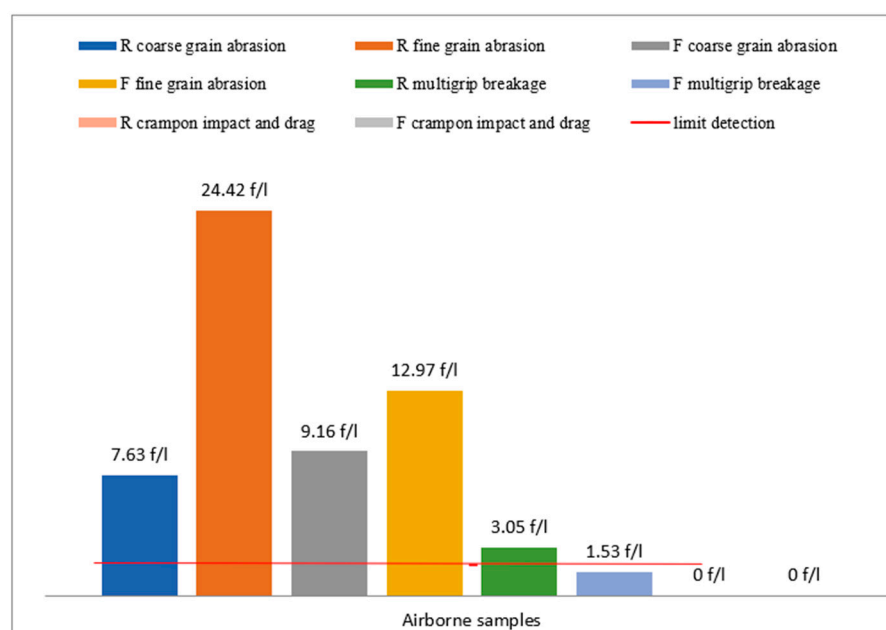
Figure 21. Histogram of the fiber/liter values calculated according to Ministerial Decree 06/09/1994 [4], for all tests carried out on samples R and F. The horizontal red line indicates the limit detection value.

Figure 21 shows a representation of all simulation tests on samples R and F. The red line represents the limit detection value according to Italian Ministerial Decree 06/09/1994 [4]. It can be observed that, in general, the R sample shows worse results than the vinyl sample F, due to its rigidity and ageing comparing to vinyl floor F.
