AE propagation velocity calculation for stiffness estimation in Pier Luigi Nervi's concrete structures / Lenticchia, Erica; MANUELLO BERTETTO, AMEDEO DOMENICO BERNARDO; Ceravolo, Rosario. - In: CURVED AND LAYERED STRUCTURES. - ISSN 2353-7396. - 8:1(2021), pp. 109-118. [10.1515/cls-2021-0010]

Erica Lenticchia, Amedeo Manuello Bertetto*, and Rosario Ceravolo

AE propagation velocity calculation for stiffness estimation in Pier Luigi Nervi's concrete structures**

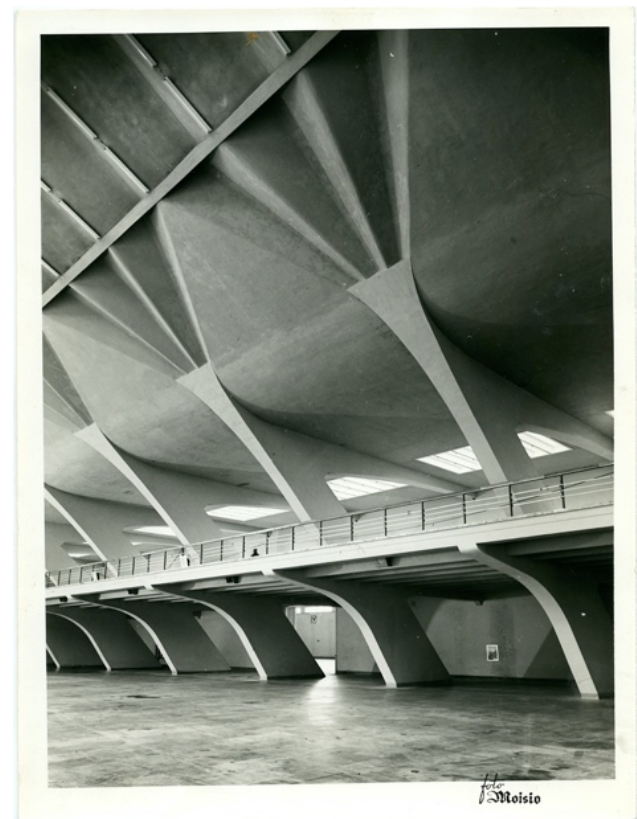
Figure 4: (a) Scheme of the various casting stages of pillars. (b) Detail of the interiors just after the completion of the hall (photo of Aldo Moisio)

The supporting structures of the vault were instead built in four different stages, in which the concrete was poured sequentially in different months. Figure 4a shows a section of an inclined pillar reporting a scheme of the various casting stages, while Figure 4b shows a picture of the interiors just after the completion of the hall.

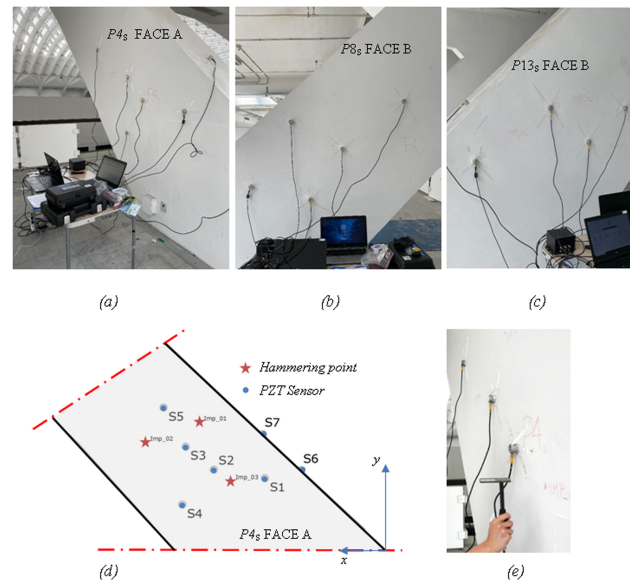
Figure 5: Application of the sensor array to the slant pillar (a) $P4_S$, (b) $P8_S$, (c) $P13_S$. (d) Detail of the sensor positions for $P4_S$. (e) Hammering performed on the surface of the pillar

In order to carry out these tests, the ND procedures were performed by a technique coming from the impact-echo, allowing to obtain, as a parameter of estimation of the damage, the P-wave propagation velocity inside the monitored element. To this purpose, an array of 7 sensors has been placed on the surfaces of the pillars in correspondence to the last level (between quote +4.40 m and 9.00 m) represented in Figure 4a. In Figure 5a–5c, it is reported the arrangement of the sensors on the three slanted pillars and their arrangement on the monitored surface is reported. In Figure 5d the position of the sensors respect to the positions of the impact points of the hammering can be observed.

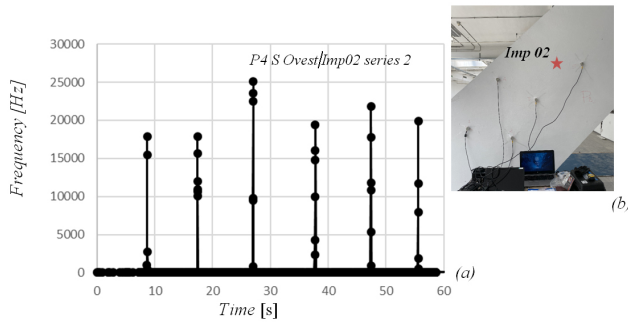
Figure 6: (a) Frequency vs time graph related to the acquisition of the acoustic signals due to the hammering in position imp02 (b)

From Eq. (9), it is easy to observe how v_p is a function of the elastic modulus (E), the mass per unit volume ρ , and the Poisson's coefficient (ν) of the material. In Figure 6, as an example, a graph of a typical AE acquisition, obtained during the hammering tests carried out on the slant pillar P4_S of Hall B, is reported. As it can be seen, peaks correspond to the hammerings performed on one of the points of impact (Imp02). For each peak, there is a varying number from 5 to 7 of the AE signals detected in relation to the number of sensors that actually perceive the elastic propagation coming from the hammering. The frequency of the signals acquired by the sensors is reported with respect to the time employed for the test. The AE frequency evaluation appeared to be very important in the preliminary filtering

of the signals. In the present study, a threshold of 1×10^3 Hz is considered. Signals acquired below this value were neglected because they definitely belonged to the background noise. The whole procedure is described in the flow-chart reported in Figure 7. The beginning of the acquisition is characterized by the generation of the artificial sources. In general, they may originate from a natural phenomenon (crack propagation or formation of micro-cracks) or from an artificial cause (impacts produced by a digital hammer). In the present case, the AE sources are generated by hammering on the external surface of the slanted pillars. During the perturbation created by the impact in the positions Imp01, 02 and 03 for each pillar, the AE signals were recorded. The acquisition is carried out for a duration of 60 s for each hammering sequence. After this, the first filtering is applied to AE signals (Figure 7). As previously mentioned, in the present experiments, only AE with a mean frequency greater than 1×10^3 Hz were considered. After this preliminary phase, the recognition of the data sets consistent with the localization procedure was performed. For the localizations, all pairs, triplets, quatrains, and so on that have the differences in the arrival times to sensors in the range $\Delta t_j - \Delta t_0 < 10 \times E^{-4}$ s were considered belonging to the same event (impact). In the analyzed case, the event generating the signals is the rhythmic hammering in the impact positions. Once these data sets are selected, a system of equations of the type of Eq. (2) can be written. The localization adopted is based on the triangulation technique and the improved AIC-method, as reported in Carpinteri *et al.* [23]. Once localized sources are obtained, and after verifying that the obtained results are localized close to the artificial source created ad hoc (maximum error accepted = 1%), the value of the p-wave propagation velocity (v_p) is extracted. Finally, through Eq. (10), it is possible to estimate the value of the elastic module (E) associated with the velocity v_p just calculated with the described method (Figure 7). In Figure 8a and 8b, the calculated v_p and the elastic
