16th World Conference on Earthquake Engineering

ENGINEERING RECONNAISSANCE FOLLOWING THE AUGUST 24, 2016M6.0 CENTRAL ITALY EARTHQUAKE

ENGINEERING RECONNAISSANCE FOLLOWING THE AUGUST 24, 2016 M6.0 CENTRAL ITALY EARTHQUAKE

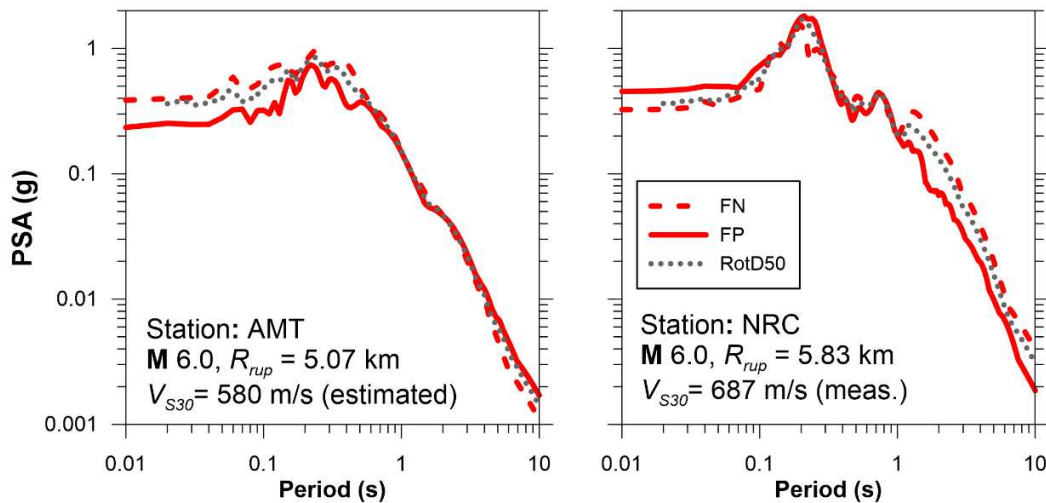
Figure 4 shows pseudo-acceleration response spectra (PSA) from the two stations most proximate to the mainshock rupture plane (AMT and NRC), which are shown in Figure 1. The corrected ground motions have been rotated into fault normal (FN) and fault parallel (FP) components. The two ground motions are of comparable amplitudes (NRC slightly higher), despite substantially different damage levels (details below). The AMT ground motion shows evidence of polarization in the FN direction at short oscillator periods (< 1.0 sec), while the NRC motion is stronger in the FN direction at long periods (> 1.0 sec).

Fig 4 – Mainshock pseudo acceleration response spectra (5% damping) for Amatrice (AMT) and Norcia (NRC) sites. Fault strike taken as 150 deg for computation.

We have visited the AMT and NRC sites. The instrument shelters at neither site appears to have been damaged by the earthquake, and both shelters are small structures unlikely to appreciably affect the recordings. Generally, the damage patterns near the AMT site were also suggestive of stronger shaking in the FN direction, which will be detailed in our Ver 2 report.
