Surface orange patinas on the limestone of the Batalha Monastery  
(Portugal): characterization and decay patterns

# Surface orange patinas on the limestone of the Batalha Monastery (Portugal): characterization and decay patterns

**Keywords** Oolitic limestone · Orange patina · Scialbatura · Stone decay · Batalha Monastery

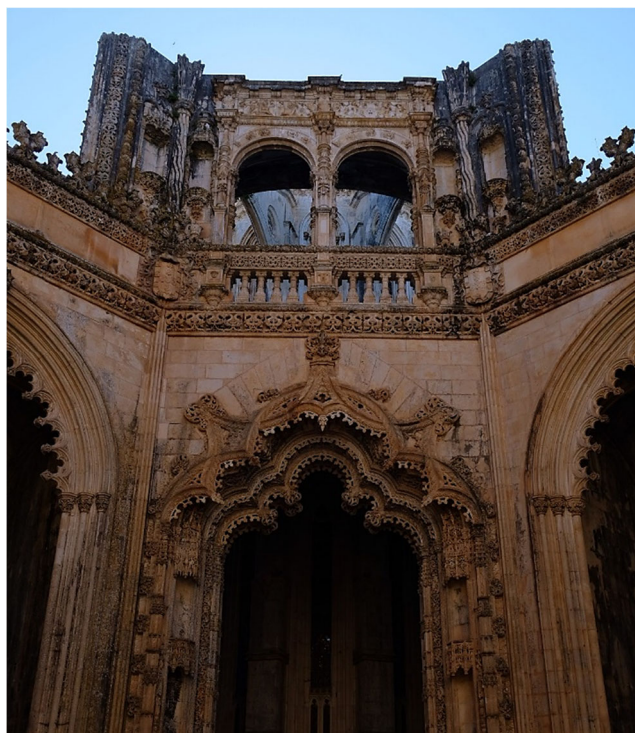
**Fig. 1** Facade and ornaments with orange patina at the Imperfect Chapels, Batalha Monastery

monastery limestone is now extensively covered with orange patinas which can be seen on the surface of facades, ornaments, columns, and walls (Fig. 1). Few studies on this subject can be found in the literature. Rattazzi and coworkers examined two statues stored in the monastery museum: the external orange layers were found to show a rather homogeneous texture with traces of gypsum and clay minerals; FTIR analysis showed bands of Al-silicates and iron oxides, interpreted as Earth of Sienna natural and Red Ochre pigments (Rattazzi et al. 1996). Aires-Barros et al. investigated the original fifteenth-century Saint Matthew statue and the external walls of the main façade. The statue showed the presence of calcite with minor nitrate, silicate, and organic products like benzoic acid, while on the external walls, the orange patinas were found to be predominantly composed by calcium oxalates such as whewellite ( $\text{CaC}_2\text{O}_4 \cdot \text{H}_2\text{O}$ ) with minor weddellite ( $\text{CaC}_2\text{O}_4 \cdot 2\text{H}_2\text{O}$ ), together with hydroxyapatite ( $\text{Ca}_5(\text{PO}_4)_3(\text{OH})$ ), halloysite, and nitrates (Aires-Barros et al. 2001).

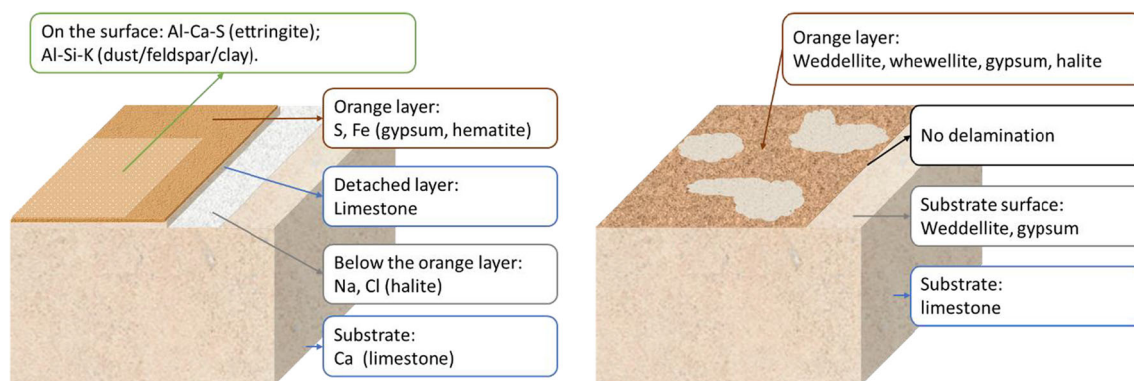
Combining the results obtained, preliminary sketch (Fig. 9) was made to elucidate the different characteristics of the two samples investigated.

Fig. 9 Sketch of the sample “S-116” (left) and the Window tracery (right)
