Combining Multiband Imaging, Photogrammetric Techniques, and FOSS GIS for Affordable Degradation Mapping of Stone Monuments

# Combining Multiband Imaging, Photogrammetric Techniques, and FOSS GIS for Affordable Degradation Mapping of Stone Monuments

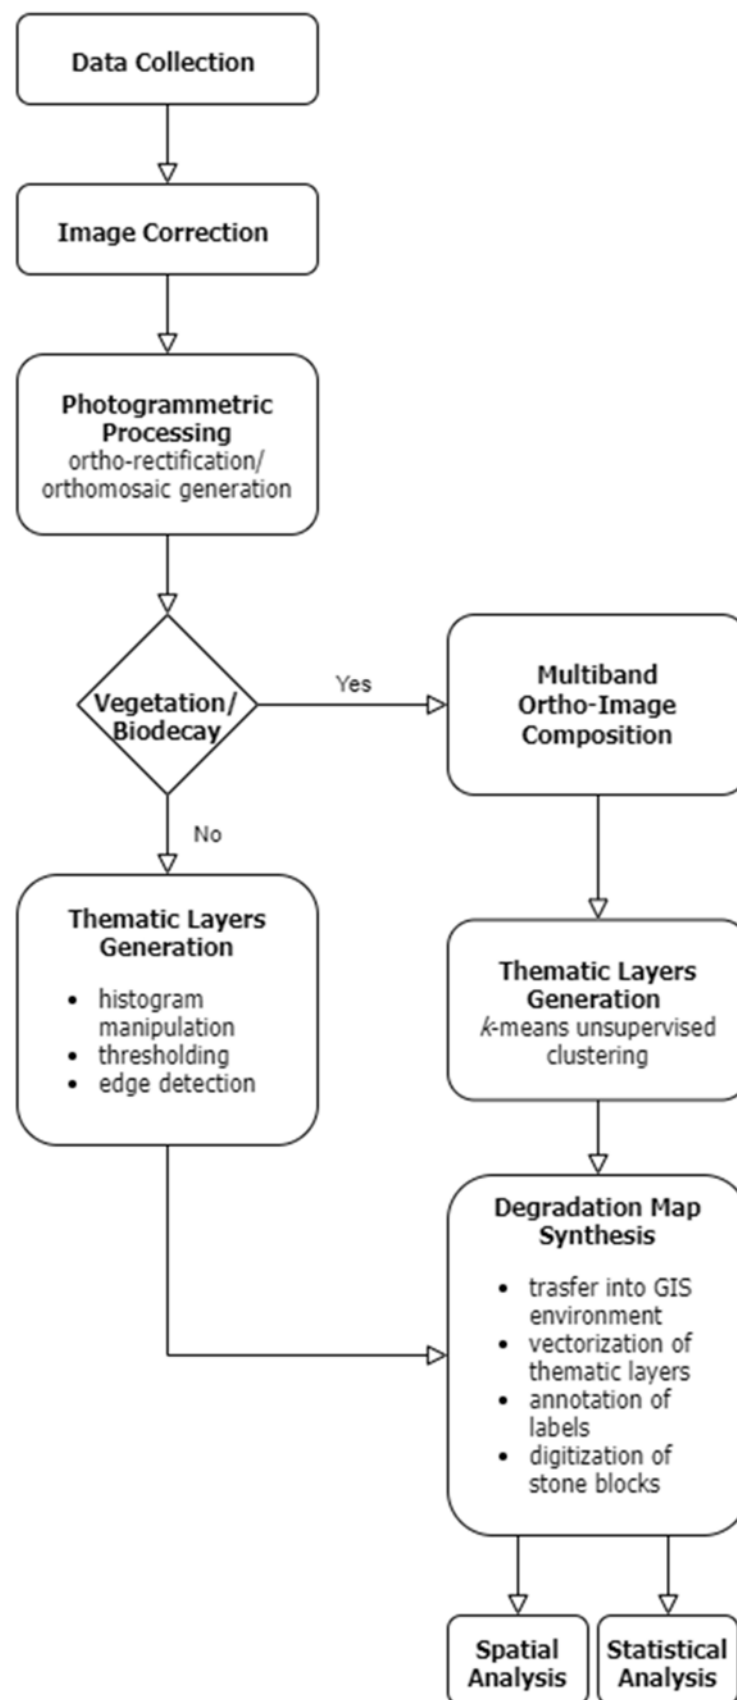
Figure 1. Schematic representation of the methodological workflow.

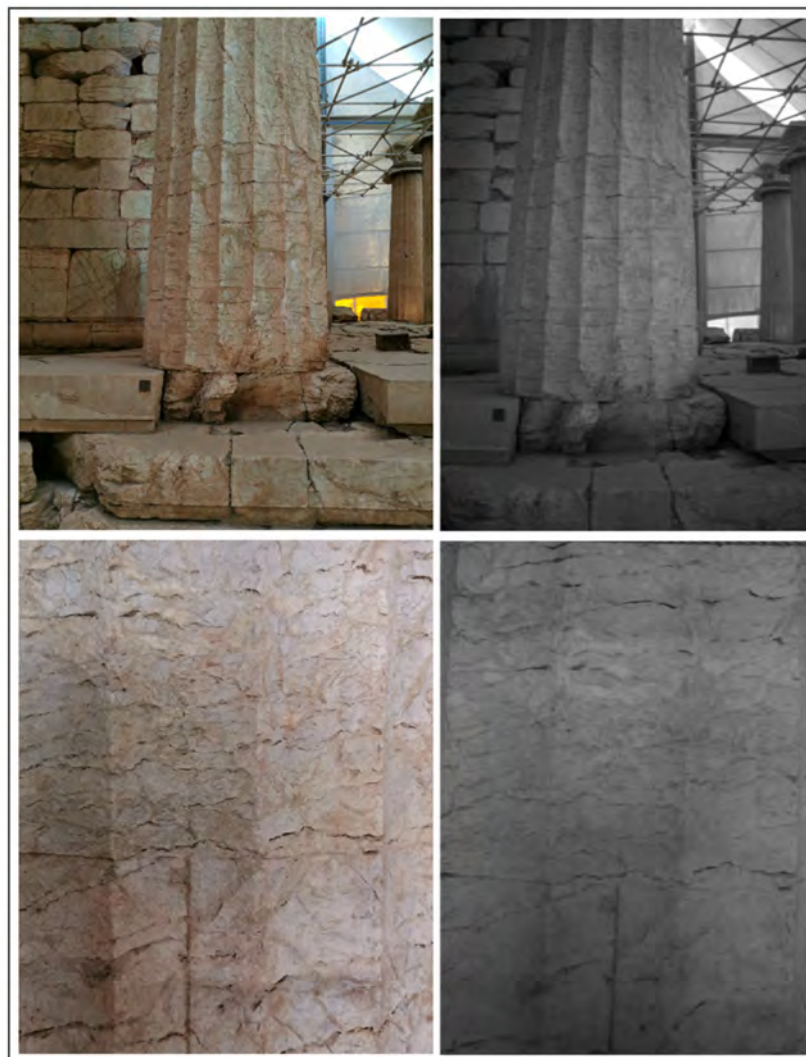
**Figure 4.** Color (**left**) and near-infrared reflectance (**right**) images of the same column captured at the Temple of Apollo Epikourios at Bassae, from further and closer range.

The thematic data about characteristic surfaces at the Temple of Apollo Epikourios were produced by digitally manipulating NIR reflectance images. These images presented more homogeneous radiometry, which was extremely important in order to extract suitable thematic information. In particular, the original and restoration materials that had been previously used presented more similar reflectance characteristics in the near-infrared than in the visible spectrum. Thus, by using NIR reflectance images, the misinterpretation of other degradation forms could be avoided (Figure 4). The architectural surfaces had been mostly cleaned, and therefore, the observable categories of degradation were only loss of material, cracks, and in certain places discoloration. After the NIR images had been corrected and rectified, binary images representing these different categories were produced. Thresholding was applied for identifying discoloration after flat-field correction, which eliminated any remaining inhomogeneous illumination problems. Edge detection and afterward binarization was performed on the first principal component of the images to detect cracks. Finally, histogram equalization and thresholding were performed to identify the loss of material. Figure 5 presents the generation of the binarized category-specific degradation images for an architectural surface and the production of thematic layers in the FOSS GIS environment. The thematic maps produced for investigated characteristic surfaces are presented in Figures 6 and 7.

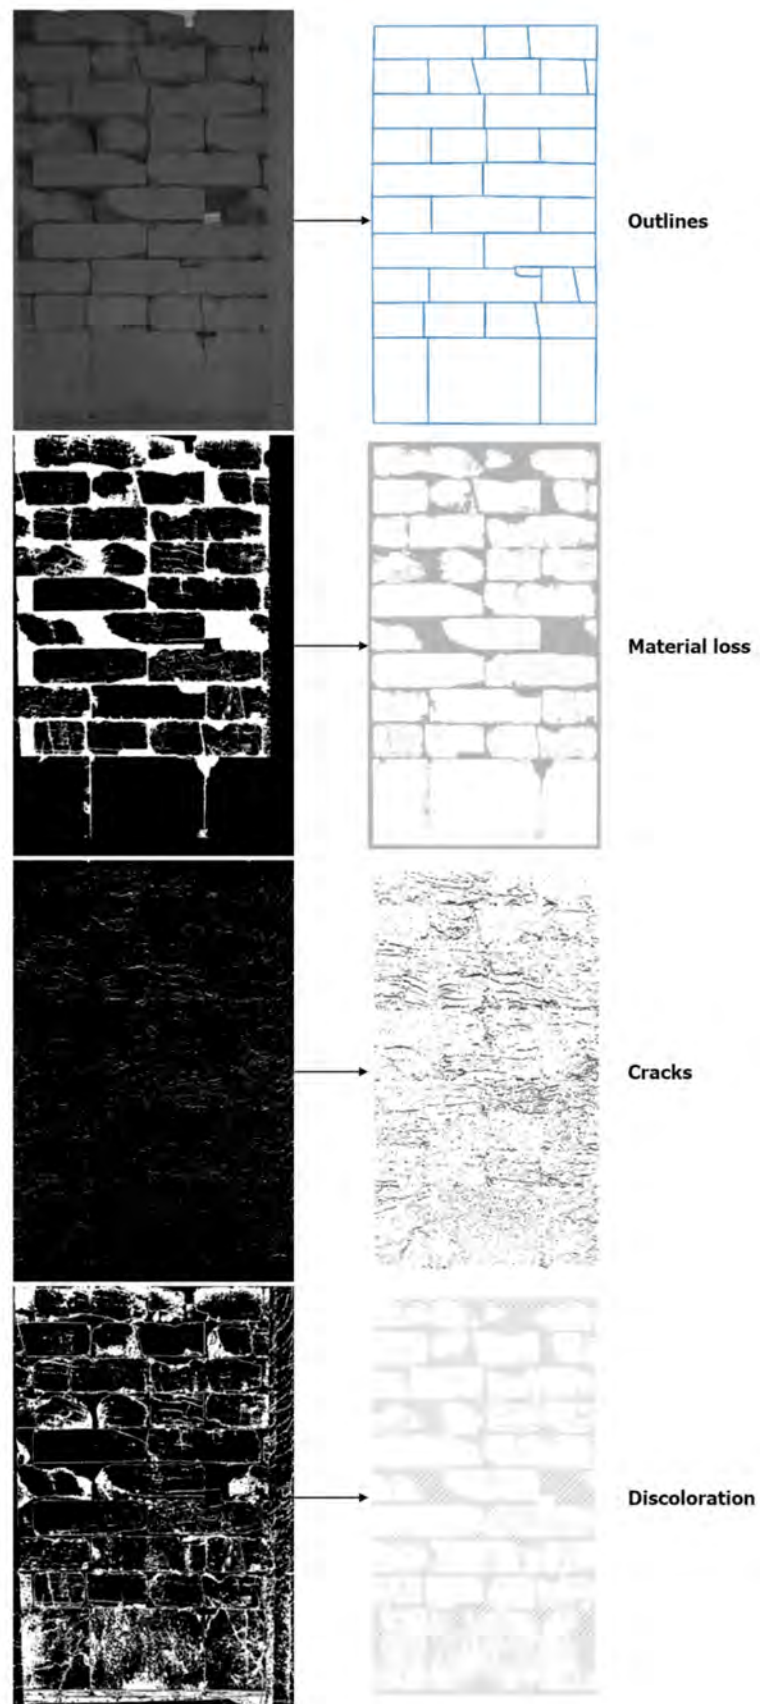
Figure 5. Generation of thematic map layers (right) in QGIS using features extracted from rectified near-infrared reflectance images (left) for the Temple of Apollo Epikourios.

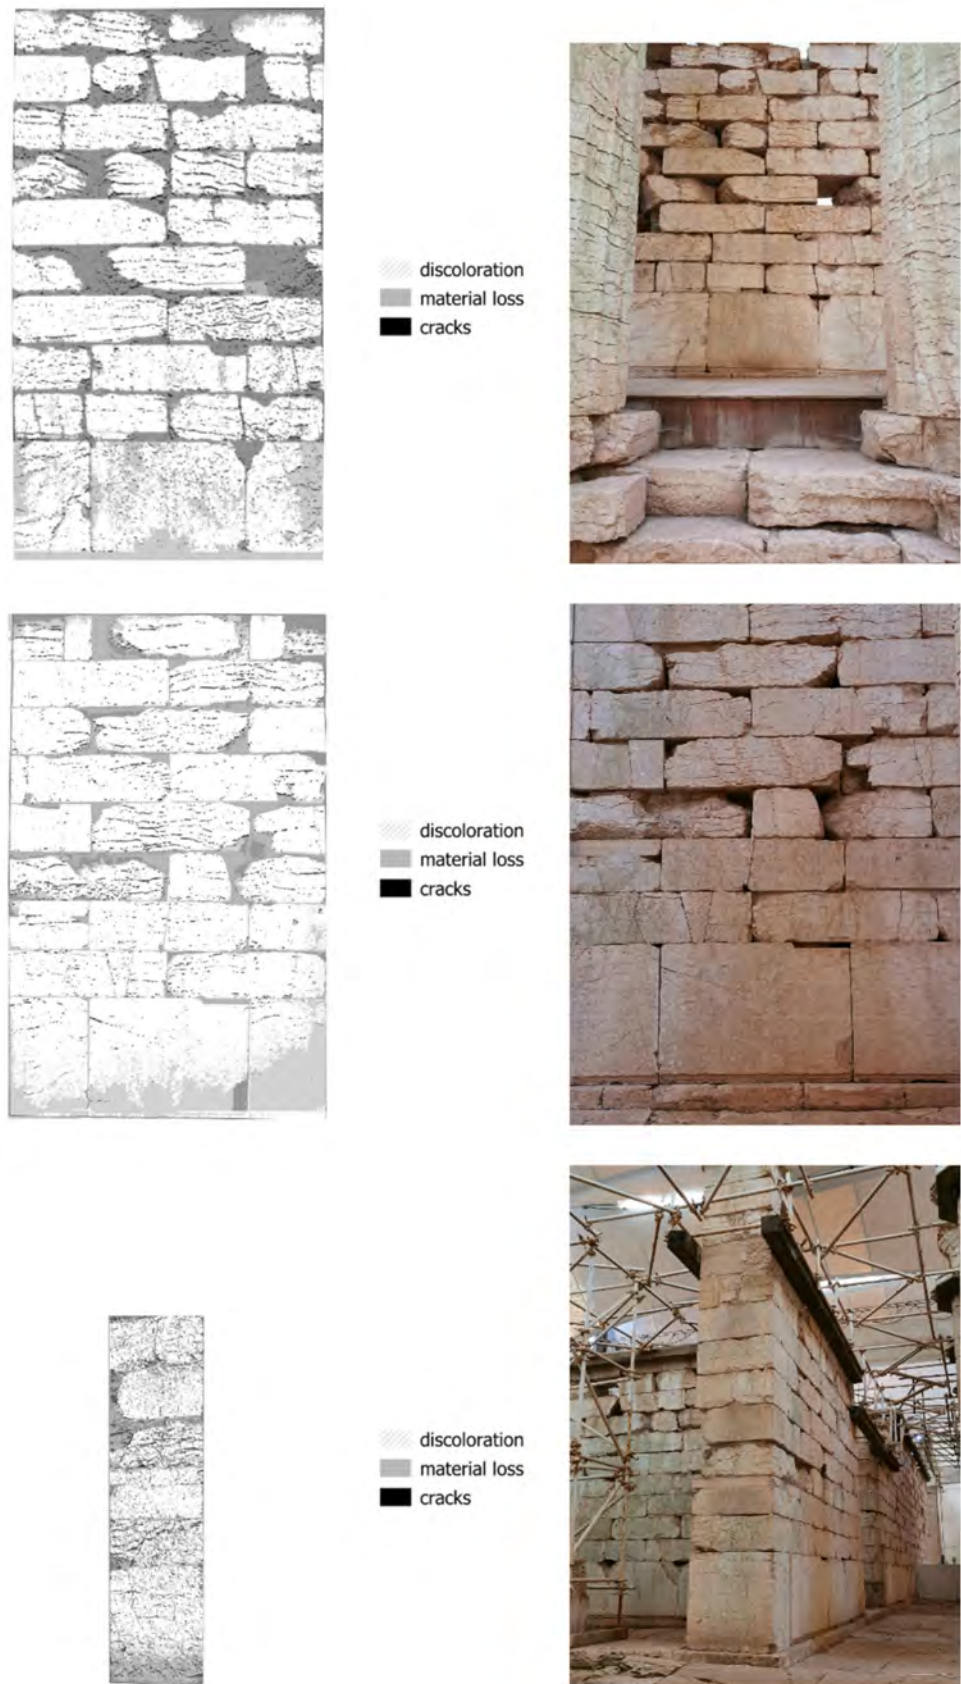
**Figure 6.** Degradation maps and corresponding images for characteristic areas of walls at the Temple of Apollo Epikourios.

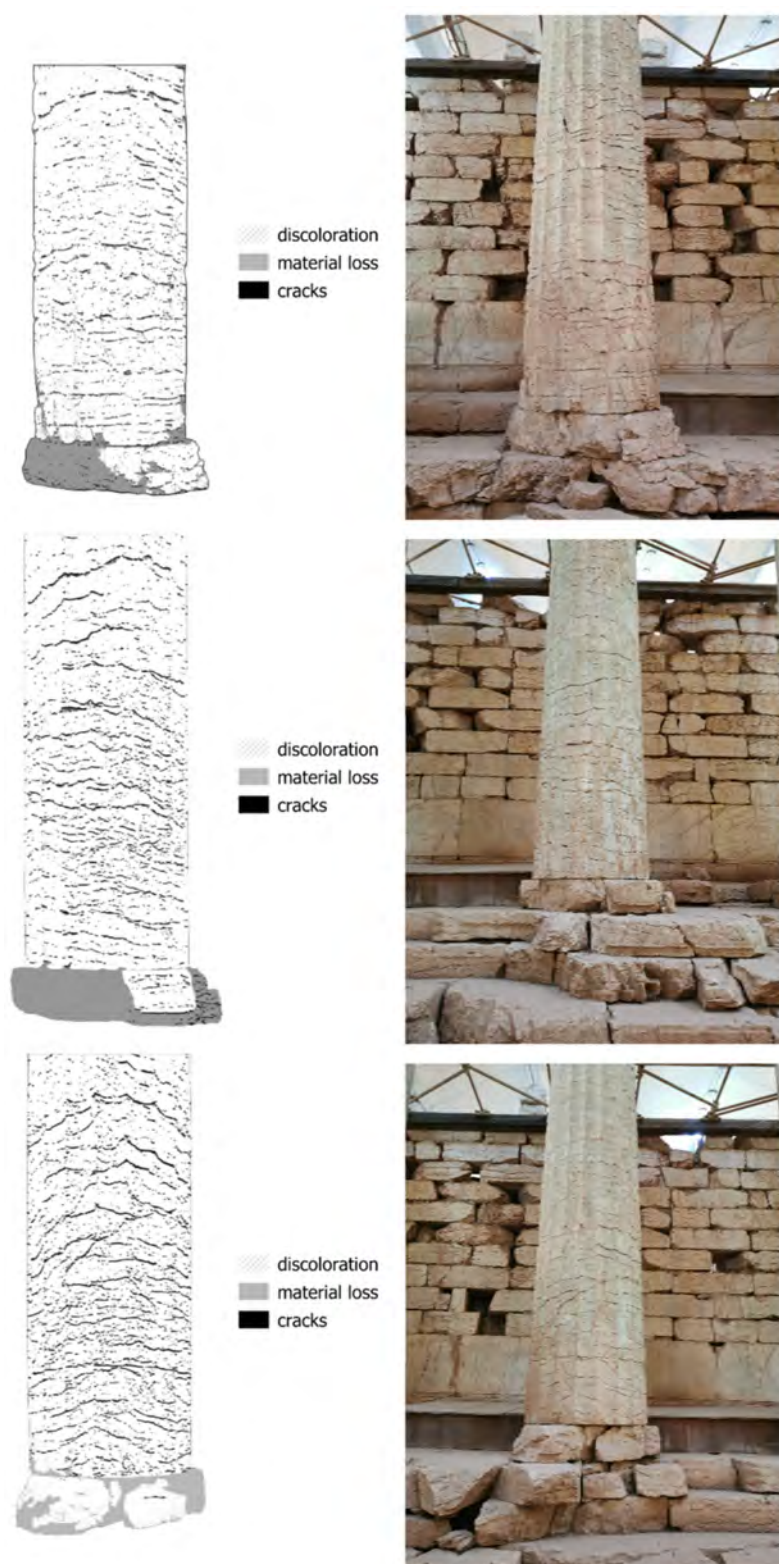
**Figure 7.** Degradation maps and corresponding images for characteristic areas of columns at the Temple of Apollo Epikourios.

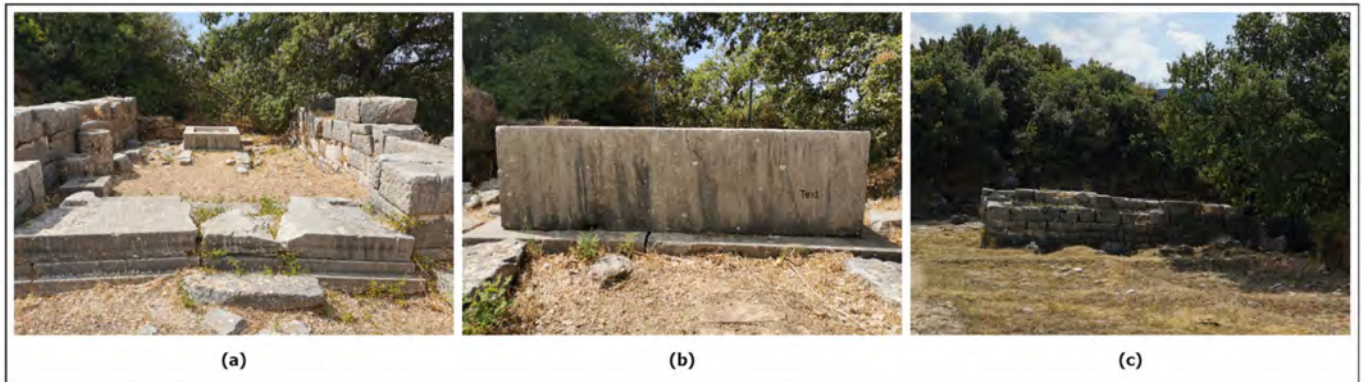
**Figure 8.** (a) Remains of the ancient Temple of Athena and Zeus Sotiros; (b) the investigated (west) side of the stone cubic pedestal of the worshipping statue; (c) the investigated (north) side of the cella wall.

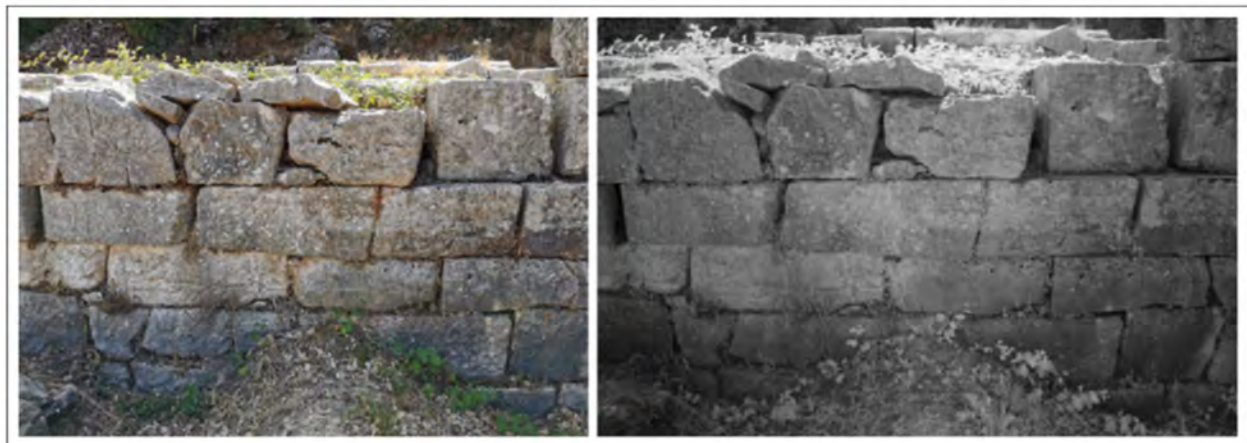
**Figure 9.** Color and near-infrared images captured at the Temple of Athena and Zeus Sotiros.

For this case study, the use of both visible and NIR-spectrum images was opted due to the existence of biological colonization (moss, lichens, biogenic crusts, vegetation), benefiting from the dissimilar reflectance characteristics that it presents at different wavelengths (Figure 9). Using a photogrammetric approach, orthoimage mosaics were generated for parts of the cella and the cubic stone pedestal with the RGB and NIR-reflectance images. Then, they were blended to create pseudo-color orthoimage mosaics (using the Green, Red, and NIR bands) in the HyperCube software. Next, the resulting base maps were segmented to the areas presenting different degradation forms following a *k*-means unsupervised clustering approach with centroids initialized using the *k*-means++ algorithm. Finally, the classified images were digitized, and the degradation was semantically annotated in QGIS to the corresponding thematic layers (Figures 10–14). A map of damage categories regarding the Temple of Athena and Zeus Sotiros remains could also be produced. Figure 15 additionally provides statistics of the coverage of the historical stone surfaces by various degradation forms. Both investigated surfaces were in their entirety covered by biogenic material or discolored.

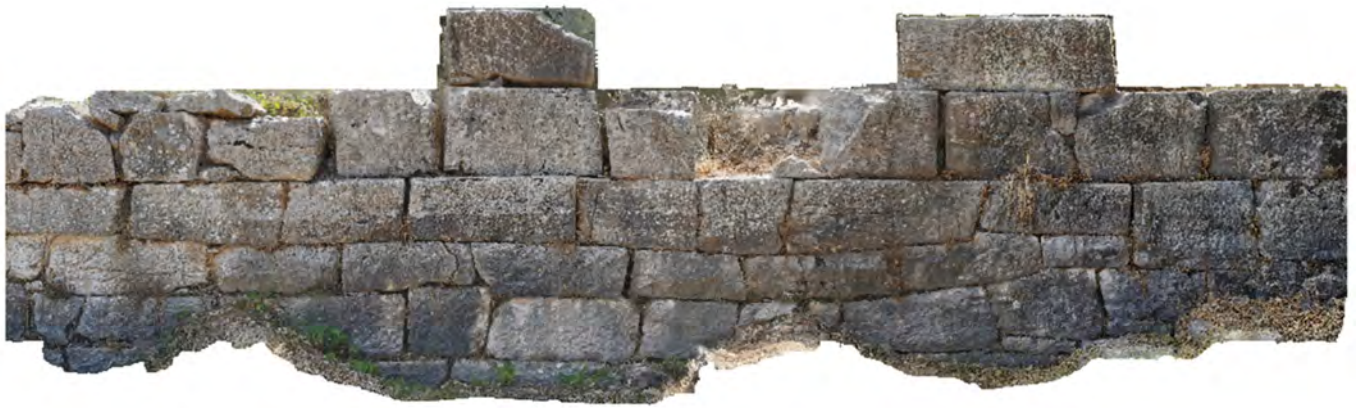
Figure 10. Orthoimage mosaic, cella wall remains at the Temple of Athena and Zeus Sotiros.

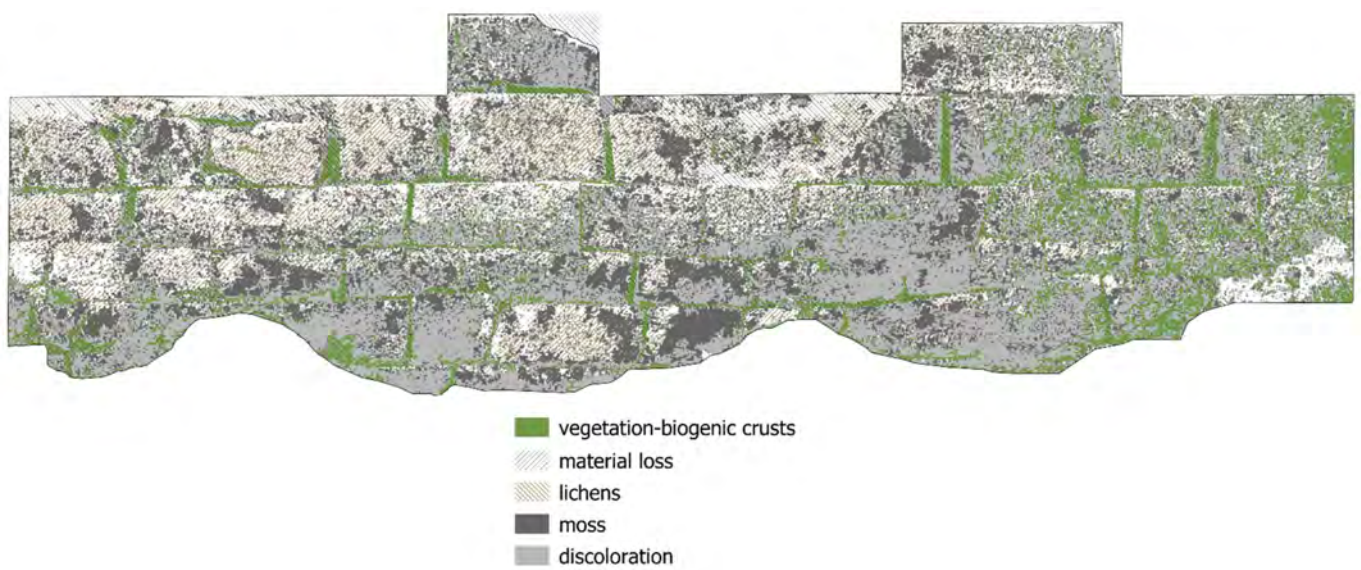
Figure 11. Degradation map, cella wall remains at the Temple of Athena and Zeus Sotiros.

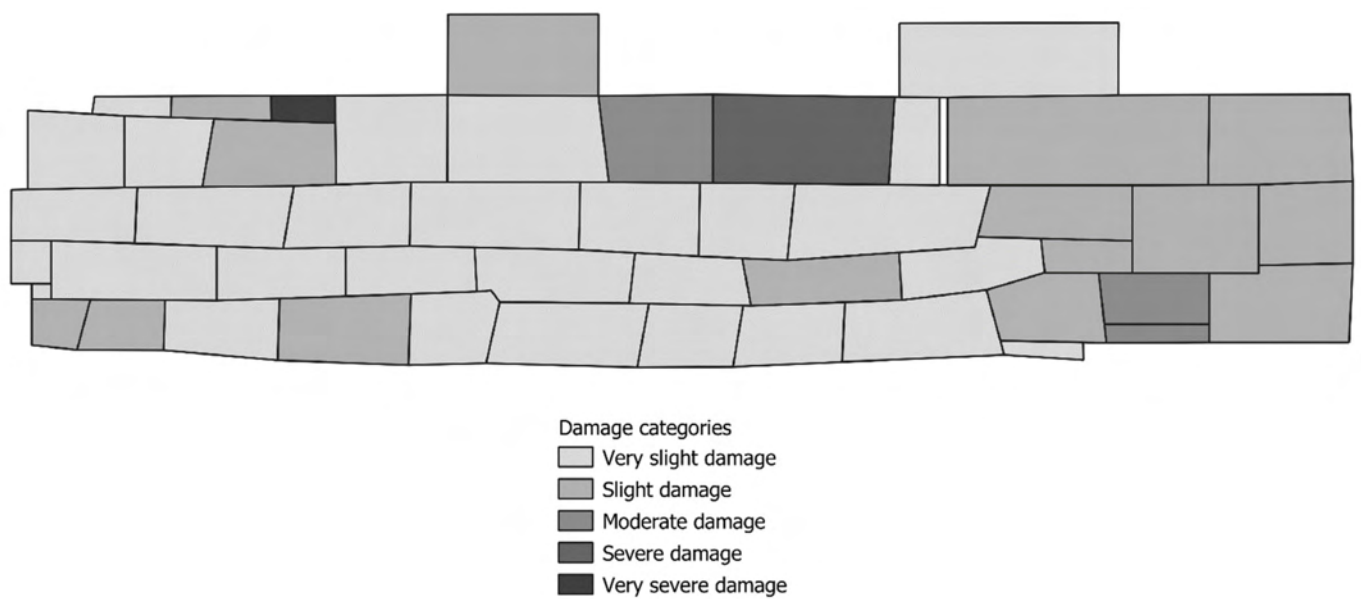
Figure 12. Damage index map, cella wall remains at the Temple of Athena and Zeus Sotiros.

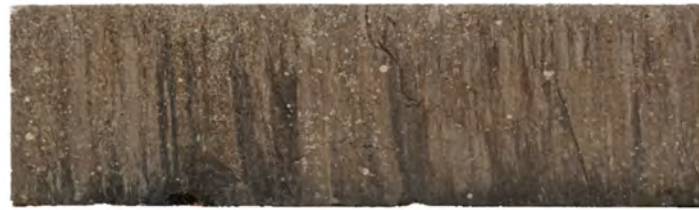
Figure 13. Orthoimage mosaic, cubic stone pedestal at the Temple of Athena and Zeus Sotiros.

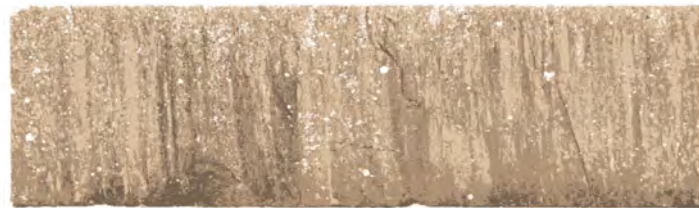
Figure 14. Degradation map, cubic stone pedestal at the Temple of Athena and Zeus Sotiros.

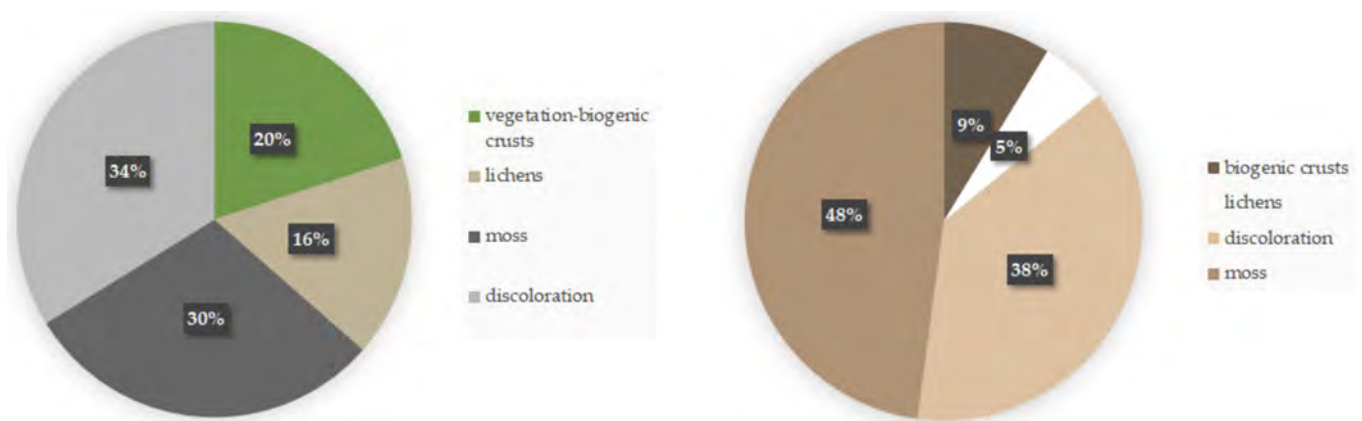
Figure 15. Degradation pattern statistics for the investigated surfaces at the remains of the Temple of Athena and Zeus Sotiros; cella wall (left) and cubic stone pedestal (right).

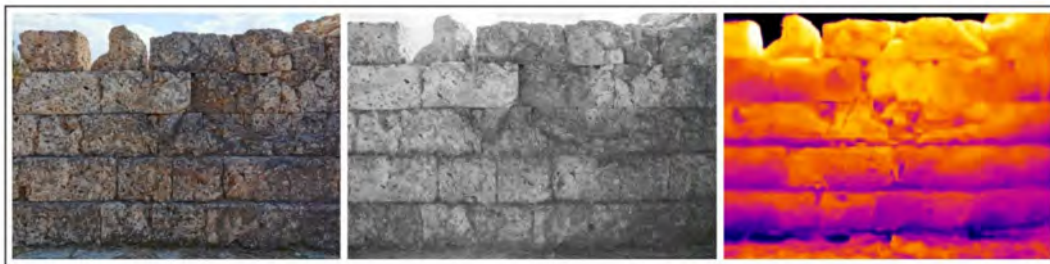
**Figure 17.** Reflectance images captured at the archaeological site of Lepreum: (from left to right) visible-spectrum, near-infrared, and a thermal-infrared image.

For this case study, photogrammetric approaches were followed using multiband datasets (examples of reflectance images shown in Figure 17), as described in Section 3.2, to generate the necessary base maps for the mapping process. The thermal orthoimage mosaic was produced following a hybrid approach exploiting both the visible and thermal images captured by the FLIR One Pro camera [58] (Figure 18). The false-color multiband image mosaic composed of three single-band mosaics (RGB, NIR, and TIR) was classified to create the thematic map (true-color image shown in Figure 19 and final degradation map in Figure 20). Statistics were again calculated for the coverage of the historic surface by various degradation forms (Figure 21), while the damage map (Figure 22) considered the presence of vegetation, moss, and biocolonization. Additionally, in this case study, the historical surface was almost entirely covered by biogenic material or discolored.

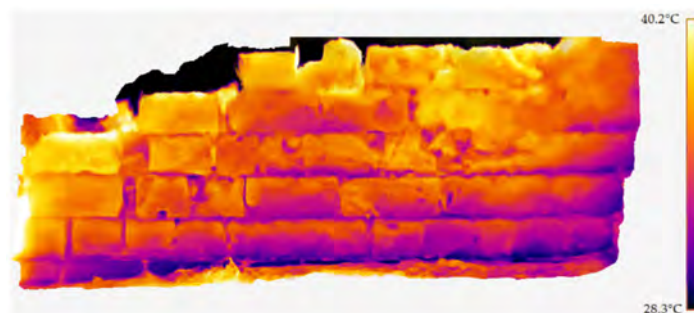
**Figure 18.** Thermal orthomosaic of an ancient wall at the archaeological site of Lepreum.

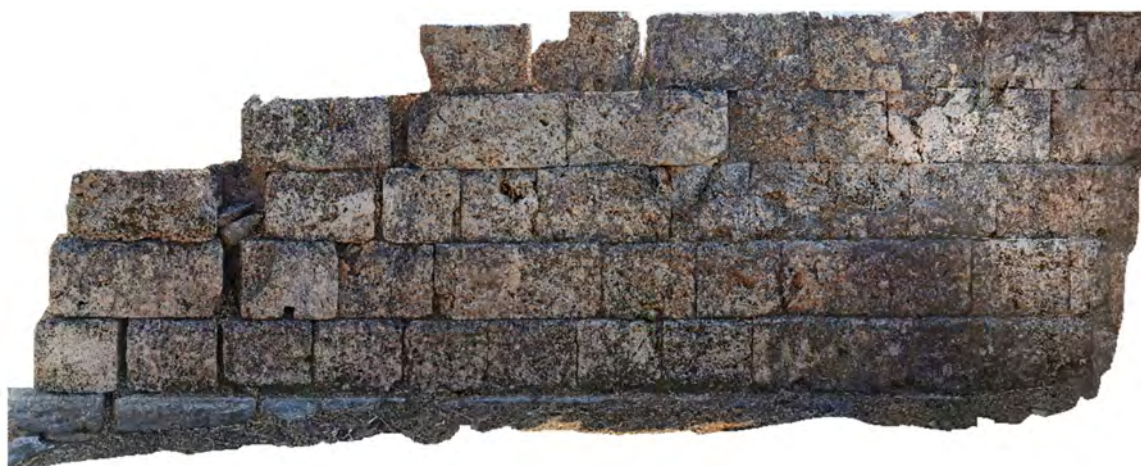
**Figure 19.** Orthomosaic of an ancient wall at the archaeological site of Lepreum.

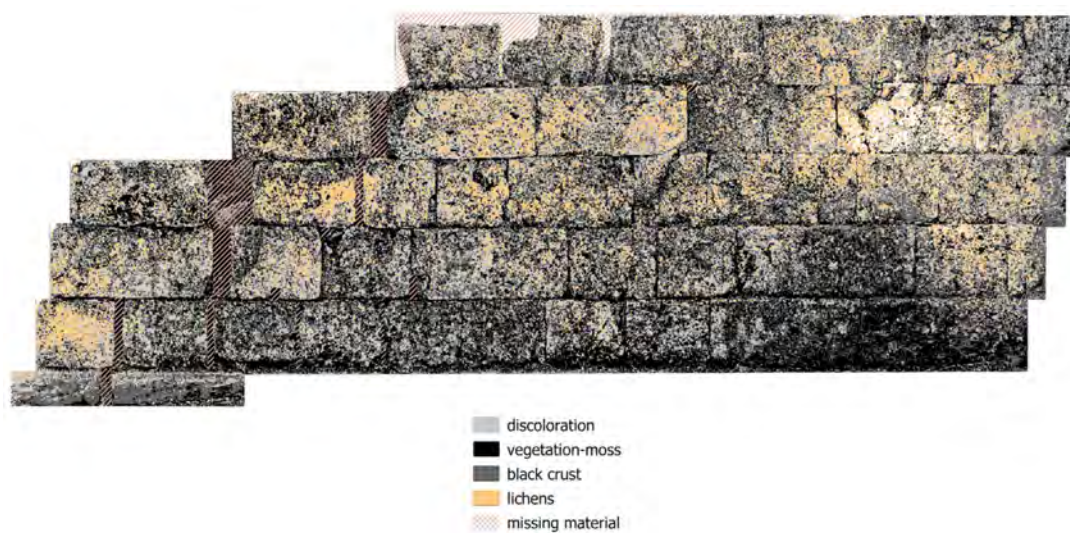
**Figure 20.** Degradation map of an ancient wall at the archaeological site of Lepreum.

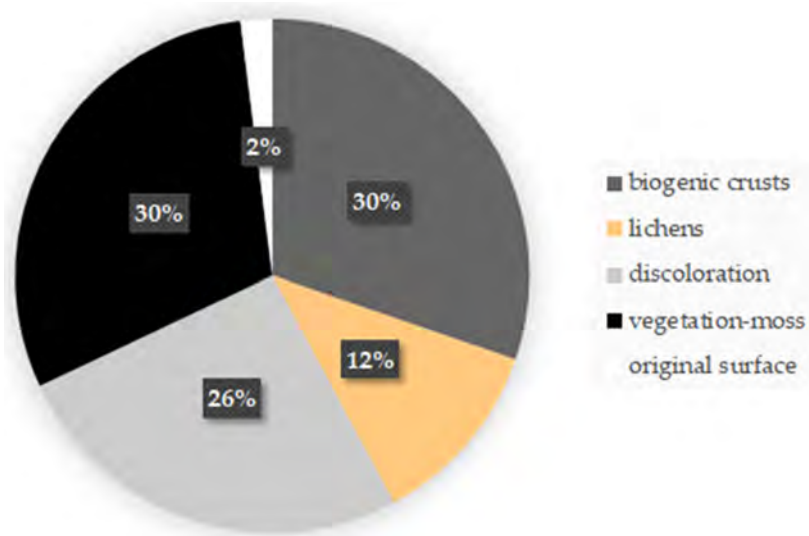
**Figure 21.** Degradation pattern statistics for the investigated surface of the wall at the archaeological site of Lepreum.

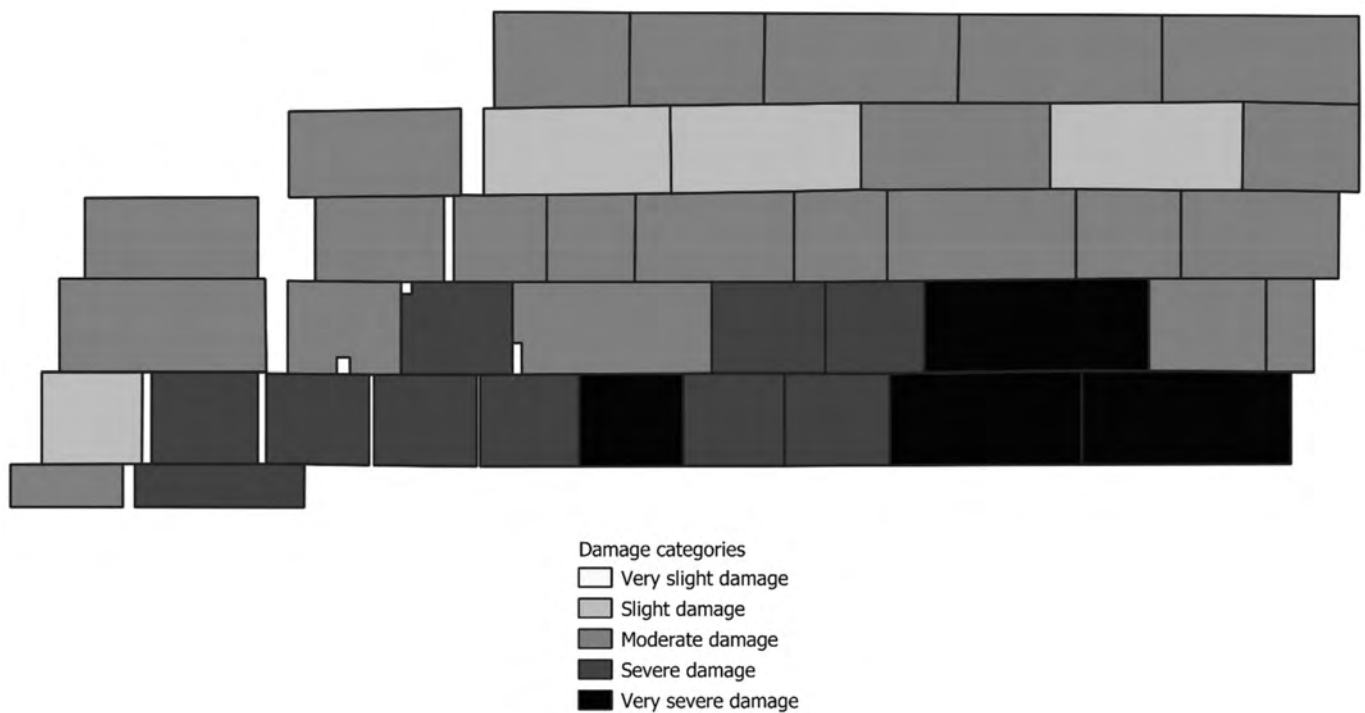
**Figure 22.** Damage index map, of an ancient wall at the archaeological site of Lepreum.
