Debris Flow and Rockslide Analysis with Advanced Photogrammetry Techniques Based on High-Resolution RPAS Data. Ponte Formazza Case Study (NW Alps)

Davide Notti ¹, Daniele Giordan ^{1,*}, Alberto Cina ², Ambrogio Manzino ², Paolo Maschio ² and Iosif Horea Bendea ²

Keywords: RPAS; debris flow; rockslide; Structure from Motion; direct photogrammetry; Sentinel-2

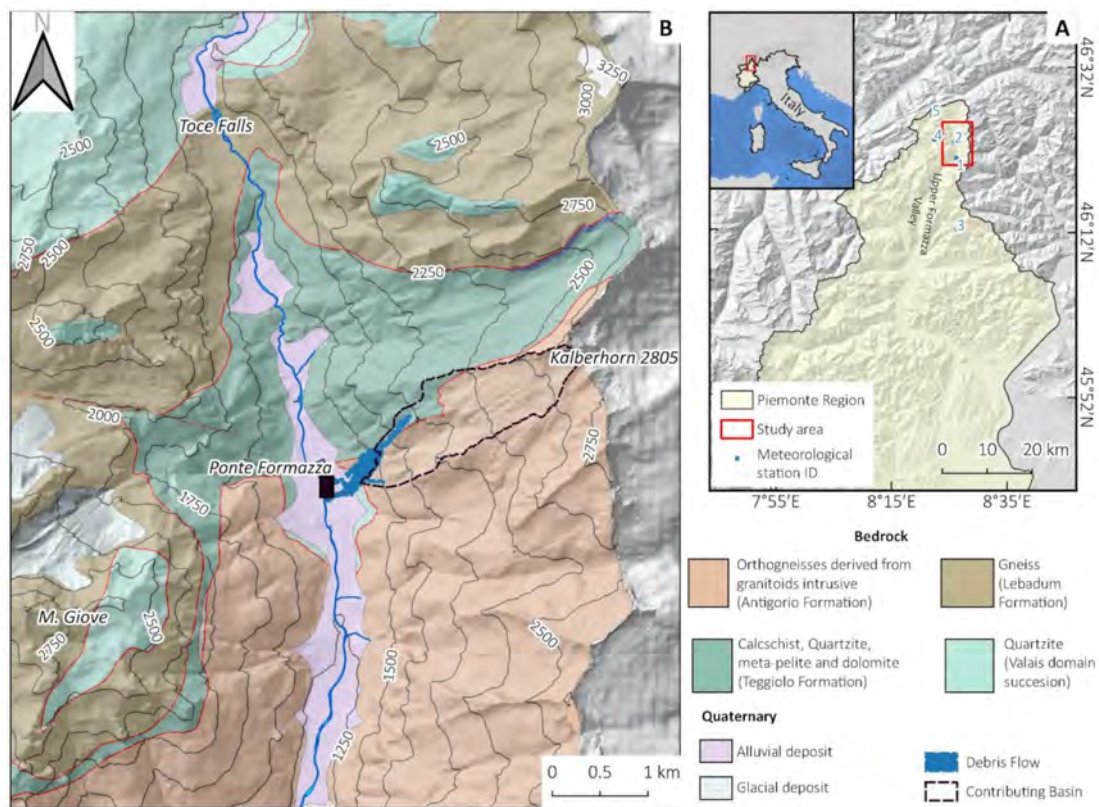
Figure 1. (A) Location of the study area. (B) Geological settings of the study area modified from [32] and available on https://webgis.arpa.piemonte.it/Geoviewer2D/index.html?config=other-configs/geologia250k_config.json (accessed on 2 May 2021) and the location of the debris flow and its contributing basin.

The study area (Figure 1) is inside Lepontine nappe of the Penninic domain, and it is located at the tectonic boundaries between Teggiolo formation (made by calcschist, metapelite lithology) and the Antigorio formation (orthogneiss lithotype) [32].

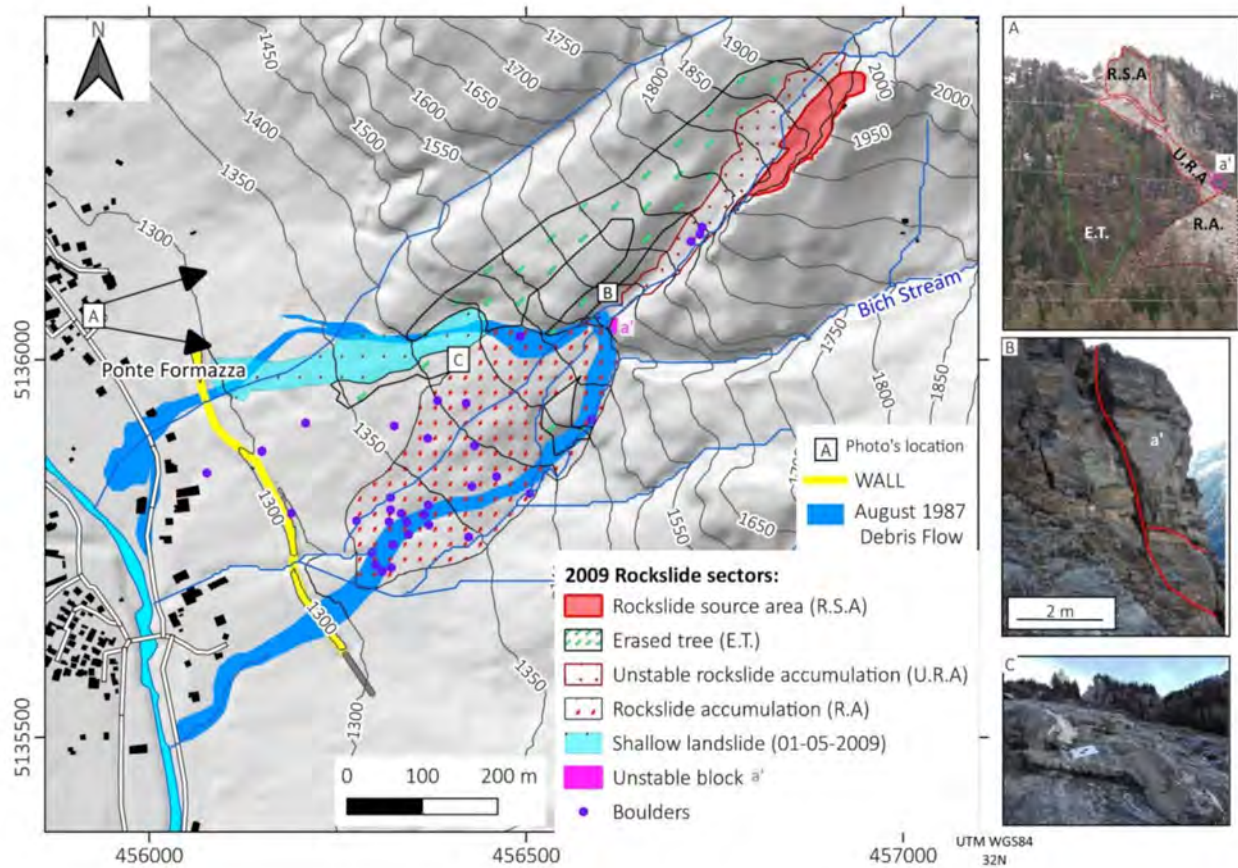
Figure 2. Map of April 2009 rockslide event and 1987 debris flow. Photo A shows a general view of the rockslide just after April 2009 (Photo Credit Colluccino M.) and the location of a'. Photo B shows a large ($10 \times 3 \text{ m}$) unstable block (a') in autumn 2017, which collapsed during the 2019 event. Photo C shows a marker used to fix RPAS photos placed on a large boulder of the rockslide.

The most massive event in recent time occurred on 9 April 2009, when a massive rockslide (Figure 2) created a large deposit that can be considered the main predisposing factor for the event that occurred in June 2019.

In 2009, the rock mass release area (R.S.A. in Figure 2) was located on a ridge at 1950 m elevation and oriented parallel to NE–SW striking steeply dipping faults. The initial failure likely occurred along such a fault, then the detached mass fell in a steep gorge on the north side of the cliff [34–36].

The rockslide mass moved quickly along the slope, which has an inclination of about 40° . The direction of the detached mass was about 210° with a drop height of 530 m over a horizontal distance of 600 m. The estimated total volume was $700,000 \text{ m}^3$. On 1 May 2009, a few days after the rockslide, a small shallow landslide affected the colluvial deposit where vegetation was eradicated (E.T. in Figure 2) [34].

The unstable rockslide accumulation (U.R.A. in Figure 2A), formed by some boulders of up to tens of metres in size, was partially blocked in a steep channel at the cliff base. This meta-stable deposit was massively moved by debris flow in June 2019. The field survey of 2017 also allowed us to detect an unstable block (a' in Figure 2B) that collapsed during the 2019 event.

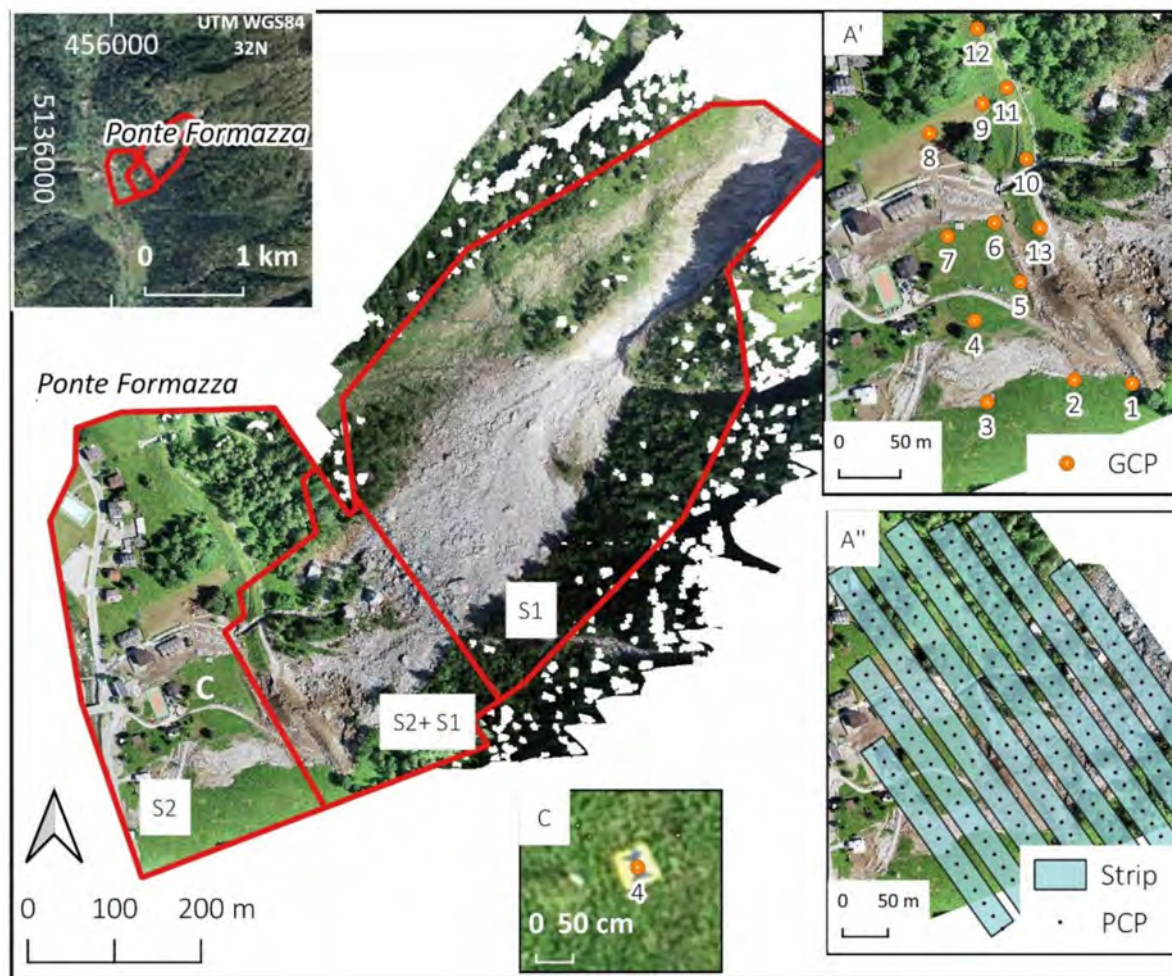
Figure 3. Area covered by 2019 RPAS survey. (S1) Higher sector, mapped by RPAS and processed with Structure from Motion. (S2) Lower sector mapped Rtk RPAS and processed with high-precision photogrammetry with two approaches (A') Traditional photogrammetric approach: GCPs location; (A'') Direct Photogrammetry approach: Projection Center Point (PCPs) coordinates. In S1+S2 the flights overlap. (C) Example of plastic GCP 50 × 50 cm (Marker004).

The survey made in 2019 in the lower part of the slope (sectors S2 and S1+S2, in Figure 3) was done using a DJI PH4 UAV equipped with double-frequency GNSS receivers.

For the lower part of debris flow (sector S2 in Figure 3) covered only by the 2019 RPAS Rtk survey (A), we evaluated the volume with a different methodology that is made of three steps, made with Agisoft Metashape™ software:

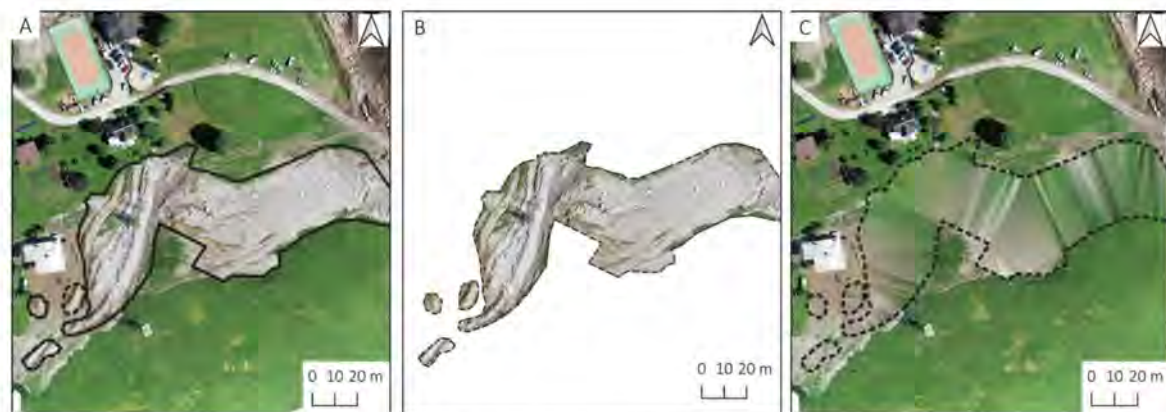
Figure 4. (A) Lower sector interested by debris flow; (B) clipped low-energy debris flow; (C) interpolated DSM that fill the clipped part.

- we first cut out from DSM the area covered by debris (Figure 4B);
- we proceeded to interpolate the clipped part to reconstruct the surface before the event (Figure 4C);
- we calculated the difference between the original raw DSM and the reconstructed DSM pre-event. This allowed us to estimate the volume also of this sector (see Figure 8A in the results).

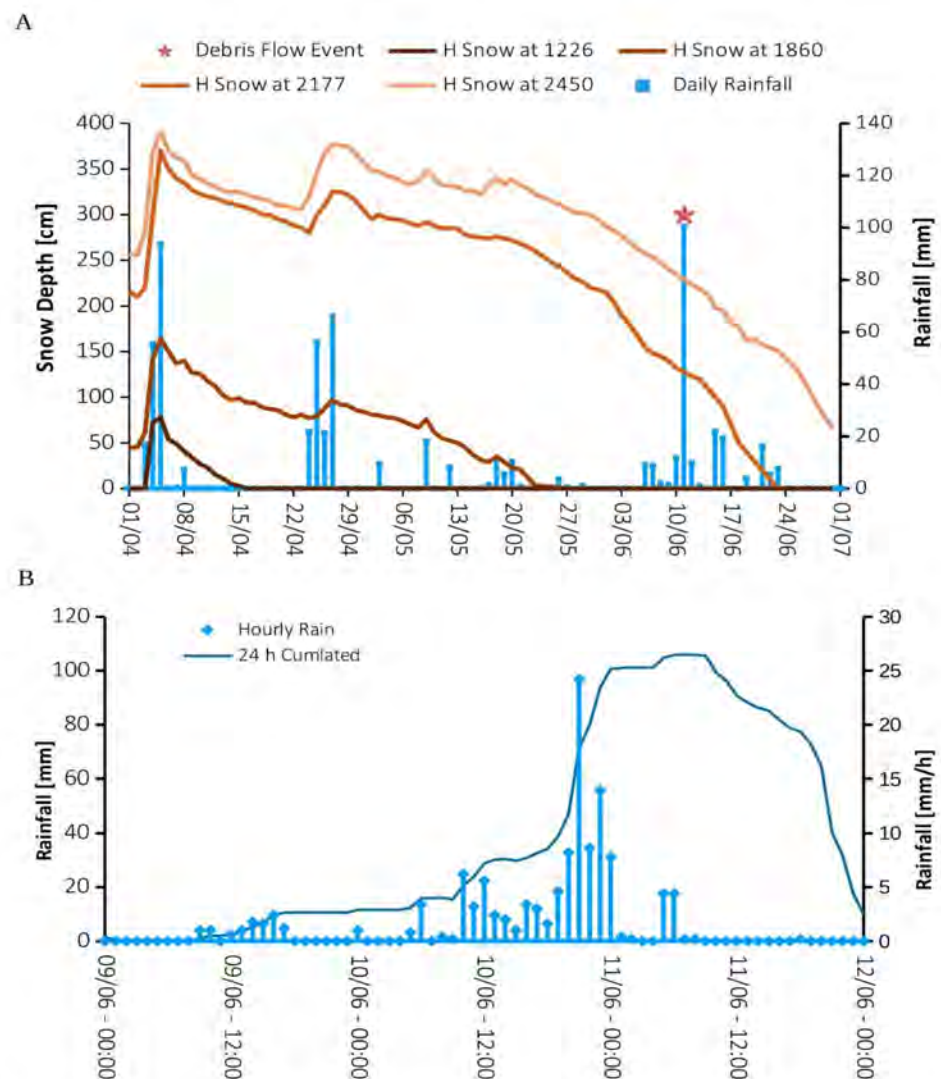
Figure 5. (A) Daily rainfall and snow depth at a different elevation from 1 April to 30 June 2019. (B) Hourly and cumulated precipitation at Formazza Bruggi rain gauge from 9 June 2019 00 UTC to 12 June 2019 00 UTC.

The debris flow was triggered by intense rainfall on 10–11 June 2019, with accumulated rainfall of 100 mm in 24 h and a peak of 25 mm/h (Figure 5B). These values are not extreme for the area; however, they occurred in the period of intense snow-melting that probably saturated the soil (Figure 5A). From the data of snow depth of the nearby stations and the Sentinel-2 images of 01 June 2019 (Figure 6B), it is possible to estimate snow depth and coverage at the moment of triggering rainstorm (Figure 6A). Half of the basin that contributed to debris flow was covered by snowpack that in the highest sector (>2500 m) reached about 200 cm of thickness. From the end of May 2019, the snowpack starts a rapid melting at 8 cm/days. All these factors contributed to soil saturation at the moment of the storm.

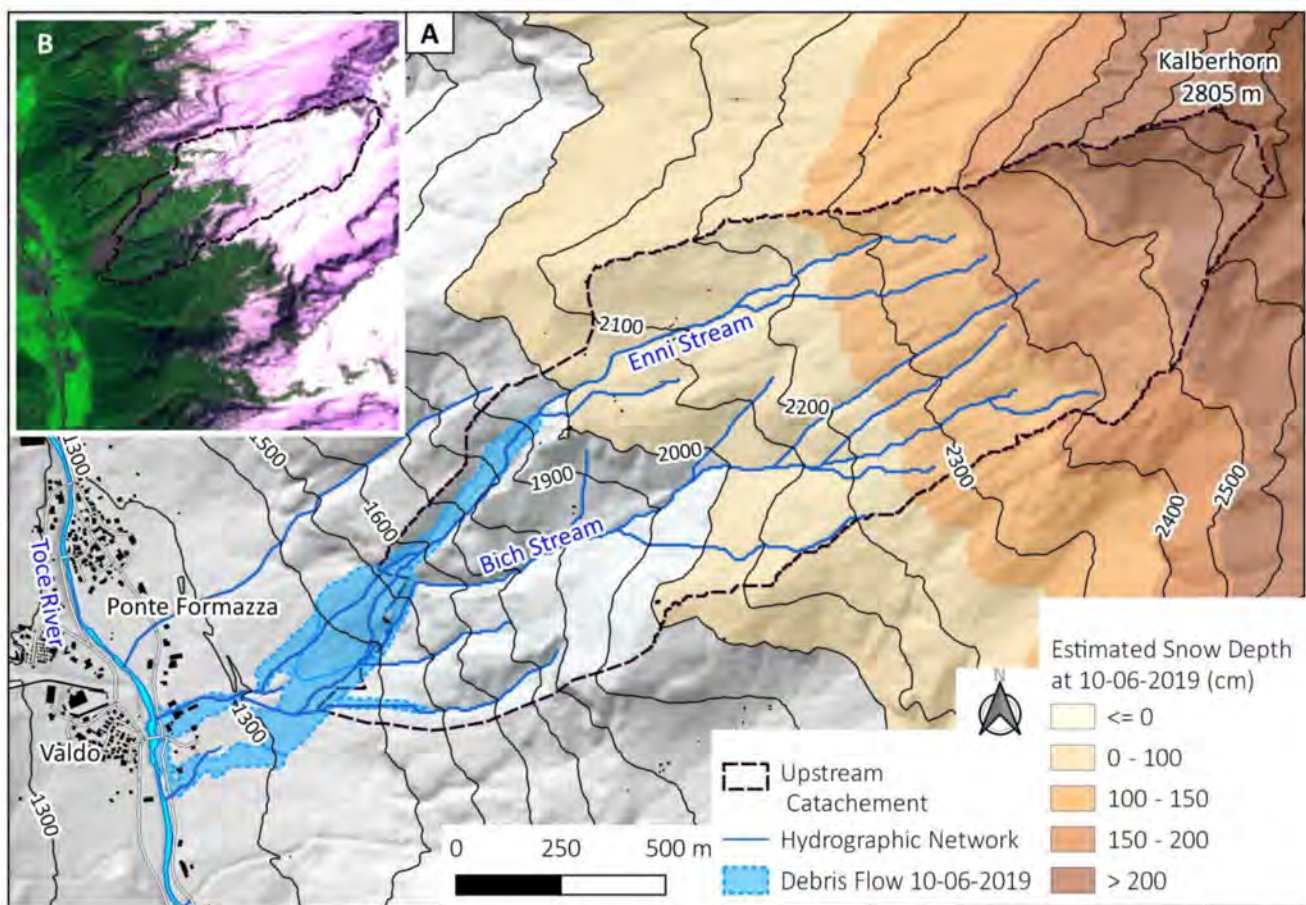
Figure 6. (A) The contributing watershed basin upstream from the debris flow area and estimated snow depth and coverage at the moment of the storm (10–11 June 2019) based on snow depth data, Sentinel-2 images and DTM data. (B) Sentinel-2 image acquired on 1 June 2019.

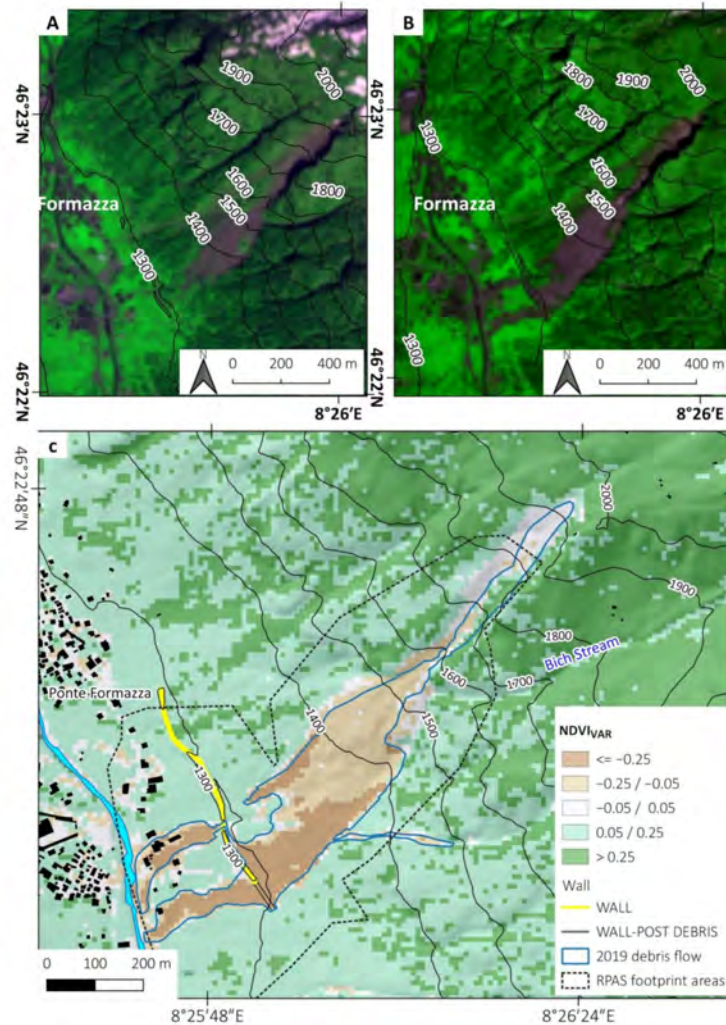
Figure 7. Low-Resolution debris flow mapping made with Sentinel-2 data. (A) Pre-event image 1 June 2019; (B) Post-event image 16 June 2019; (C) $NDVI_{var}$ map and the boundaries of debris flow furtherly mapped with RPAS

The processing of Sentinel-2 images (Figure 7A,B) allowed us to map the area affected by debris flow in 2019 quickly. Thanks to the first post-event images available a few

Figure 7C shows the $NDVI_{var}$ perfectly matching the boundary of the debris flow area furtherly mapped with RPAS, especially in the bottom deposits sector. It is also possible to see that the decrease of NDVI is higher in the lower sector of the slope where vegetation was erased. The areas already occupied by debris and boulder of the 2009 event show a negative $NDVI_{var}$ because the debris flow buried pioneer vegetation of the 2009 rockslide deposits.

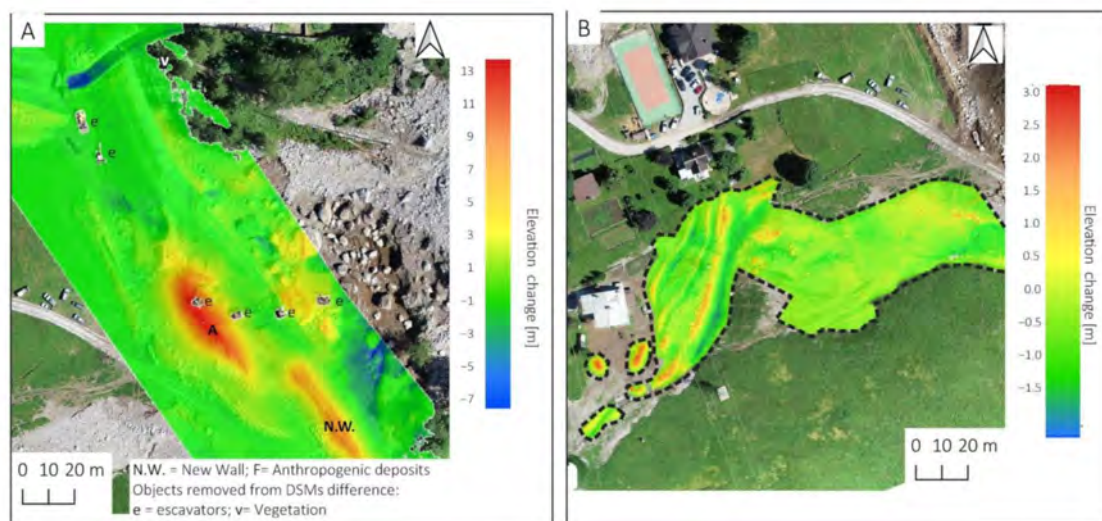
Figure 8. (A) DTM of difference (2018–2019) of the wall sector, the volume of accumulated materials is 31,064 m³ (Case 3c). (B) Low-energy debris flow sector DTM of difference made with clipping and interpolation of 2019 DSM (estimated volume 155 m³).

The results Figure 8A show that the volume of accumulated material is respectively 30,909 m³ (Case 3b) and 31,064 m³ (Case 3c). The difference between direct photogrammetry with only 3 GCPs and full solution (3c) is about 720 m³ (2.4%); this is excellent accuracy results for geomorphological analysis. It is possible to appreciate that the excavators were also removed from the volume computation.

Using the methodology described in paragraph 3.4, we calculated the DTM of change and the volume for the low-energy sector of the debris flow (Figure 8B) where there is no available 2018 data (12s in Figure 13). In this case, the estimated cumulated volume is about 155 m³, a modest amount compared with the rest of the debris flow volume (described in Section 4.3.4).

- Low-energy sectors (cyan colors in Figure 13). A small portion of debris flow overpassed the wall for these deposits (11). We calculated the volume for the 's' portion (155 m³) with the method described in Section 3.5 and showed in Figure 8B.

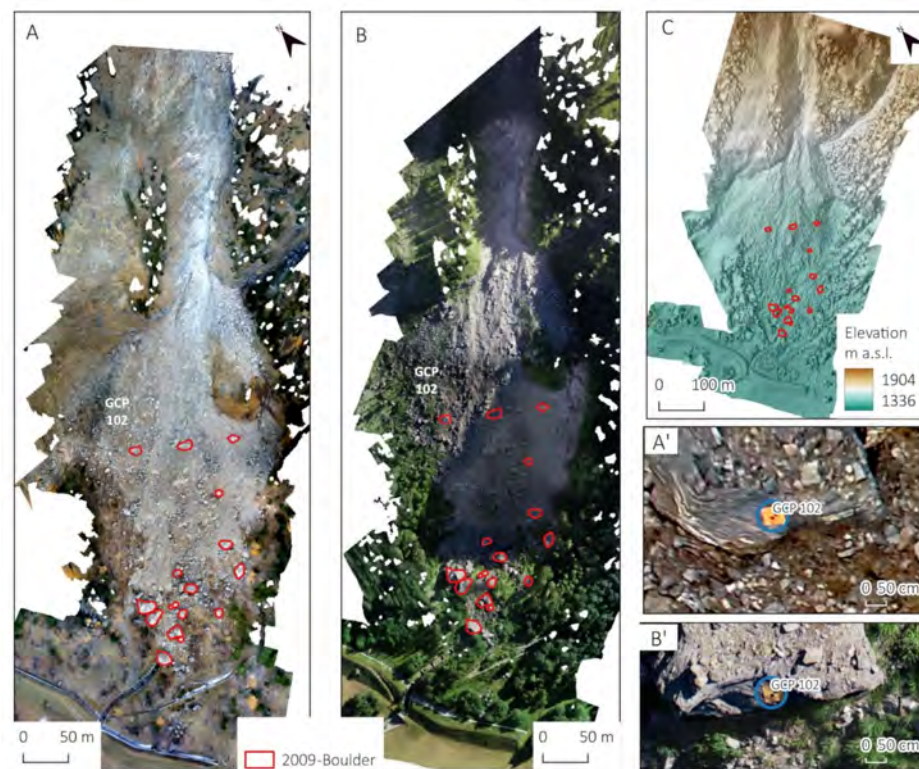
Figure 9. High-resolution orthophoto of 2009 rockslide deposits made with RPAS in November 2017 (A) and July 2018 (B), a detailed zoom view on GCP 102 in 2017 (A') and 2018 (B'). In panel (C) the 2017 DSM made with SfM used for the comparison with the 2019 post-event DSM.

The High-resolution RPAS surveys carried out in 2017 and 2018 allowed to obtain an extremely detailed orthophoto (Figure 9A,B) and DSM of the rockslide accumulation (Figure 9C). The 3-D views allowed us to measure and estimated the volumes of large boulders as on the field. It is interesting to note how most of the GCPs installed in 2017 are still well visible in the 2018 orthophoto (e.g., Figure 9A',B').

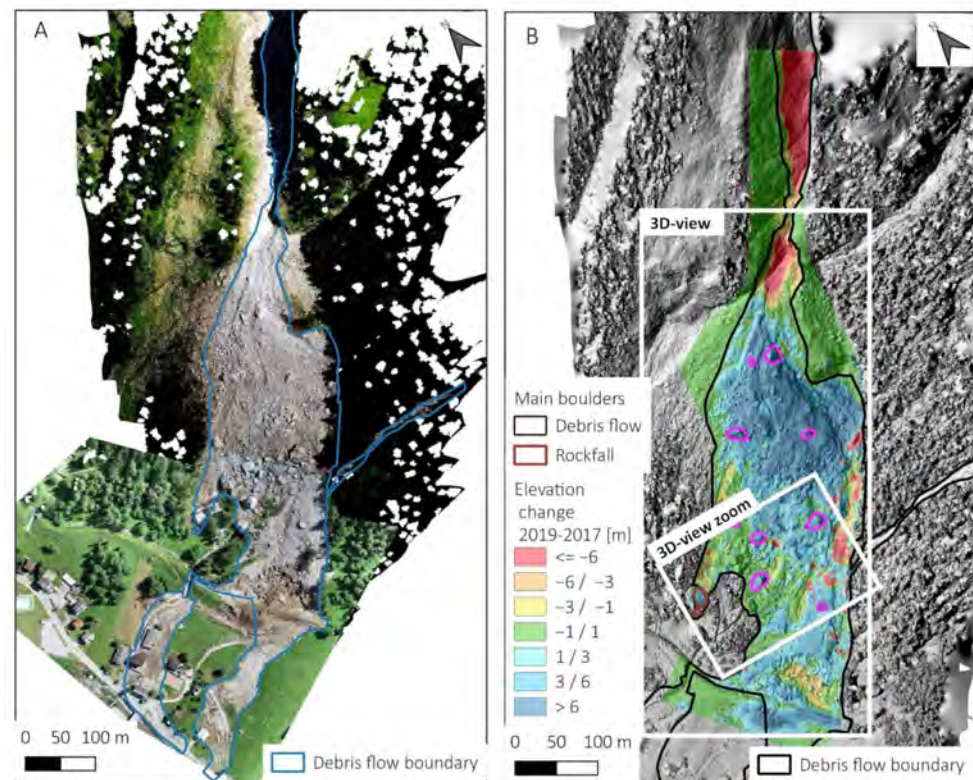
Figure 10. 2019 event (A) UAV post-event orthophoto with the boundary of the debris flow; (B) DSM change (2019–2017) draped on the hillshade model and the most massive boulders mobilized during the 2019 event.

The orthophoto allowed a precise mapping of most debris flows (Figure 10A), especially in the lower part, and at the downslope of the wall. Here the relatively low-energy flow created fine-sized debris deposits (from the decimetric block to the sand matrix). Some UAV footage available on the Local Team web video platform [46] shows the debris flow deposit just a few hours after the event. The videos helped to understand some depositional patterns of the restored area at the moment of our RPAS flight 15 days later.

The difference between DSM 2019 and 2017 allowed us to understand the complexity of the processes during the 2019 event (Figure 10B). The main events and their geomorphological evidence can be resumed as follows: (i) The canyon of Enni Stream was utterly washed out of the 30 m thickness of debris and boulders, and now the bedrock is not covered by rockslide deposits; (ii) the giant block a' that was positioned at the top of the fan fall down during the 2019 event following a linear trajectory independent from the rest of debris flow; (iii) most of the debris mass was deposited in the middle sector of the slope, here it is possible to see how the Enni stream migrated from the central part of the fan to the left sector joining the Rich stream; (iv) a sector characterized by the presence of a heterogeneous deposit composed by large blocks in a coarse-grained matrix due to the debris flow transport effect and the rolling component of the movement of unstable rock blocks; (v) the contribution of Rich stream energy and water to the lower sector of the debris flow that accumulated 10 m of materials behind the wall built after the 2009 rockslide; (vi) part of debris flow overpassed the wall, and the rest get around the wall and reached the main Toce river, with two separate branches. These flows hit several buildings, roads, and some sports facilities. The relatively low-energy debris flow avoided more severe damage to buildings, and the few residents were evacuated some minutes before, avoiding life risk.

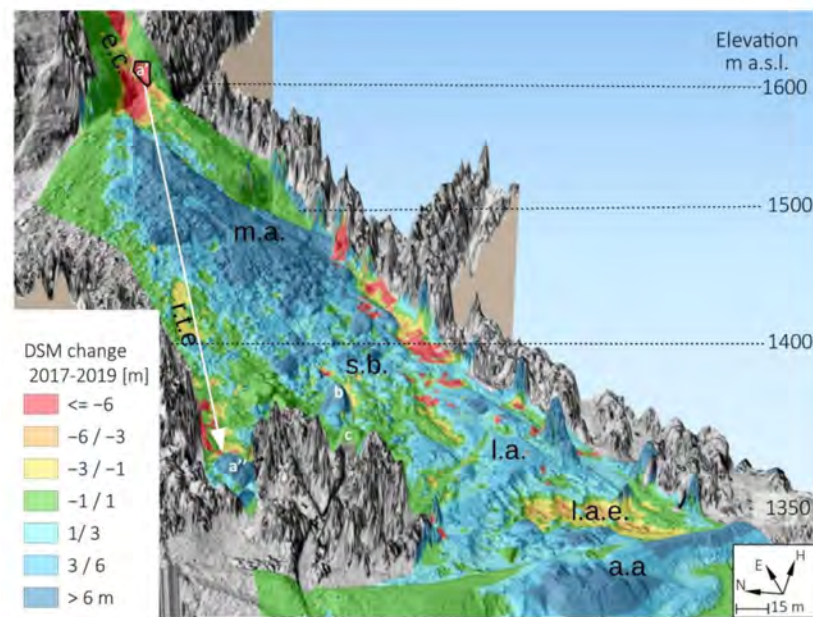
Figure 11. 3-D shadow model of the affected area with DSM change 2019-2017 draped on. It is possible to detect: the erosion channel (e.c.); the collapsed block (a'), its rolling/bounce erosion trace (r.t.e.) and its final position (a''); the main accumulation (m.a.); the area with large sparse boulders (s.b.); the lower accumulation (l.a.) partially excavated (l.a.e); the anthropogenic accumulation (a.a.).

In the general 3D view (Figure 11), it is possible to detect the area of erosion in the upper part of the channel, the detachment on the large boulders (a'), and its trajectory until its final position (a''). The main accumulation (m.a.) is located at an altitude of 1500 m. In the lower part of the slope, the debris flow shows the fine-size of the blocks (i.a.), and the restoration work moved part of this debris (l.a.e) to make a new section of the wall (a.a.).

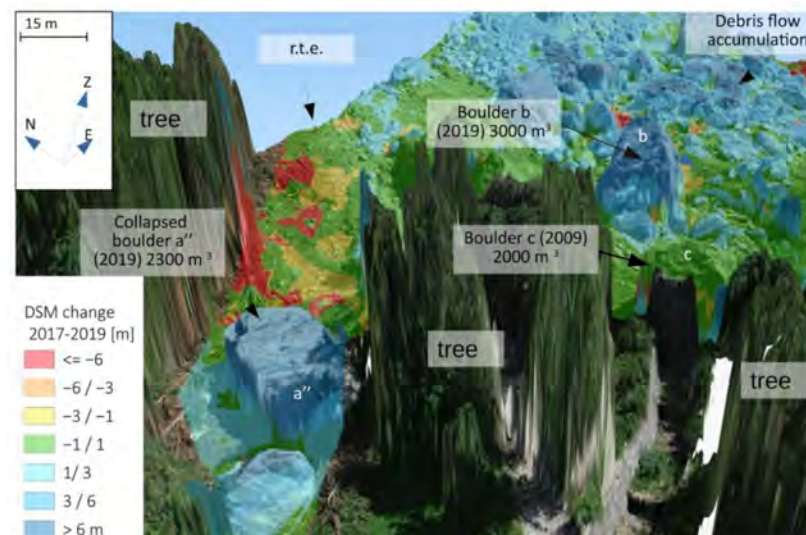
Figure 12. A detailed 3d view of the accumulation. It is possible to detect the most massive boulders from 2009 (c with no change in DSM difference) and 2019 events (a'' and b). The areas covered by trees are excluded from DSMs differences.

In Figure 12, a 3D view of the areas with the largest boulders is represented with more detail. It is interesting to note how the DSM difference allowed us to distinguish the boulder “c” that is part of the 2009 rockslide, from the block a” derived from the new detachment and the rest of the boulders like “b” that is part of the debris flow.

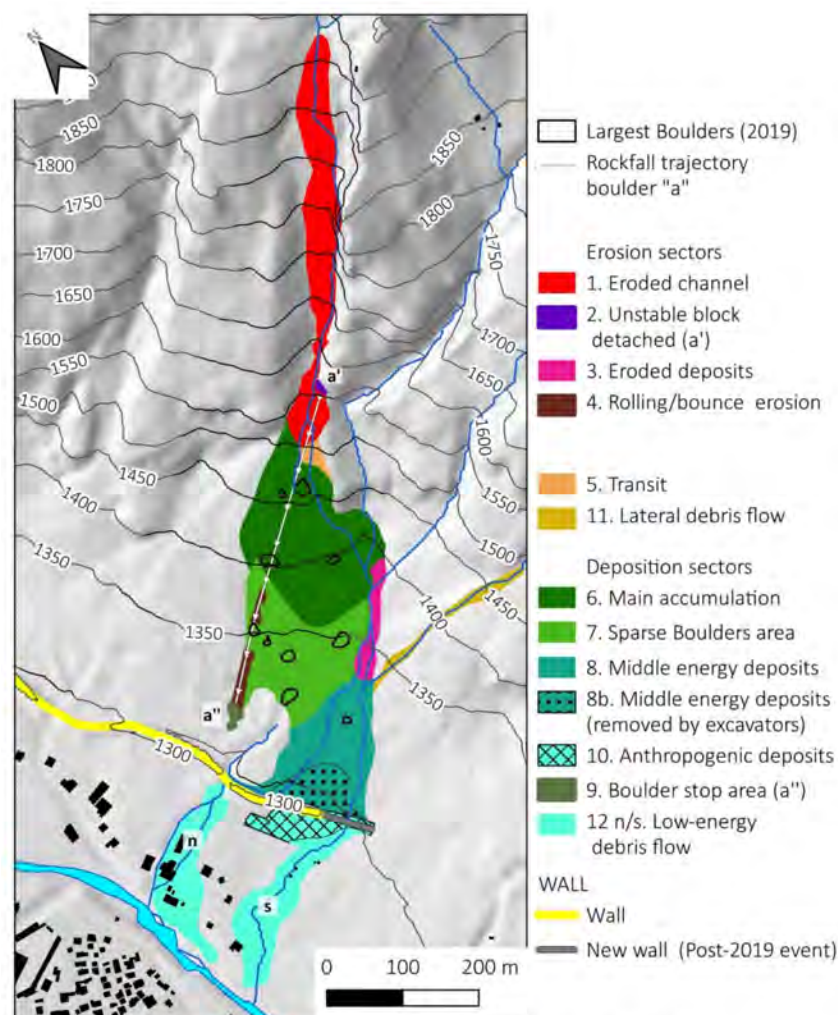
Figure 13. Geomorphological sectors of 2019 debris flow and rockfall.

- Erosion sectors (red/violet colors in Figure 13). Here it is possible to find the eroded channel (1) (source of most of the material mobilized; the area of the detachment of the block a') (2) and the erosion caused by its rolling and bounce (4 a/b); a small area of erosion (3) on the left side of the rockslide deposit related to debris flow action increased by the Bich stream.

- Deposition sectors (green colors in Figure 13). Most of the debris was deposits in the middle sector of the slope just after the channel (6) at 1400 m a.s.l. Just below this deposit, we can find a dispersed accumulation where most of the boulders stopped (about 211,000 m³) (7); the lower sector of the slope (under 1350 m) is characterized by middle energy deposits blocked by the wall (8) and partly removed by remedial work in July 2019 (8b). Part of the removed material was used to build a new section of the wall (10). On the right side of the accumulation, we can also find the collapsed boulder a'' (2000 m³) that stopped about 30 m from the wall (9).
