Geometric and structural information for the analysis of historical domes: the case of SS. Trinità church in Torino

## GEOMETRIC AND STRUCTURAL INFORMATION FOR THE ANALYSIS OF HISTORICAL DOMES: THE CASE OF THE SS.TRINITÀ CHURCH IN TORINO

GIULIA DE LUCIA<sup>1,3\*</sup>, ROSARIO CERAVOLO<sup>2,3</sup>

**Keywords:** Masonry domes, FE models, laser scanner survey, SS. Trinità church

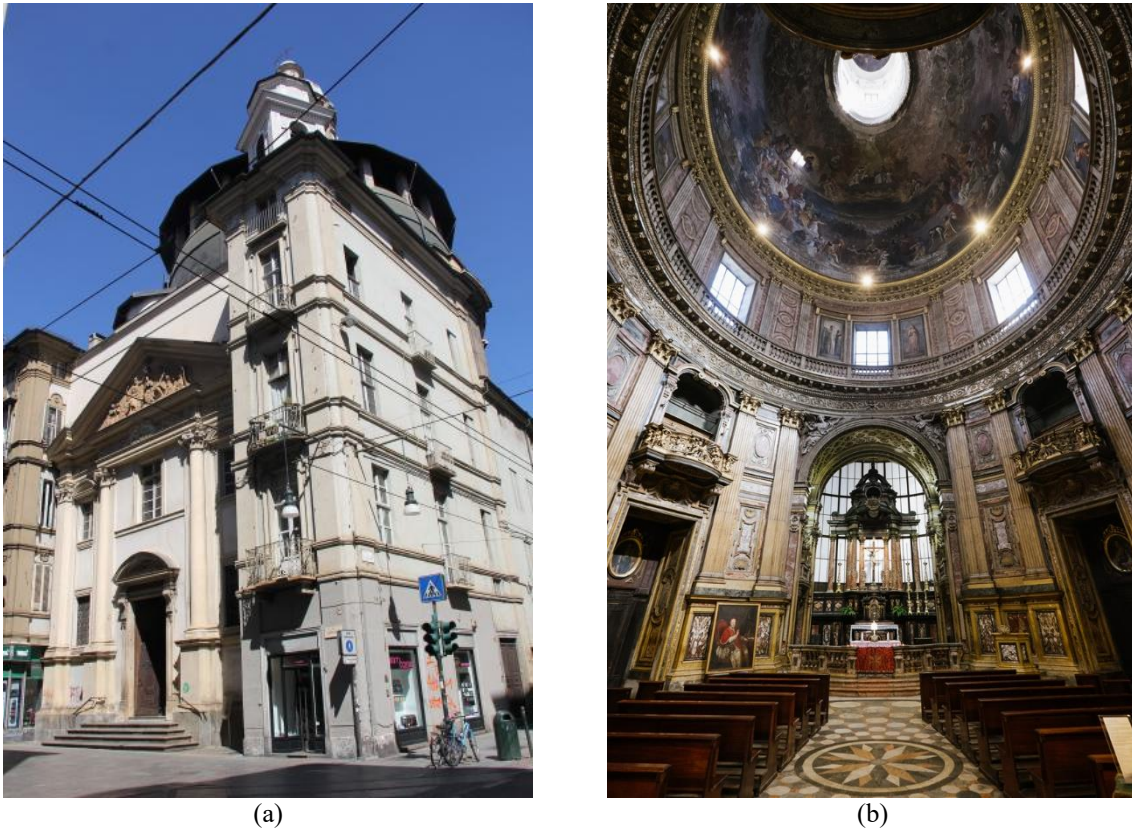
**Figure 1:** The SS. Trinità church in Torino: (a) outside view; (b) inside view.

This study regards the structural analyses conducted on the SS. Trinità Church in Torino (Fig. 1) in order to investigate the structural behaviour and the structural health conditions of the building, in particular its masonry dome-tambour system. Masonry domes represent an important element of the Italian architectural heritage, but their conservation is a complex issue due to their geometric and structural complexity. For this reason, the use of accurate numerical models able to simulate their global structural behaviour is a precious tool [1][2][3][4][5]. To this aim, a multidisciplinary approach is required to take into account various kinds of data needed for the most accurate possible design of models. The case study presented is a church with a large masonry dome built at the end of the 16<sup>th</sup> century under commission from the SS.Trinità confraternity. This is located in the historical centre of the city, near the Royal Palace (ducal palace at that time). The project of the church was requested to the architect Ascanio Vitozzi (1539-1615), a member of the confraternity, who greatly influenced the architectural and urban plan of Torino in the early Baroque age. The church was designed using particular geometric rules based on triangles and hexagons, due to their religious symbolism and referring to the church being dedicated to the Most Holy Trinity. It has a central circular plan, with a main altar and two secondary ones. The cylindrical masonry structure is concluded by a massive cornice which support the dome-tambour system, and the church reaches a height of 50 metres [6][7][8].
