The October 2000 flooding in Valle d'Aosta (Italy): Event description and land planning measures for the risk mitigation

The October 2000 flooding in Valle d'Aosta (Italy): Event description and land planning measures for the risk mitigation / Ratto, S.; Bonetto, F.; Comoglio, C.. - In: INTERNATIONAL JOURNAL OF RIVER BASIN MANAGEMENT. - ISSN 1571-5124. - 1:2(2003), pp. 105-116. [10.1080/15715124.2003.9635197]

Sara Ratto , Franco Bonetto & Claudio Comoglio

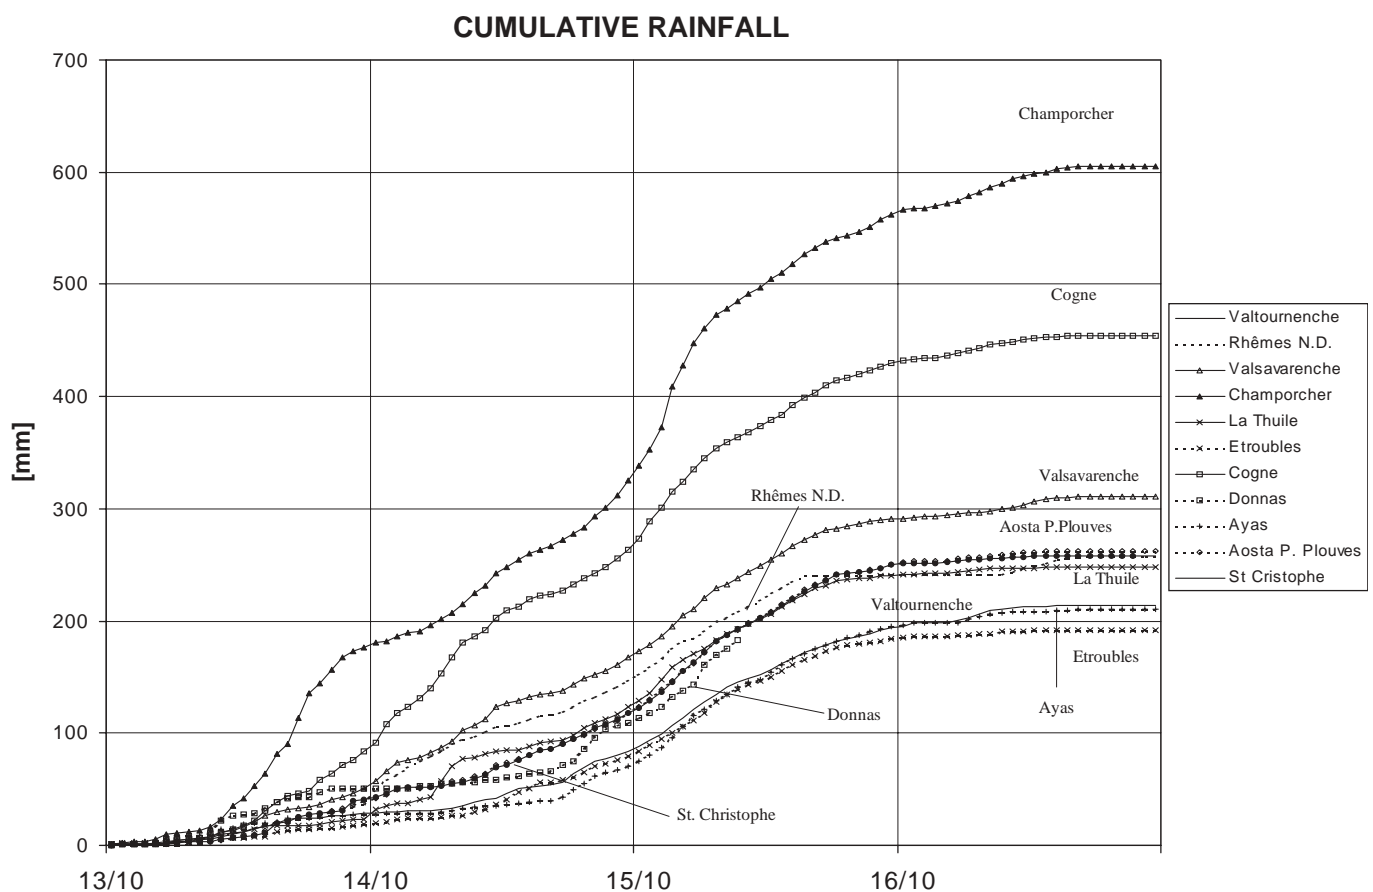
Figure 7 Total rainfall.

Figure 8 Cumulative rainfall.

Taking into account the whole event of October 13–16th, from the values of the cumulative rainfalls (Figures 7 and 8) and of the

- Champorcher and Cogné stations (and so the southern sector of Valle d'Aosta) recorded maximum total values exceeding 450 mm;
- the other stations anyway recorded maximum total values higher than 200 mm;
- 7 stations recorded the maximum of hourly intensity between the 03:00 a.m. and the 08:00 a.m. of Sunday 15th;
- 4 stations recorded the maximum of hourly intensity between the 00:00 a.m. and the 07:00 a.m. of Saturday 14th.

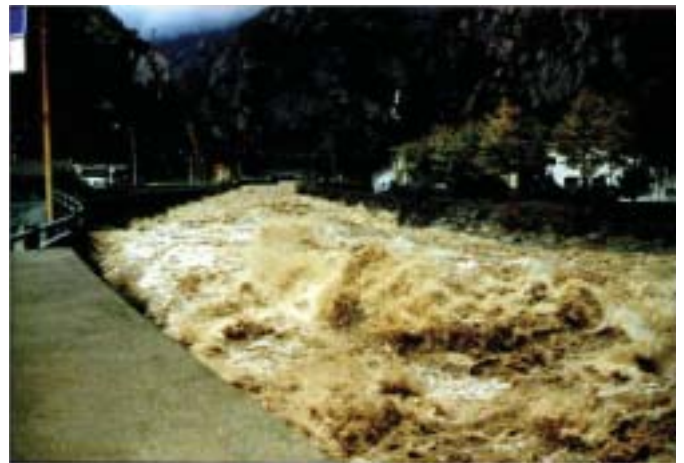
Photo 2 Hône – Ayasse torrent.

- A drastic increase of the water levels in all the regional watercourses, with the Dora Baltea river already reaching its overflow threshold levels since Saturday 14th (Photos 1 and 2).
- Debris/earth flows, landslides and soil slips activation between Saturday 14th (Cogne area) and Sunday 15th morning from 07:00 to 09:00 a.m. (in the rest of the region) (Photos 3–8).

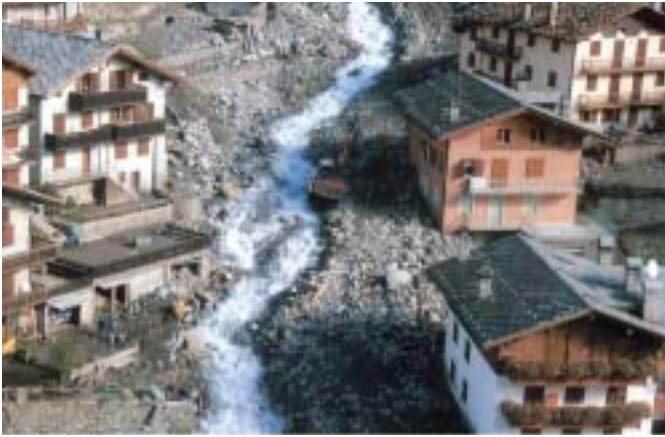
Photo 3 Cogne – Epinel Arpisson torrent. (author: local media).

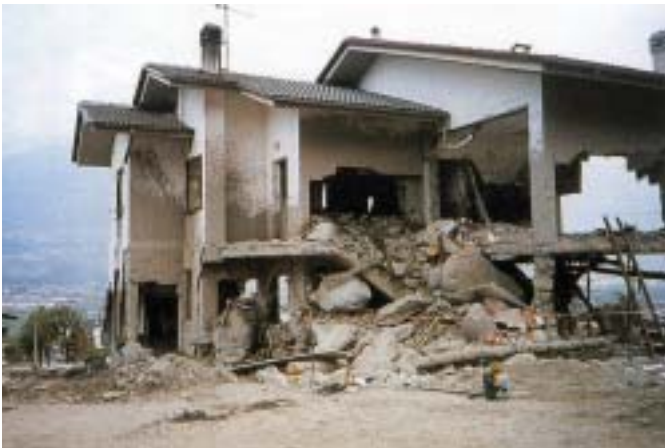
Photo 4 Pollein – Effects of debris flow (author: local media).

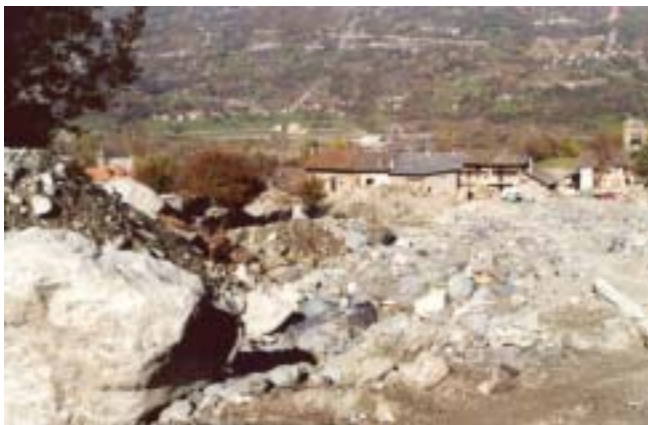
Photo 5 Fénis – Debris flow deposit.

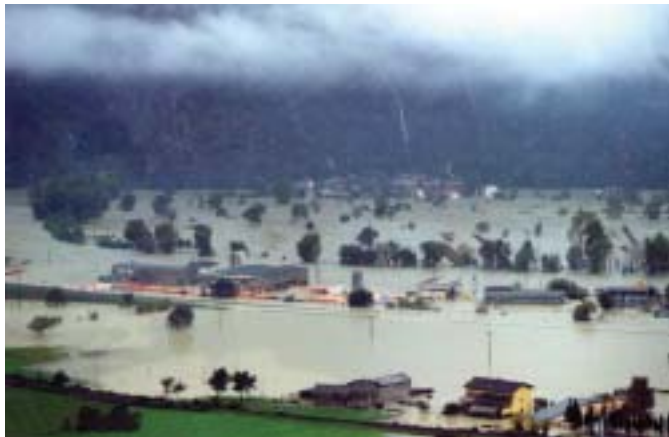
Photo 11 Donnas. Dora Baltea river flooding.

- Dora Baltea river flood, even through its peak was recorded on Sunday 15th between 09:00 a.m. (central region) and 14:00 p.m (lower region) (see Photos 9–11), already caused serious damages on Saturday 14th.
- Surveys on the damages along the watercourses during the days after the flood transit (Photos 12–14).
- Activation/reactivation of landslides phenomena involving broad areas and huge volumes, some of them still developing nowadays (Photos 15–16).

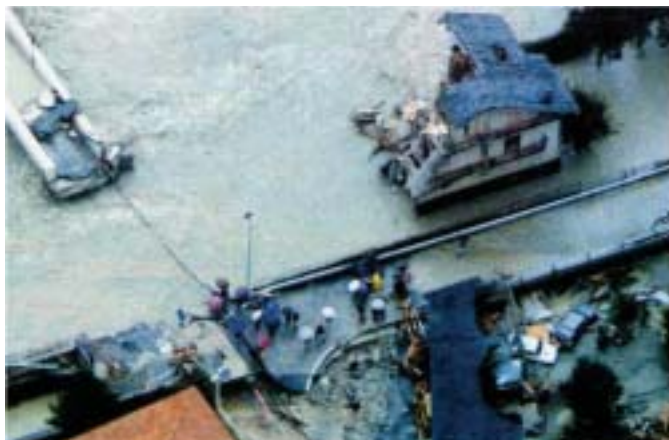
Photo 12 Donnas. Dora Baltea – Flood effects (*author: local media*).

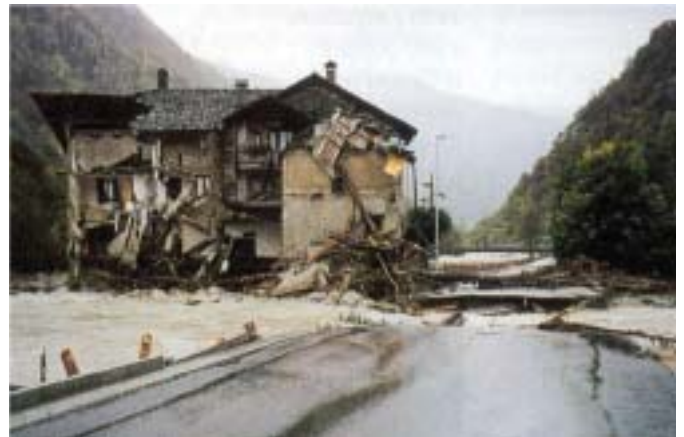
Photo 14 Gressoney-St-Jean. Lys torrent – Flood effects (*author: local media*).

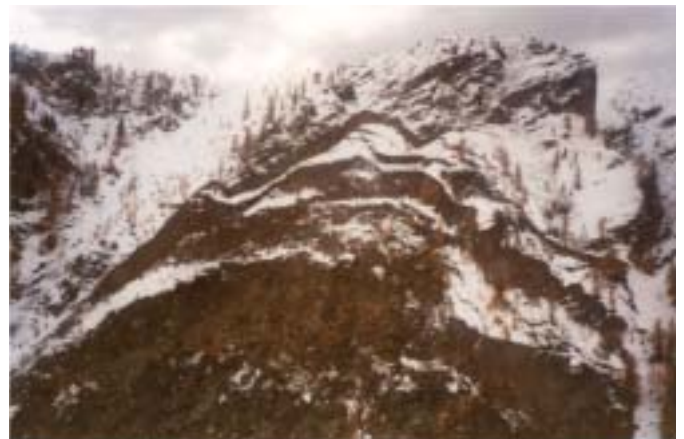
Photo 15 G.S. Bernardo valley – Citrin landslide.

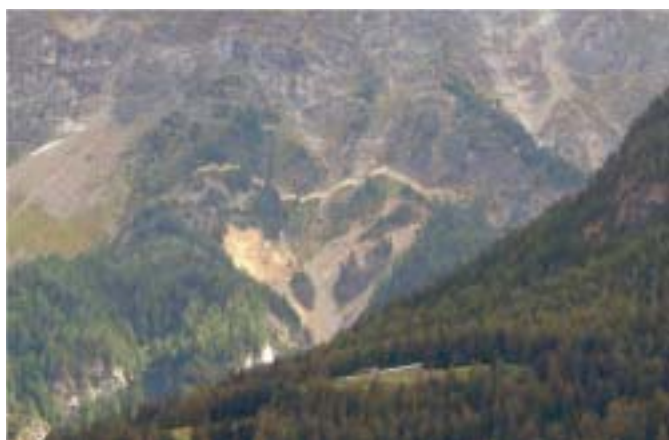
Photo 16 Becca di Nona landslide (author: Ketty Carere).
