Experimental investigation on crack propagation paths in spur gears

F Curà¹, A Mura¹ and L Corsaro¹

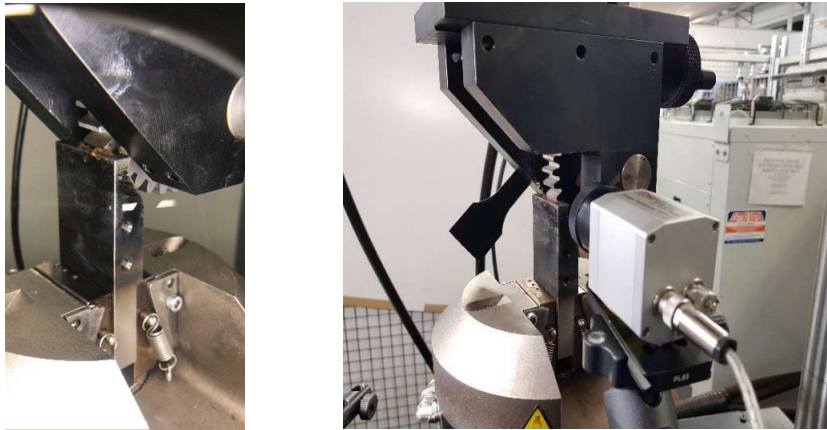
Figure 2. Test apparatus.

A special device connected to a standard fatigue machine was realized to perform bending tests for both standard and thin rim gears (see Figure 2, left side). A punch integrated into the device was able to apply the pulse loading to the gear tooth. In particular this punch was designed in order to load the tooth along its involute profile in both position and direction referred to the single contact point [8].

During bending tests, an IR thermocamera (*IR tech Timage Radimatic "XT"*) was utilized to monitor the surface thermal profile in the tooth root fillet zone (see Figure 2, right side). The thermal detector was located at a distance of 60 mm from the gear. A reference specimen (see Figure 2, right side) allowed to acquire the environmental temperature during each test. Gears and reference specimen were both covered by black spray paint to generate a surface with an emissivity close to 0,95. Two different thermal profiles were extracted from each thermogram near the root tooth fillet, respectively an *area* and a *point* of 2x2 pixel (located inside the area close to the crack initiation point). The relative temperature ΔT (difference between the absolute temperature and the temperature of the reference specimen) was computed for Gears. Figure 3 illustrates an example of the area position near the tooth root fillet.

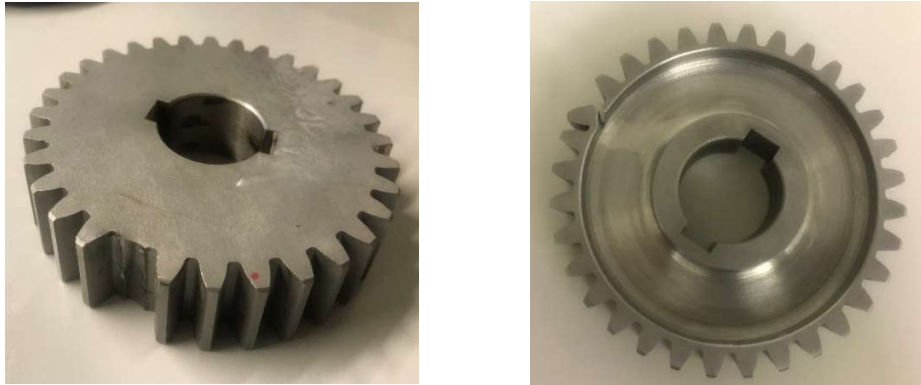
Figure 4. Gear 1 (left) and Gear 2 (right) crack paths.

Figure 4 shows, as an example, Gear 1 and Gear 2 and their failure typologies. As it can be observed, Gear 1 crack path (on the left) corresponds to a classical fail safe condition, while in Gear 2 (on the right) a crack path directed through the rim can be pointed out.

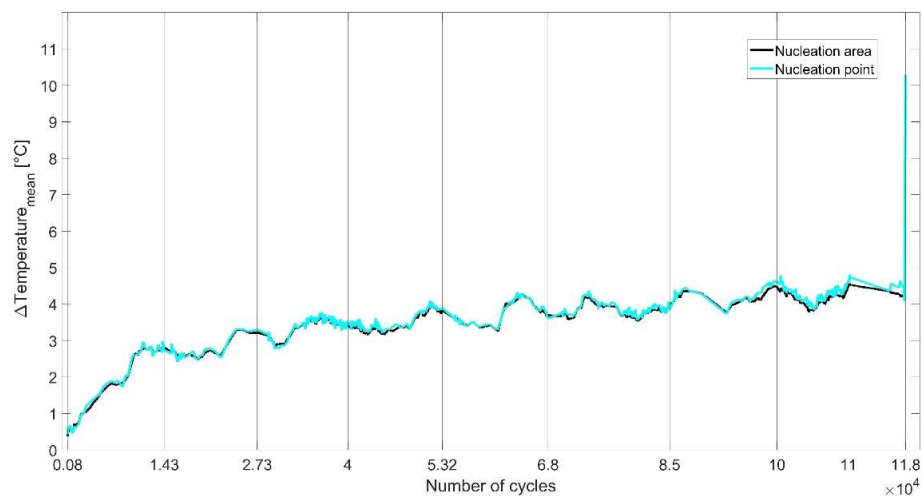
Figure 7. Gear 1 thermal profiles.

Figure 6 points out CR parameter values for Gears 2 and 3, characterised by different back up ratio (m_b) values and with the same web ratio (m_w), driving respectively to fail safe and catastrophic failures. Finally, Figures 7 and 8 show the thermal profiles monitored during the fatigue tests respectively for Gear 1 and Gear 2. In particular, in each Figure is reported the difference temperature ΔT (respect to the ambient temperature or reference specimen) as a function of the number of cycles, referred to both crack nucleation point and to an area around the nucleation point (nucleation area, mean value of temperature).

From the analysis of these Figures, it can be noted the increase of thermal profiles in the first phase of the test, then a stabilised condition of temperature and, finally, an abrupt variation corresponding to the failure. Nucleation point and area profiles show in both cases identical trends.

The comparison between Figures 7 and 8 shows that the fatigue life of Gear 2 is lower than that of Gear 1 in term of number of cycles (118000 cycles for Gear 1 and 104300 cycles for Gear 2), as expected. Moreover, the relative temperature ΔT level is higher for Gear 1 than for Gear 2. This unexpected result may be interpreted as a strong dissipation flow in the case of Gear 2 within the whole wheel body, due to the high displacements involved in fatigue tests.

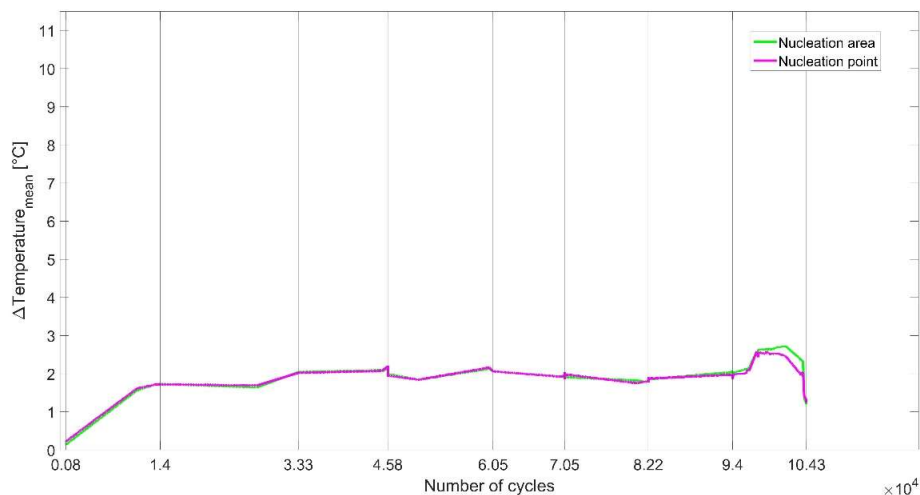
Figure 8. Gear 2 thermal profiles.
