# Technology, diagnosis and structural assessment on timber composite beams in Venice Arsenal at the Biennale

**Abstract** In the architectural and cultural heritage of the Arsenale of Venice, the authors have worked on several interventions for diagnosis and recovery of roofs, foundations and floors of the so-called "woods of Venice". The work refers to the complex of the "Sale d'Armi" located in the central area of the Arsenale, currently used as exhibition space for the Biennale of Venice. The original nucleus (1460) was used as weapons deposit of the Serenissima. The South "Sala d'Armi", three buildings on two levels realized in the 17<sup>th</sup> century, were rebuilt after the fire of 1728. This article describes the diagnostic assessment, including dendrochronological and mechanical assessment, carried out in one of these buildings, the largest one, a large room at full height, which currently preserves original timber elements left in place after the fire: composite beams belonging to a timber floor supported by timber columns. The paper focuses on a very interesting construction system such as the historical composite wooden beams. This technology, although in frequent u

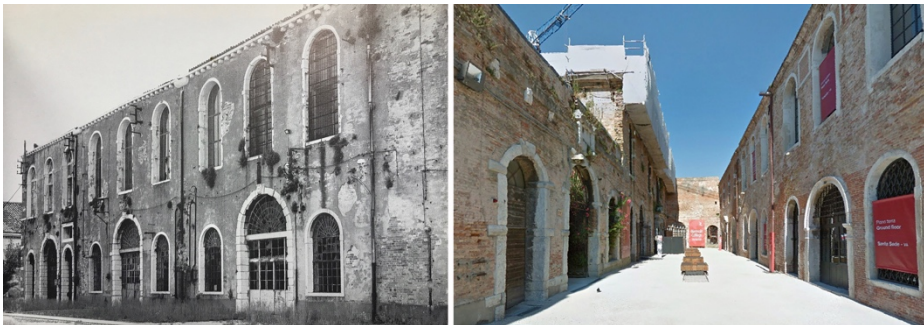
**Fig. 4** View of the Sala d'Armi South, 1980's (left) (from U. Pizzarello, V. Fontana, 1983); Sala d'Armi North and South during the recent restoration.

Since 2007, having survived almost intact in the load-bearing structures, after the passage of management to the Venice Biennale, the block of buildings has undergone a complete restoration which foresees its new destination as exhibition, show and cultural spaces linked to the activities of the Biennale (Fig. 4).

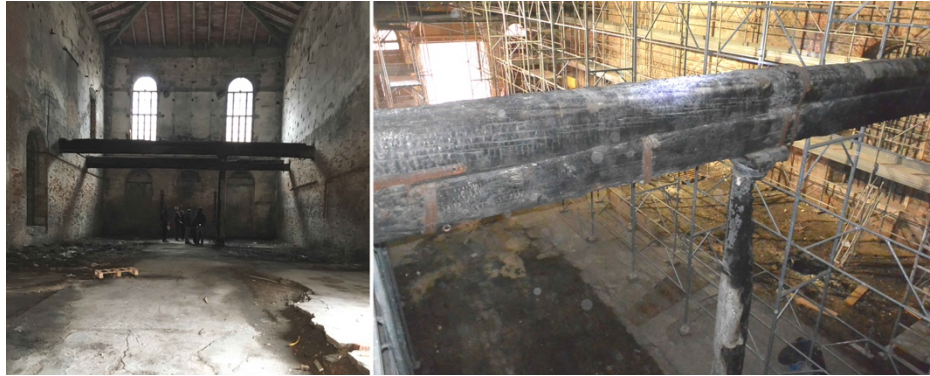
**Fig. 5** Interior view of the Sala d'Armi “E” (left), detail of the burned wooden beam with wooden column (right). (Photo D. Ferrante, 2019)

As evidence of the architectural importance of the building, the two large wooden beams, object of the present study, were still preserved on site (Fig. 5).

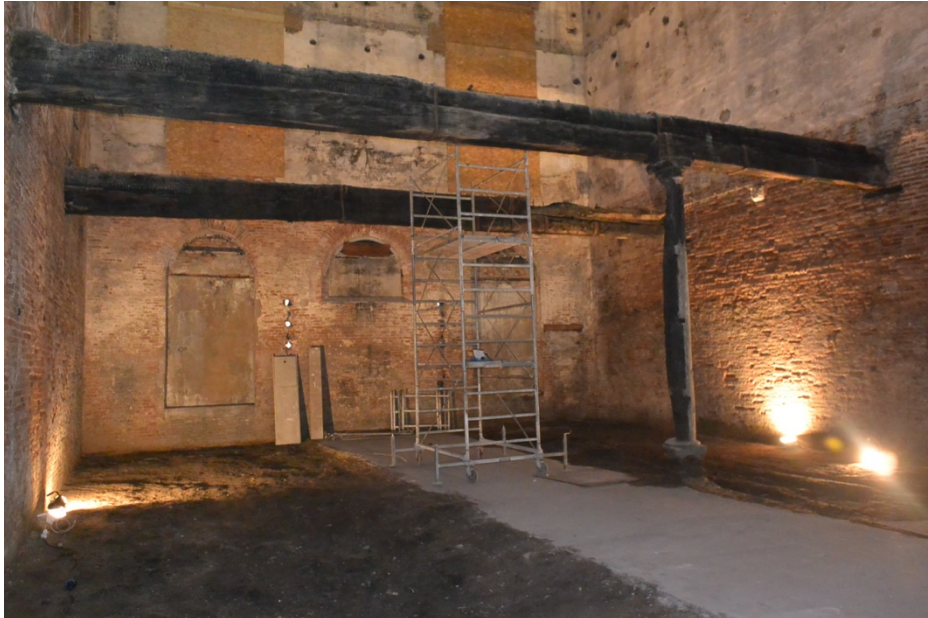
**Fig. 7** Interior view of the Sala d'Armi "E", composite beams and wooden column (Photo D. Ferrante, 2019)

A single wooden column with Doric capital is currently present in the first beam, with a height of about 4.30 m (Fig. 7).

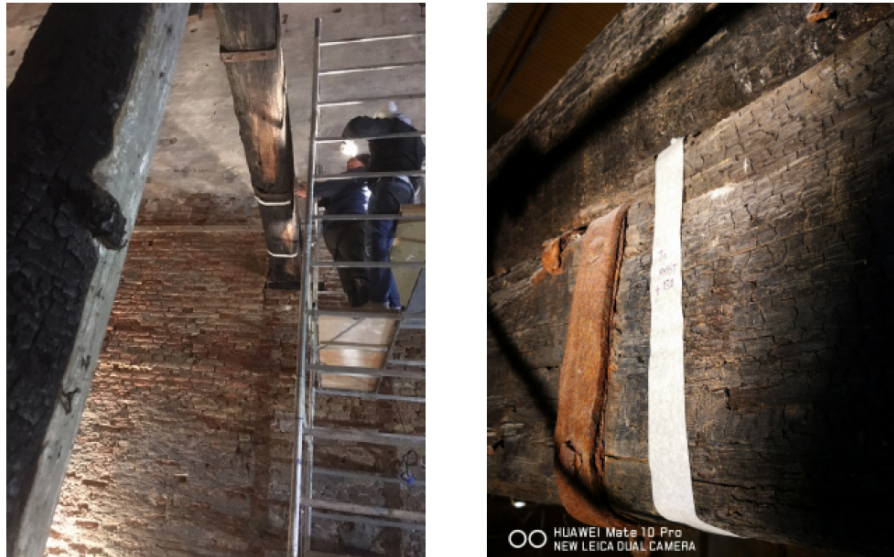
**Fig. 9** Diagnostic survey on the composite beam. Overlapping of the different wooden elements composing the beam. Example of resistance drilling carried out on the beam.

These types of surveys went alongside with instrumental investigations, with the help of resistance drilling for wooden elements whose state of conservation needed to be verified. Furthermore, also the constructive survey was integrated with the use of resistance drilling to verify the thickness of the different parts constituting the joint, a very important indication for the assessment of the state of conservation and mainly of the stability of the structure.

The diagnostic assessment mainly concerned the timber elements of the main supporting structure of the trusses, to which the investigations on secondary elements were added ( Fig. 9).
