BRIDGE|50 research project: Residual structural performance of a 50-year-old bridge

ABSTRACT: This paper deals with the BRIDGE|50 research project aimed at investigating the residual structural performance of a 50-year-old concrete bridge recently dismantled in Italy. A group of 29 precast prestressed beams, including 25 I-beams and four box beams, and two pier caps has been placed in a testing site. The preliminary activities already developed and the planned experimental program are discussed. The project includes photographic mappings, drone surveys, non-destructive testing, full-scale load tests, and extraction of a large number of samples from the tested structural elements for laboratory tests.

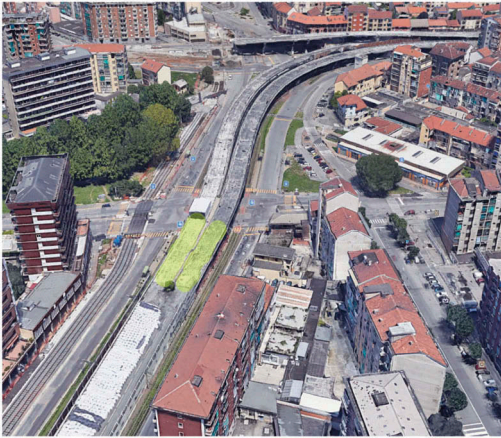
Figure 1. Aerial view of the Corso Grosseto viaduct.

The 50-year-old Corso Grosseto viaduct is a 80-span double deck road viaduct recently dismantled in Turin, Italy. Figure 1 show an aerial view of the viaduct still

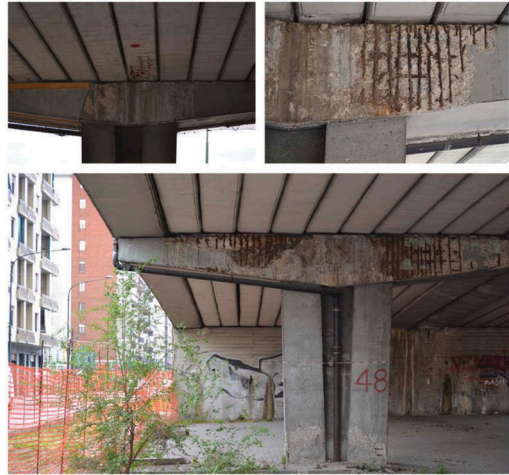
Figure 3. View of the bridge deck and details of the pier caps.

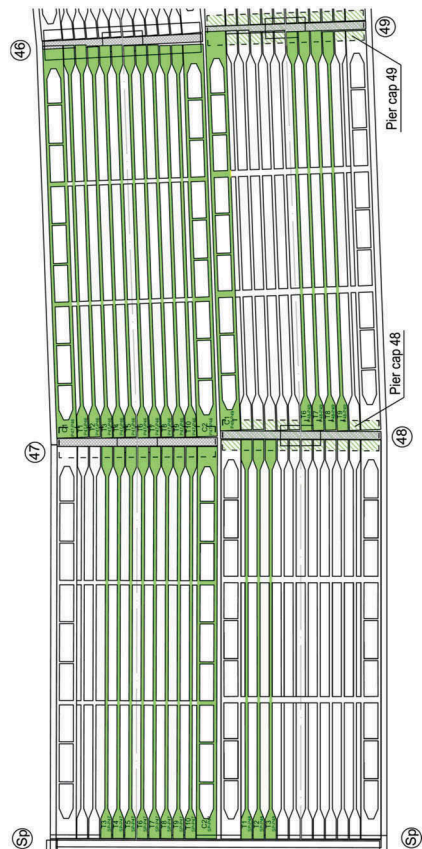
Figure 4. Deck beams and pier caps selected for testing.

deconstructed according to the plan shown in Figure 4 by cutting the structural members, including 29 PC deck beams (25 I-beams and four box beams) and

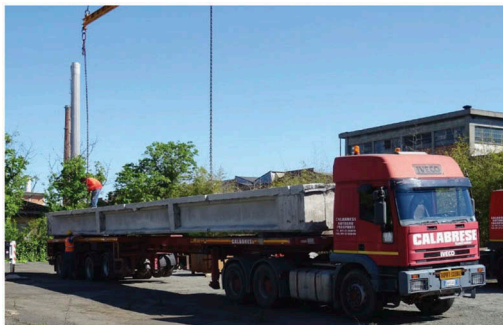
Figure 7. Beams moved by trucks to the testing site.

two PC pier caps, by using rotating disks with diamond wires (Figure 5). Therefore, the structural members have been lifted (Figure 6) and moved by trucks to the testing site (Figure 7). Figure 8 shows some of the beams during the storing process, with the beams placed sequentially on New Jersey supporting members in the testing site. A detailed description of the dismantling and deconstruction process of the bridge and setup of the testing site is described in Anghileri et al. (2020).

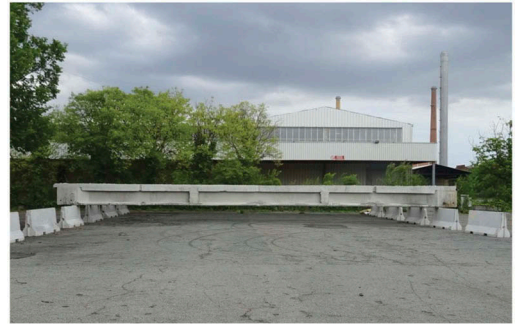
Figure 8. Beams placed sequentially on New Jersey supporting members in the testing site.

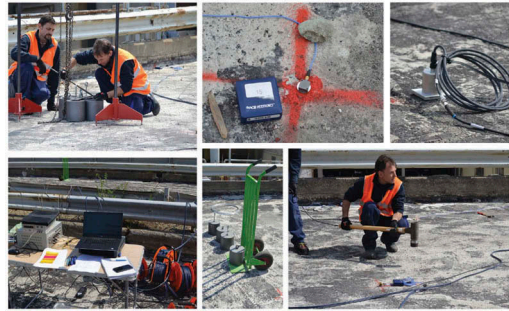
Figure 11. Dynamic identification experimental tests.

Finally, a preliminary dynamic tests campaign has been carried out on bridge decks. The purpose of this campaign is to characterize the dynamic behavior of the decks under service condition. Dynamic measurements have been acquired by using different excitation sources (Figure 11). The collected data have been analyzed in order to extract the principal
