First mirror test in JET for ITER: Complete overview after three ILW campaigns / Moon, Sunwoo; Petersson, P.; Rubel, M.; Fortuna-Zalesna, E.; Widdowson, A.; Jachmich, S.; Litnovsky, A.; Alves, E.; Subba, F.. - In: NUCLEAR MATERIALS AND ENERGY. - ISSN 2352-1791. - 19:(2019), pp. 59-66. [10.1016/j.nme.2019.02.009]

## First mirror test in JET for ITER: Complete overview after three ILW campaigns

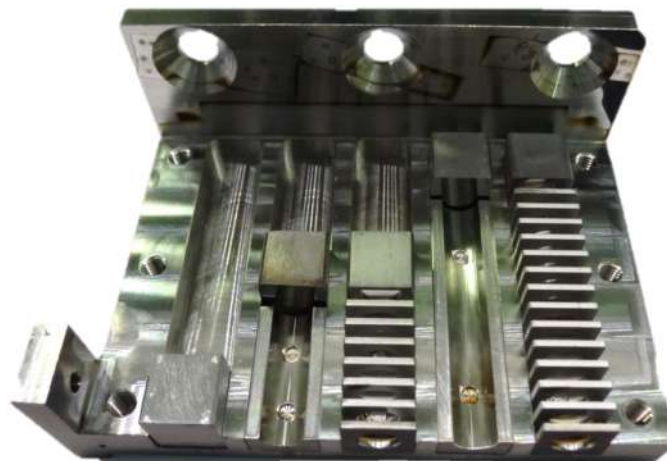
Fig. 2. Five-way cassette from main chamber wall. From the left: mirror at 0.0 cm at the cassette mouth placed in the standard square channel; 1.5 cm deep circular and baffled channels and a similar set with mirrors at the depth of 4.5 cm.

The test mirror in JET is a poly-crystalline molybdenum  $1\text{ cm}^3$  cube with a polished surface on one-side. Fifteen mirrors were exposed during ILW-3, while ten others were facing plasma during all three ILW campaigns ILW1-3. Test mirrors were placed in pan-pipe shaped cassettes installed on the main chamber wall (5 pieces for ILW-3) and in the divertor: base under the bulk tungsten tile (4 for ILW-3, 4 for ILW1-3) [10] and in shadowed regions of the inner (3 for ILW-3, 3 for ILW1-3) and outer legs (3 for ILW-3, 3 for ILW1-3) [7], as shown in Fig. 1. The cassettes have several channels (2, 3 or 5) each housing one mirror with a small holder to fix the mirror in the channel. For a given cassette one mirror was placed at the mouth (0.0 cm), while other specimens were sitting deeper, e.g. 1.5, 3.0 cm, from the entrance, thus at the longer distance from plasma. Standard channels have square  $1 \times 1\text{ cm}$  cross-sections, as shown in [7] and it also can be perceived in Fig. 2: first channel on the left. This has been the feature of all cassettes in the divertor. Only the construction of a five-way cassette installed at main chamber during ILW-3 was designed differently in order to test protection of mirrors against deposition by using baffled structures; a series of hollow (0.57 cm diameter) baffles, as shown in Fig. 2. One mirror placed at the entrance, two mirrors in baffled channels (1.5 and 4.5 cm) and, for comparison, two others were in straight channels of circular
