Improving the dynamic behaviour of historic buildings using experimental data: application to a Baroque church

Rosario Ceravolo^{1,2} · Erica Lenticchia^{1,2} · Gaetano Miraglia^{1,2} · Linda Scussolini¹

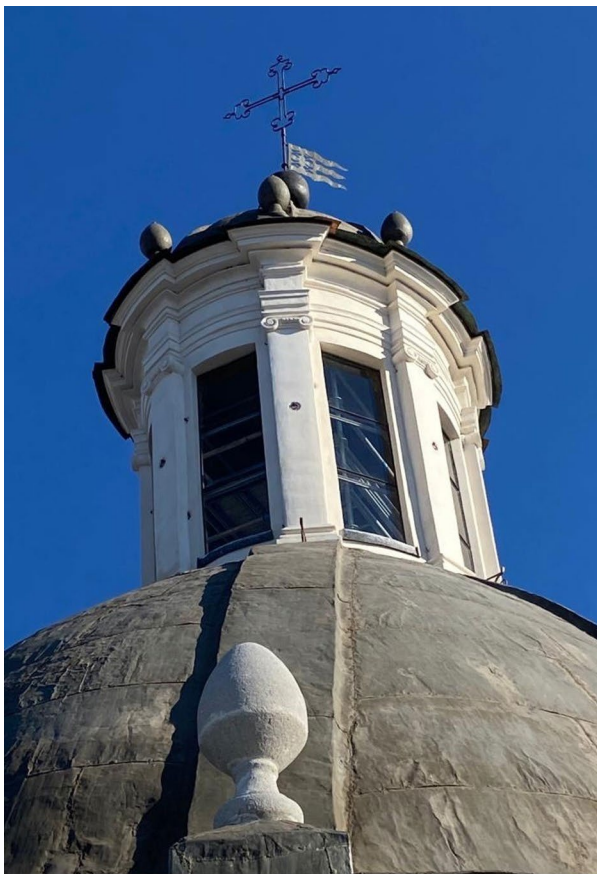
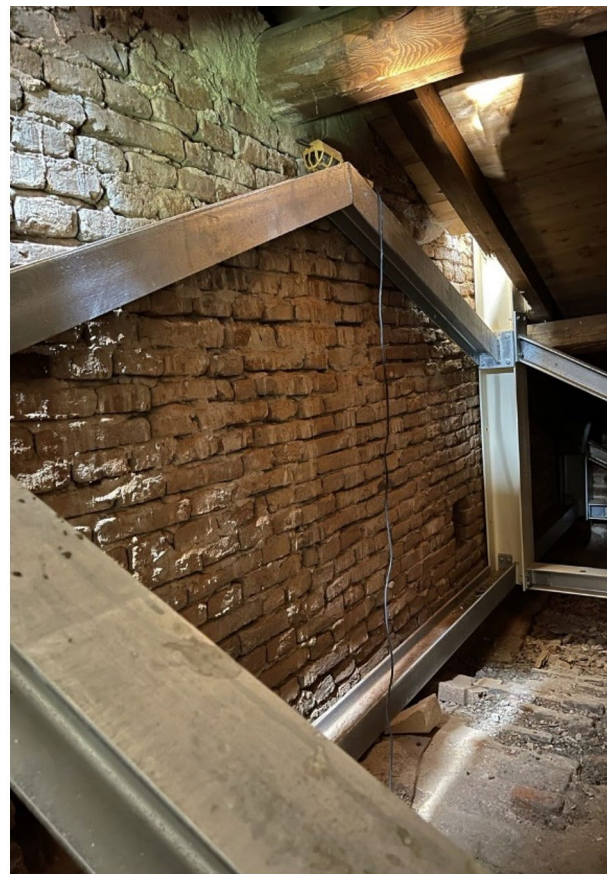
Fig. 7 Installed intervention on the lantern (a) and on the façade (b)

The systems installed on the lantern and on the façade are reported in Fig. 7.

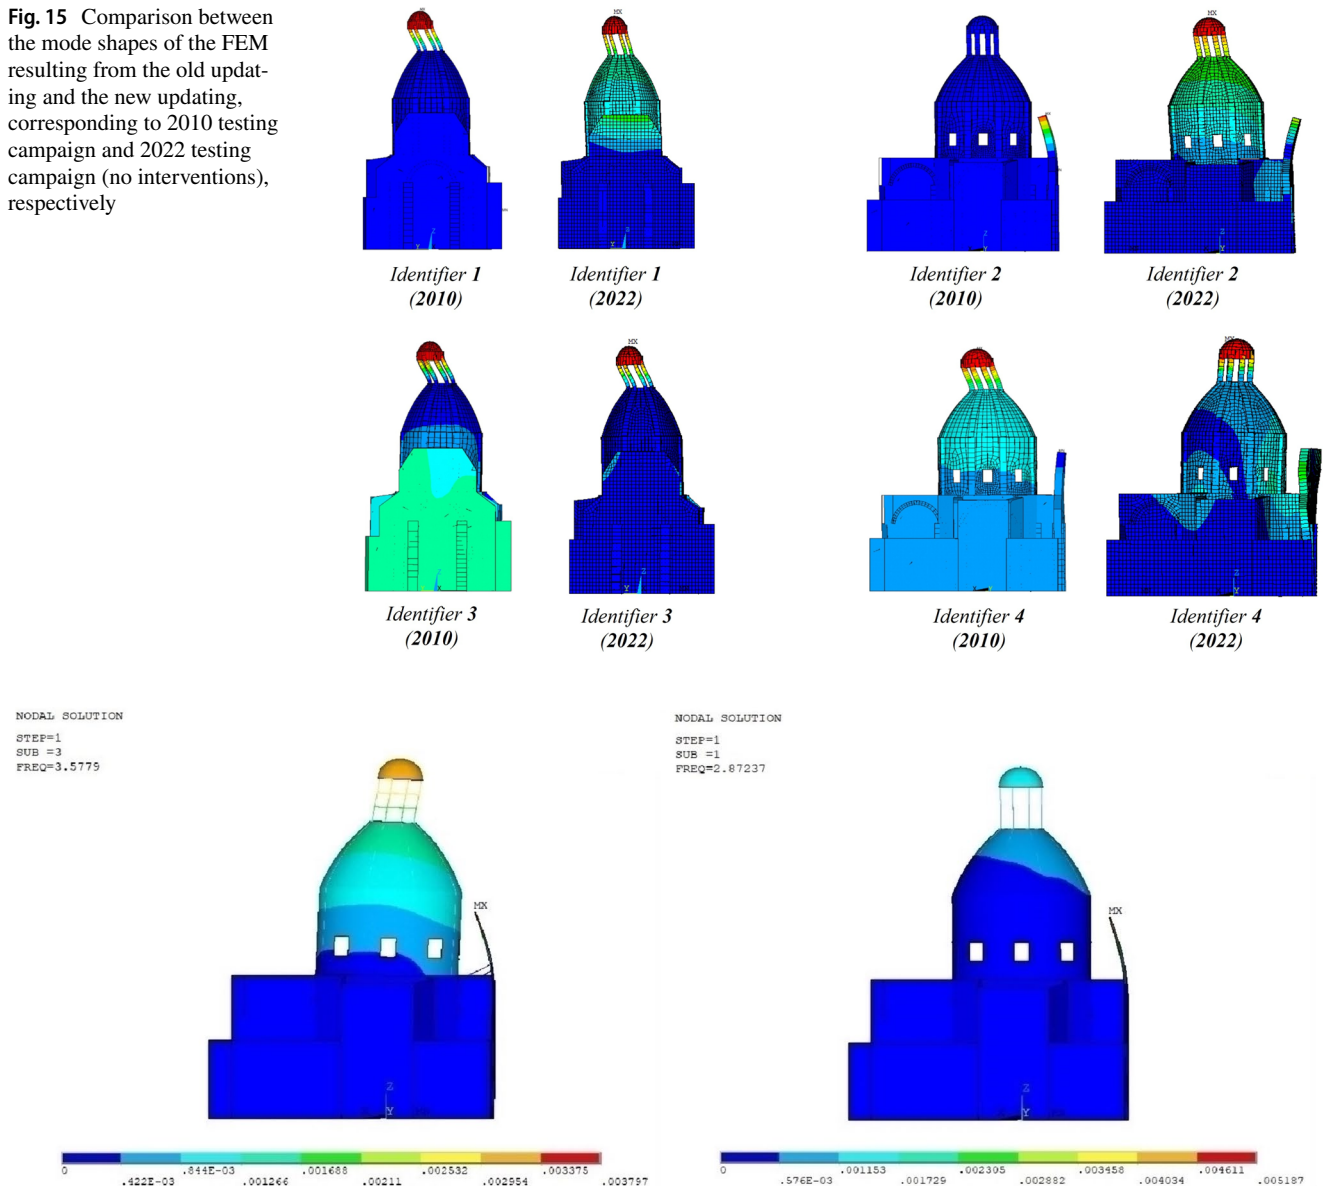
Fig. 16 Mode shape of mode at 3.88 Hz predicted by the new calibrated FE model with (left) and without (right) retrofitting interventions

the definitive permanent monitoring system is installed. Figure 16 depicts the comparison between the mode shape of the mode at 3.88 Hz predicted by the new calibrated FE model with and without upgrading interventions, respectively.
