Large-Scale Experimental Static Testing on 50-Year-Old Prestressed Concrete Bridge Girders

Keywords: prestressed concrete; existing bridges; deck girders; large-scale tests; structural capacity

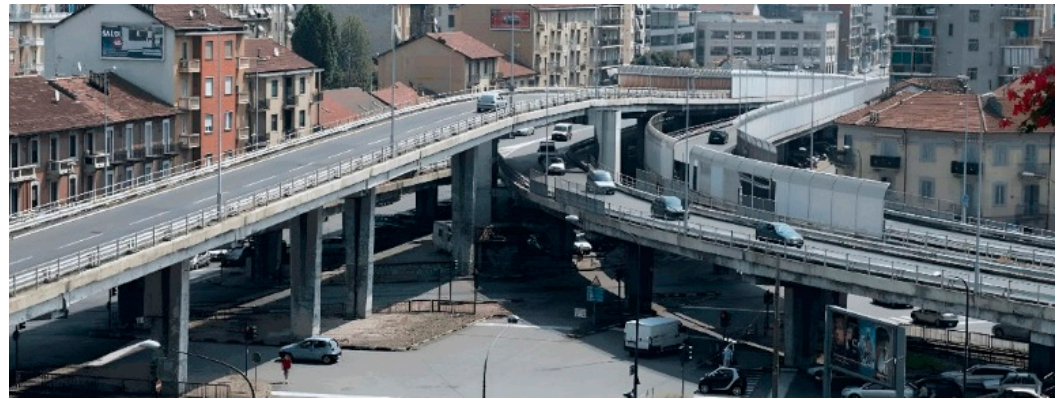
Figure 1. Historical view of the Corso Grosseto viaduct.

The Corso Grosseto viaduct, built in Turin (Italy) in 1970, was a multilevel road interchange developed along two main lines, the Corso Grosseto West–Corso Grosseto East route and the Corso Potenza–Corso Grosseto East route. Each route was linked by two structurally independent decks, one for each carriageway. The viaduct consisted of 80 simply supported spans, ranging from 16 to 24 m, for a total length of about 1.4 km (Figure 1).

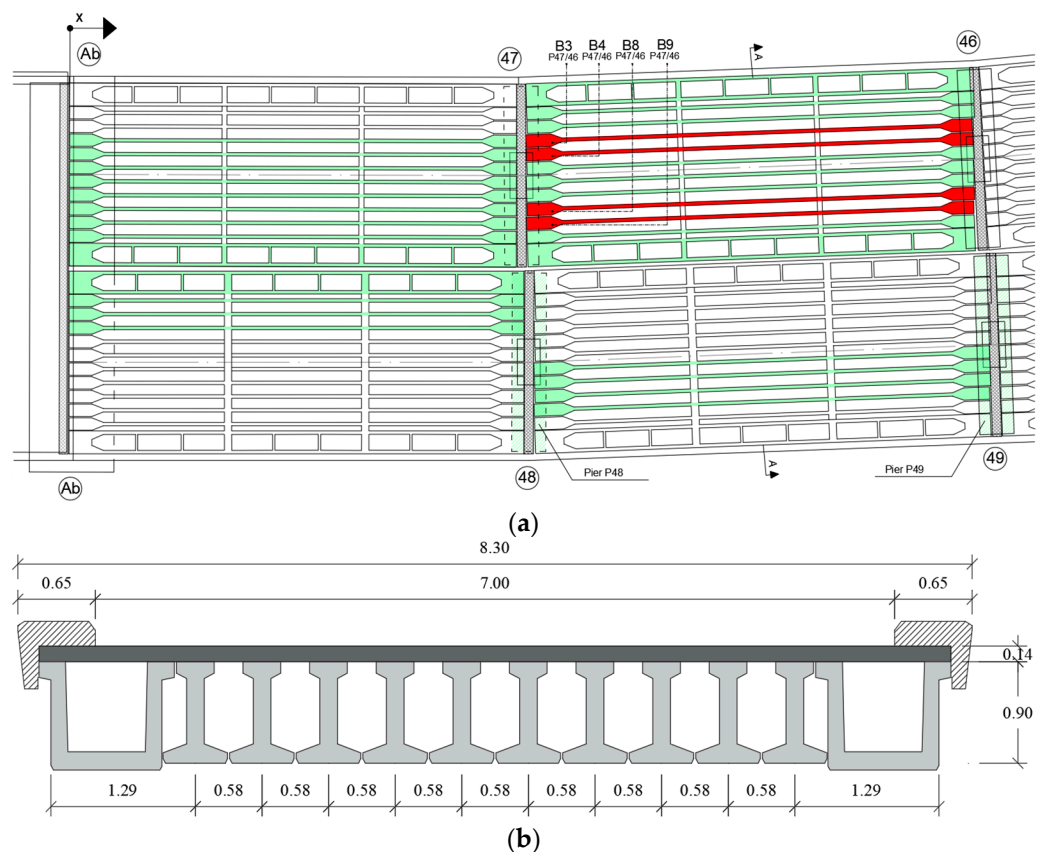
The deck of each span consisted of 10 precast PC I-beams and 2 U beams all connected by a cast in situ slab, with transverse beams at third points of each span. Figure 2 shows a technical drawing of the top view and cross-section of the viaduct. The elements retrieved for the project are depicted in Figure 2a in green, whereas the elements tested, whose results are reported in this paper, are painted in red.

Figure 2. (a) Top view; (b) cross-section of the PC deck (in meters).

A proper identification code reported in Figure 2 was assigned for each structural member to record the element position on the original location.

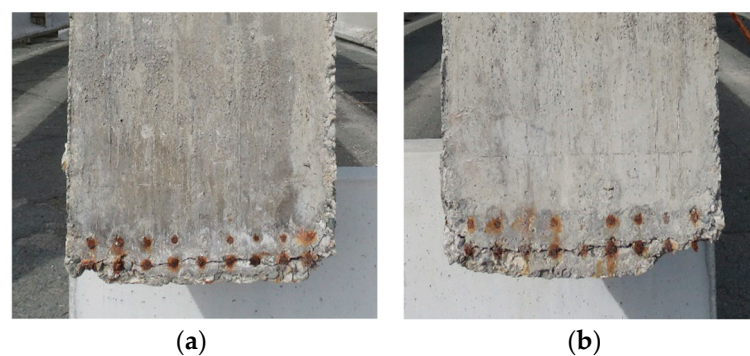
The B3-P47/46 and B4-P47/46 girders showed 5 mm wide horizontal cracks at the edges caused by corrosion activity that transversally crossed the strands (Figure 6). The visual inspections revealed no other corrosion-induced damages. The presence of such kind of damage can be ascribed to the presence of structural joints.

Figure 6. Cracks on the end of the (a) B3-P47/46 and (b) B4-P47/46 beams.

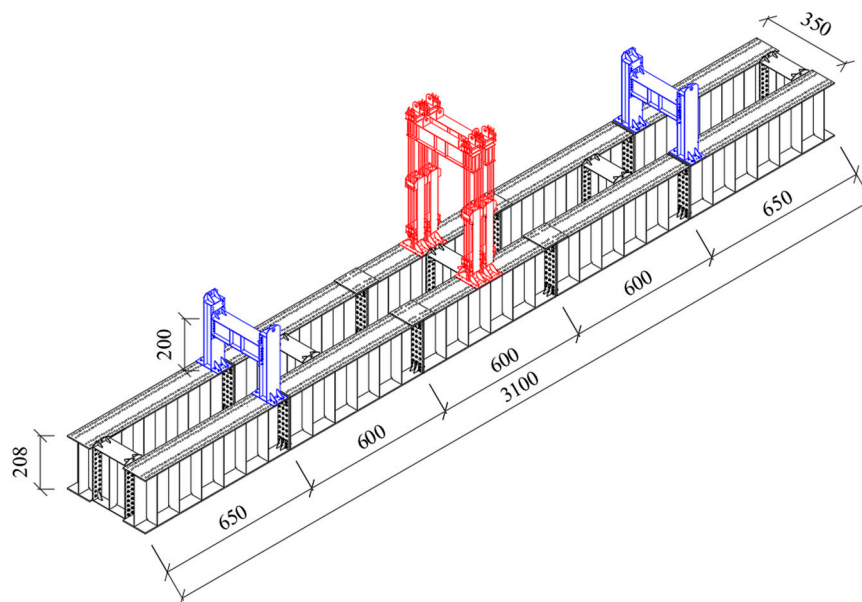
A large steel reaction frame was designed to investigate the structural behavior and load-carrying capacity of the girders with different loading configurations (Figure 7). The test bench was provided by the Center SISCON of Politecnico di Torino for testing structures with a span of up to 30 m.

Figure 7. Technical drawing of the reaction steel frame in black, supporting frames in blue and loading frames in red (in cm).

The PC beams under testing were positioned on the supporting frame (blue color in Figure 7), where specifically designed bridge bearings replicate the simple support static scheme. The hinge and roller have a support plate of 400×400 mm and allow for $\pm 4^\circ$ of rotation; the roller allows a longitudinal displacement of ± 150 mm. The base plate of the bearings is bolted to the supporting frames, which in turn are bolted to the main frames (black color in Figure 7). The latter consist of two main longitudinal steel beams, each composed by 5 I-shaped welded steel segments. These segments were built by welding a 2 m high web to 1 m wide flanges with plates stiffeners spaced 1 m. The longitudinal beams are transversally connected by 5 I-shaped elements 1.5 m long. The loading system (red color in Figure 7) is constituted by two couples of hydraulic jacks hosted into steel member hinged to the steel frame with single capacity of 1200 kN and a maximum stroke of 750 mm. The hydraulic jacks, contrasting on the steel member, act on the pushing system, which transfer the load to a steel transverse beam through six 32 mm steel bars. The transverse steel beams were used to transfer the load from each couple of hydraulic load cylinders to the specimen under testing. Both the supporting frame and the loading system can be installed through a bolted connection along the longitudinal beams with a step of 10 cm in order to obtain different loading schemes. The hydraulic testing system allows for the performance of force-controlled loading tests at a controlled loading rate.

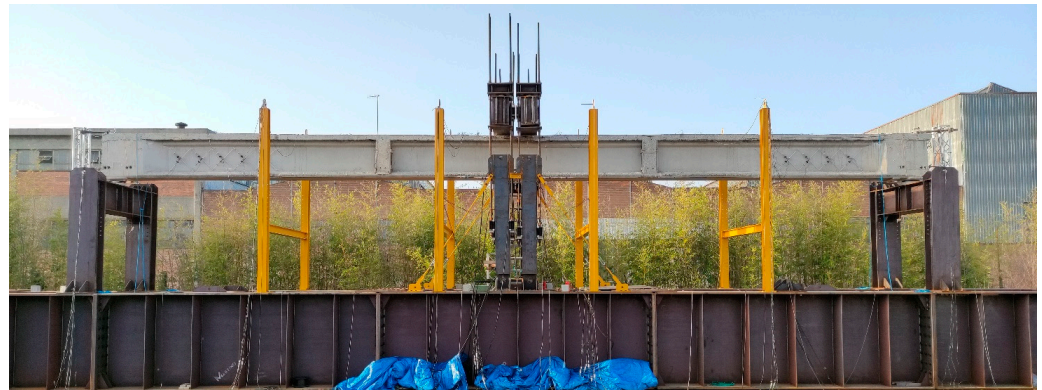
The span length of the flexural tests reported in the present work was 19 m and the two couple of hydraulic jacks were located 0.6 m away from the midspan to conduct the loading tests in a three-point bending type configuration (Figure 8), aimed at investigating the bending resistance of the girders.

Figure 8. Three-point bending test configuration.

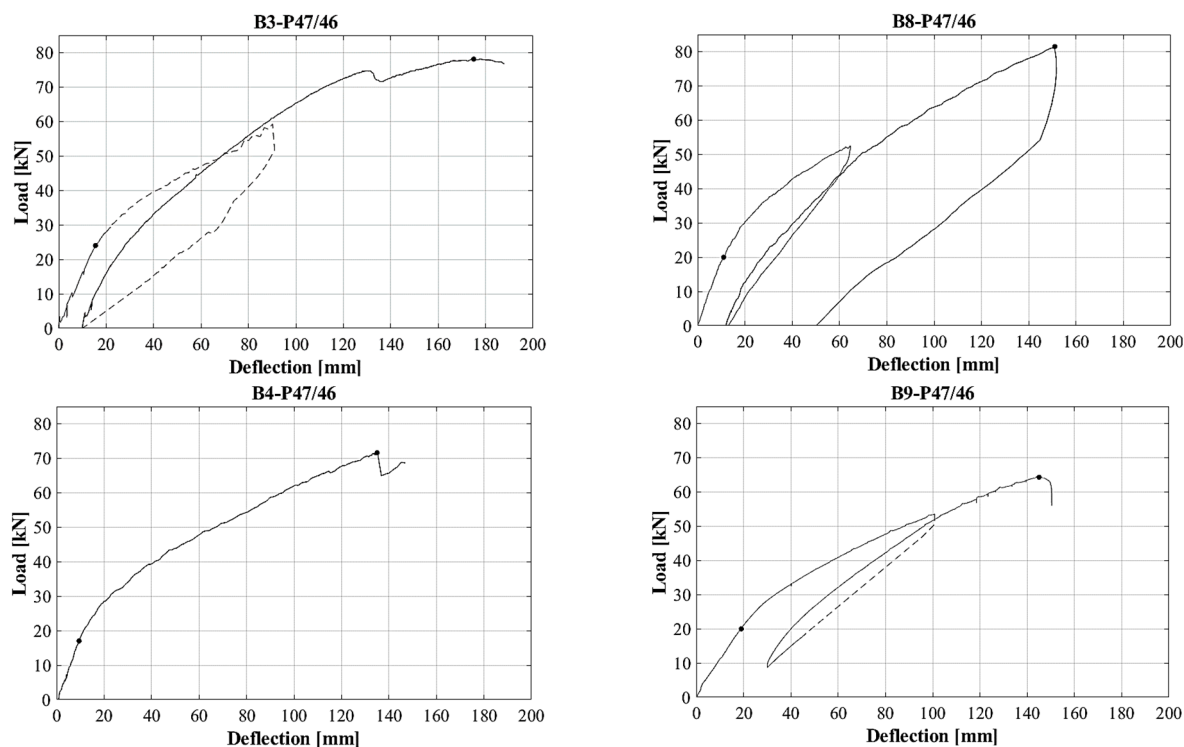
In the present paper, the most representative outcomes of the structural response are reported and discussed. The girders were tested by adopting a static loading with a rate of 2.6 kN/min. In the following figures, the reported load refers to the force transmitted by one of the four actuators; therefore, the total load can be obtained multiplying the value reported in the following diagrams by 4. It should be noted that the actual load applied to the girder, other than its self-weight, should be calculated by adding the loading frame weight (estimated as 11.82 kN per actuator) to the recorded applied load. The dashed curves in the load–deflection curves in Figure 10 indicate measurements that are not reliable following to unexpected setup technical problems. The first test was aimed at controlling the parameters reported in the following paragraphs using a two-phase loading test. As mentioned above, due to technical problems and then for comparison purposes, the second test was set in an identical two-phase protocol; the third test reports a one-phase loading test to study the outcomes from a monotonic procedure in comparison with the previous two; finally, test number four was performed to analyze the properties of the PC beam without the contribution of the cast in situ slab to the structural performance of the specimen. In the case of B9-P47/46, the second loading phase started before reaching complete unloading; it started at a load level lower than the first cracking load.

Figure 10. Load versus midspan deflection with dots located at the estimated first cracking and peak loads for each girder.

The deflection of girders under loading is a significant parameter; it can be used for the calibration of structural models able to properly assess the stiffness and resistance characteristics. Figure 10 shows, for each girder, the load–deflection curve obtained at the midspan of the girders (position D05 according to Figure 9) during each loading phase. From the slope of the curves, it is possible to observe the linear elastic response branch up to flexural cracking followed by crack propagation stage up to failure. Referring to the first, second and third load test (Table 1) on specimens composed by precast beam and cast-in situ slab, all curves show similar flexural stiffness and a cracking load of 24, 20 and 17 kN, respectively. The B3-P47/46 specimen reached its maximum capacity before collapsing with a load of 78.2 kN, related to an applied bending moment of 1438.9 kNm at midspan. The maximum applied loads for B8-P47/46 was 81.1 kN, corresponding to a bending moment of 1492.2 kNm. The B4-P47/46 specimen was loaded up to a failure load of 71.4 kN, corresponding to a bending moment of 1313.8 kNm. The B9-P47/46 PC beam collapsed after reaching a maximum load of 64.6 kN, corresponding to a bending moment of 1188.6 kNm. At the maximum applied load, B3-P47/46, B8-P47/46, B4-P47/46 and B9-P47/46 exhibited maximum midspan deflections of 167 mm, 150 mm, 135 mm and 145 mm respectively. The curve of the B3-P47/46 beam shows a load reduction at 75 kN associated to a holding phase required for the visual inspection stage of the cracking pattern. The drop recorded in the response of the B4-P47/46 beam at 72 kN can be associated to a first crushing of the cast in situ slab.

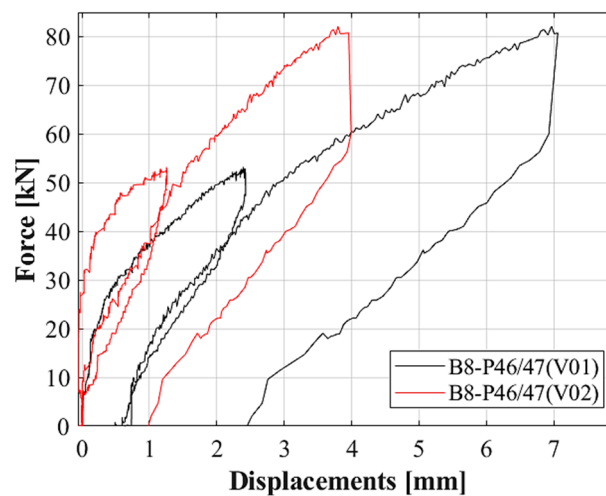
In order to remove vertical displacements from the deflection of the beams due to support settlement, transducers were placed in the support zone (devices V01 and V02 in Figure 9). During the load tests, not relevant settlements were measured at the support level, but their values were taken into account. As an example, the vertical displacements recorded for the B8-P47/46 beam are reported in Figure 13.

Figure 13. Vertical displacements of the support for the B8-P47/46 beam.

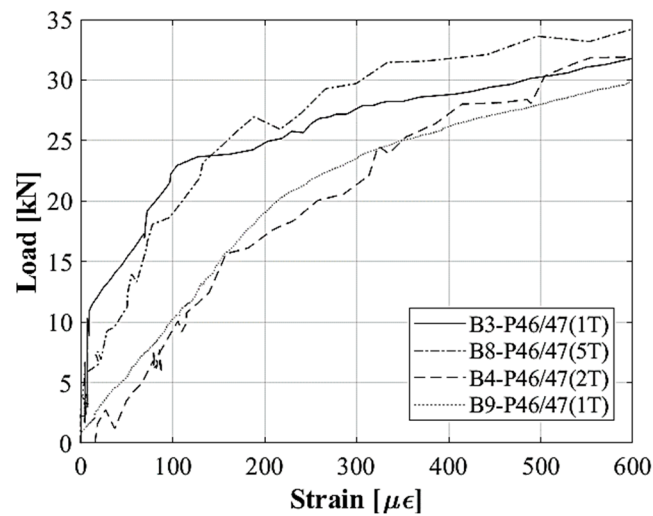
The first cracking load was estimated from the load–strain curve recorded by the LVDTs placed at the bottom flange of the PC specimens in the zone of tension. Figure 14 shows the plot of load versus tensile strain, regarding LVDTs, which recorded the minimum cracking load. To highlight the variation in the slope of the curves, a diagram up to 35 kN is shown. For the B3-P47/46, B8-P47/46, B4-P47/46 and B9-P47/46 beams, cracks began to open at an estimated applied load of 23 kN, 25 kN, 16 kN and 20 kN, respectively.

Figure 14. Applied load versus tensile strain.

It can be observed that each curve starts with a linear trend. Once the applied load is sufficient to cause cracking, the nonlinearity begins and a change in the slope occurs. Figure 15 shows the mapping of the crack pattern recorded at the end of the load tests using markers by manual procedure and then reported in digital format. Typical flexural cracks were detected around the loading zone at the midspan in the region under the transverse steel beams. Cracks formed outside the midspan region present an influence of the shear effect and reveal an inclination toward the loading area. The top region of all the girders shows the crushing of the concrete in compression, which led to the failure. The subsequent collapse involved the whole section as a rigid rotation between two segments of the beam when the applied loading force was not promptly released.

The first cracking estimated by the LVDTs placed in the bottom flange showed some variability among the girders. It is important to observe that the beam B9-P47/46 shows a value of 20 kN, which is also the result of the removal of the cast in situ slab for both its absence in the resistance mechanism and its weight in terms of loading. This first cracking could be also deeply affected by the actual residual prestressing and, in turn, it can be a parameter for its evaluation. The compressive strains reveal a large deformation at the level of the most compressed element of the girder (the cast in situ slab or the top flange) and the analytical evaluation of the neutral axis position allows us to infer that the maximum strain at the top fiber was obviously larger. No valuable slip was measured in the experiments between the concrete at the edges of the girders and the selected unbonded strands, and this reveals an efficient stress transmission and a proper transmission length within this loading scheme. Other strain measurements confirm the outcomes of crack formation and the resisting mechanism evidenced during the loading test up to collapse.

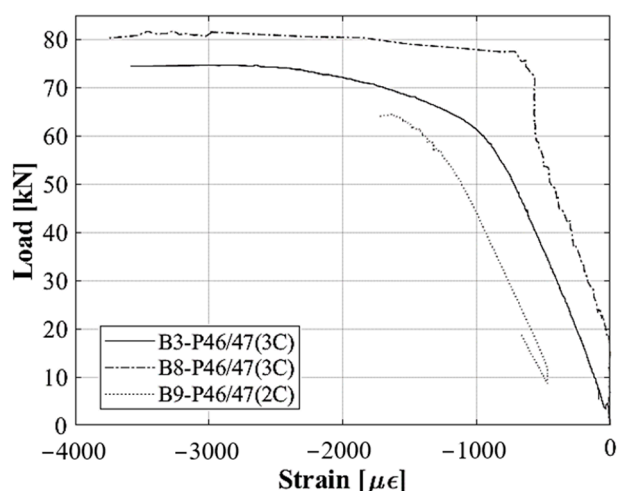
The compressive strain recorded in the top region of the girders is a parameter to study the distribution of strain along the cross-section during the load test and can provide key information on the structural response of the girders during the load test. The continuous strain measurements obtained for the B3-P47/46, B8-P47/46 and B9-P47/46 beams in the top compressed region are presented in Figure 17. The maximum compressive strain recorded at the half of the thickness of the cast in situ slab of the composite sections of B3-P47/46 and B8-P47/46 was $-3.6‰$ and $-3.8‰$, respectively. For the B9-P47/46 beam, the compressive strain recorded at the half of the thickness of the top flange at failure load was $-1.7‰$.

Figure 17. Applied load versus top compressive strain.

For the B8-P47/46 curve, an anomalous behaviour at the beginning of the test was recorded, characterized by a constant strain value with increasing load, and probably linked to a locking of the LVDT supporting frame.

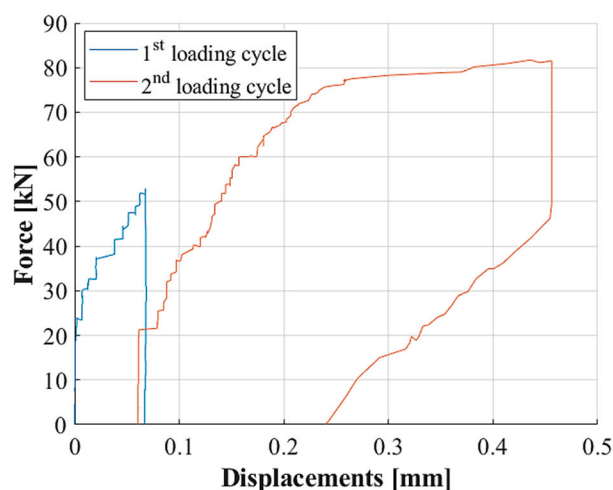
The prestressing force in PC structures is transferred from strand to the concrete due to bond at the strand–concrete interface. If the bond strength degrades over the years, the transfer of effective prestress is affected. In order to evaluate the possible slip of prestressing strands during the load test, the relative displacement between concrete at the end of the beam and the strand unbonded for the first 3 m with the sensors in positions STR-01 and STR-02 (Figure 9) was measured. During the load tests, no significant slipping of the strands was recorded. As an example, the displacements recorded by the sensor STR-02 of the B8-P47/46 beam are reported in Figure 18. The slipping of the strand can be observed starting from a load of 24.05 kN. The maximum value of the slip recorded at failure load is 0.46 mm.

Figure 18. Force–strand slip curves for STR-02 of B8-P47/46.

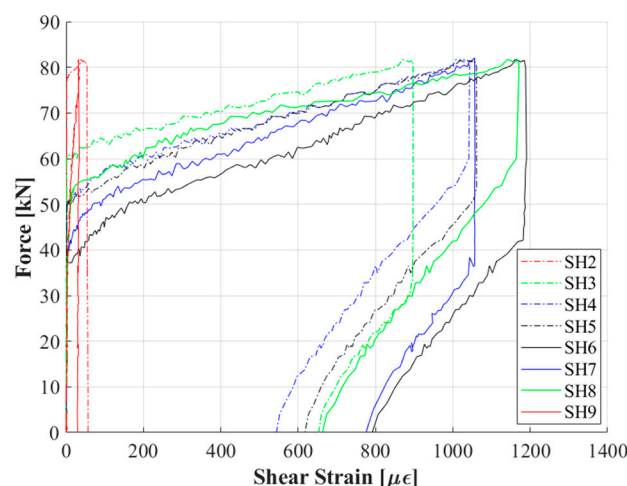
were designed and installed to record shear strains in relevant positions. Figure 19 shows the measurements recorded by the transducers' reading tensile effect belonging to the B8-P47/46 beam. The dashed–dotted lines refer to the sensors installed on the left side of the beam (position A in Figure 9); the solid lines represent the strain recorded on the right side (position B in Figure 9). A correspondence between the dashed and solid lines can be observed, with the exception of SH6 and SH8, which show a slight increase on the right side compared to the left one. Furthermore, a reduction in strain is recorded by moving from the midspan to the support zone.

Figure 19. Tensile shear strain of the B8-P47/46 beam.

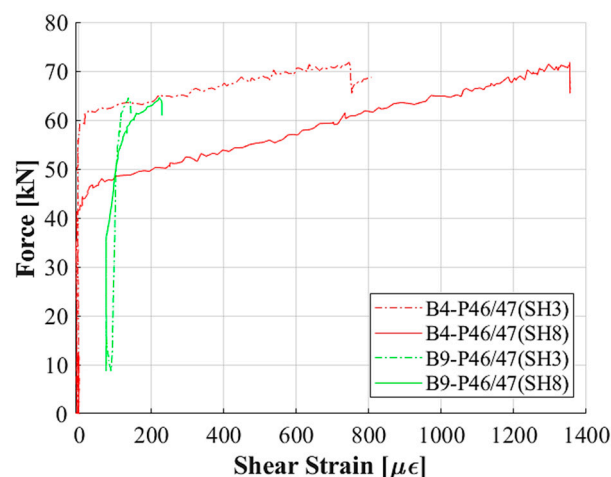
Figure 20 shows a comparison of the tensile shear strains at positions SH3 (A) and SH8 (B) of B4-P47/46 with the cast in situ slab and the B9-P47/46 beam without the cast in situ slab. Lower shear strains are reported for the B9-P47/46 specimen compared to B4-P47/46; this could be due to the different resistance mechanism when approaching the maximum load.

Figure 20. Force–tensile shear strain for SH3 and SH8 for the B4-P47/46 and B9-P47/46 beams.

These results are in line with the crack pattern recorded after the load tests shown in Figure 15. Indeed, the beam B4-P47/46 shows both flexural and shear cracks, whereas the beam B9-P47/46 reveals only few vertical cracks typical of a bending failure mechanism.
