Integrated 3D Mapping and Diagnosis for the Structural Assessment of Architectural Heritage: Morano's Parabolic Arch

# Integrated 3D Mapping and Diagnosis for the Structural Assessment of Architectural Heritage: Morano's Parabolic Arch

This paper illustrates an integrated approach to 3D mapping and structural diagnosis by means of non-destructive testing for the preservation of a historical industrial monument: the parabolic arch of Morano sul Po. This paper reports the results of the non-destructive test campaign carried out on the structure and focuses on the procedures for structuring an integrated approach, which served as the basis to provide guidelines for its conservation.

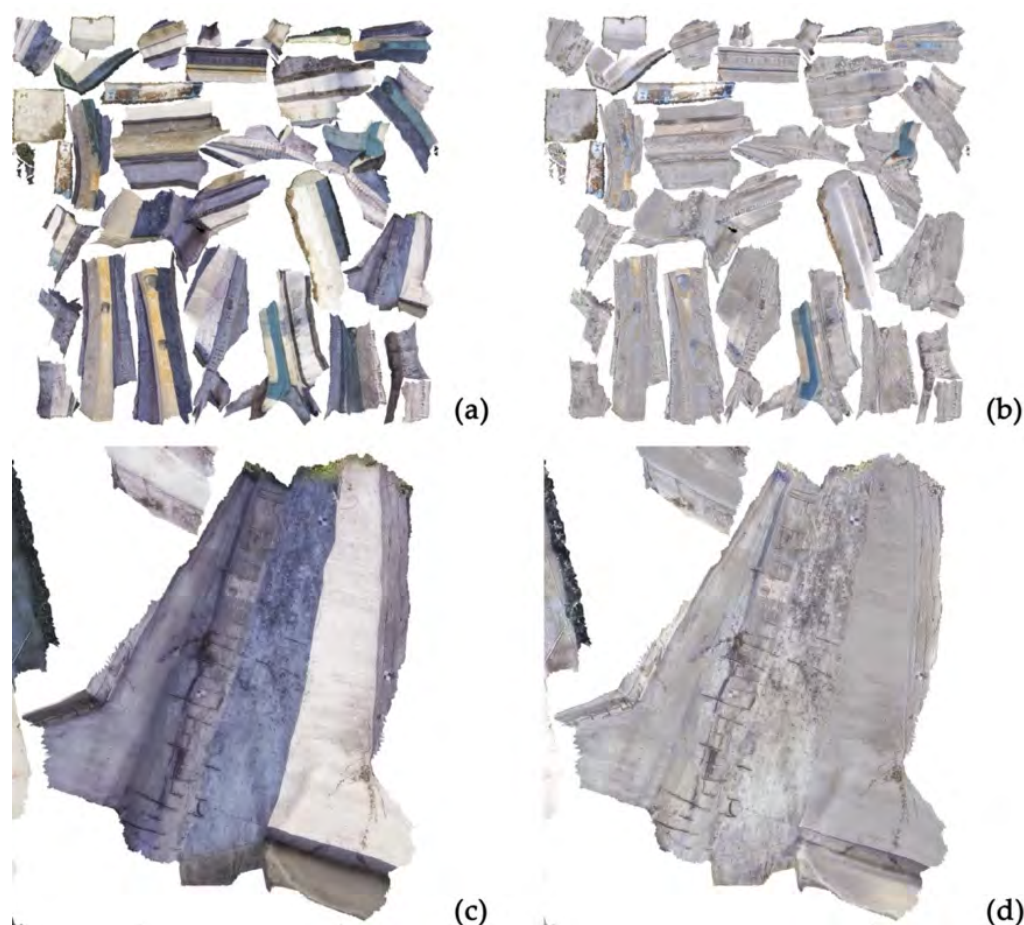
**Figure 6.** (a) Original UV map; (b) UV map after the editing process; (c) detail of the original UV map; (d) detail of the UV map after the editing process.

In order to facilitate the RGB reclassification for the semi-automatic decay detection procedure, the photogrammetric texture was edited with the aim of removing the shadows—due to the different sun exposures characterizing the different surveyed surfaces of the arch—and the radiometric discrepancies caused by the non-homogeneous illumination. As often happens when the data collection is performed in outdoor spaces, the impossibility of managing the lighting may cause the presence of areas characterized by significant differences in terms of radiometry. This can represent a problem for the reclassification task, where the RGB discrepancies are crucial for the proper detection of the analyzed degradation. For this reason, a 3D mesh was computed and a high-resolution UV map was generated (Figure 6). UV mapping is a texturing methodology that consists of projecting a 2D image—namely, the UV map—onto a 3D surface. The UV map is generated by processing oriented images of the photogrammetric block through orthorectifying and mosaicking procedures. Each point on the 2D textured surface corresponds to a vertex on the 3D mesh and is assigned a three-dimensional position, allowing for the texture to be projected onto the model. The UV space uses the Cartesian axes called U and V, while the 3D model is positioned in the XYZ reference system [28].

The generated UV map was processed with the aim of performing a radiometric equalization to homogenize the radiometry of composite elements of the same material but characterized by different solar exposures. This operation was carried out using the Agisoft Delightner platform, which allows for performing the equalization procedure by identifying different samples of underexposed and overexposed areas. The results of this operation can be observed in Figure 6d.

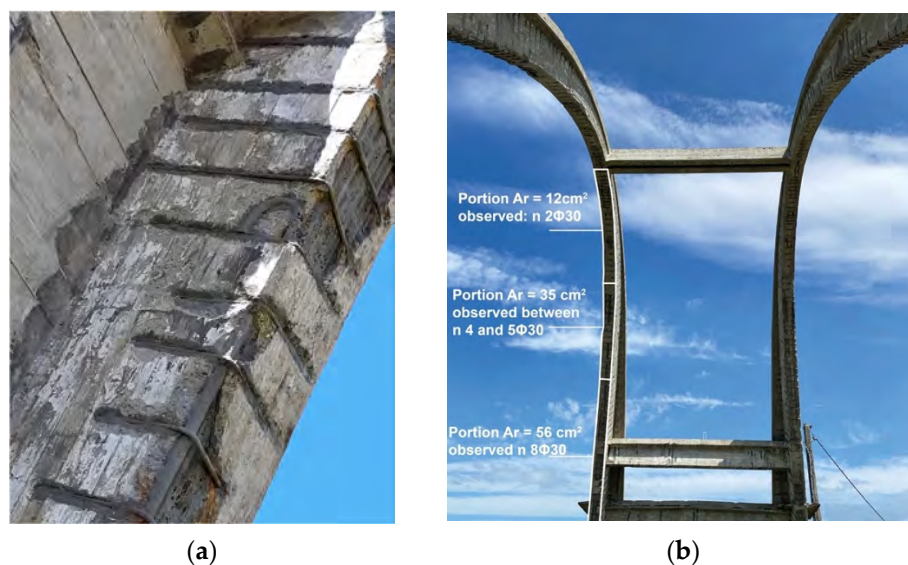
**Figure 9.** (a) Detail of the reinforcements of the arch; (b) measurements of surveyed reinforcements in the different portions of the arches.

Consistent with the design reported in the original drawings, it was observed that the percentage of longitudinal reinforcement decreased from the base toward the key of the arch (Figure 9b).

Pacometric tests allow for non-destructive verification of the presence and number of reinforcements in the structural elements of the work, as well as their orientation and arrangement, while also being able to estimate the thickness of the cover of the investigated elements. It was possible to directly measure the diameter of some of the outermost bars since the iron cover layer was absent in some places of the structure. Further comparison in terms of overall reinforcement area was possible from the design drawings (Figure 2b). The reinforcing bars were smooth with a diameter of 30 mm and had overlapping areas with hooked ends (Figure 9a). The stirrups, also smooth, had a pitch equal to 25 cm and a diameter of 12 mm. Pacometry made it possible to verify the presence of rebar even in areas where the cover was intact.

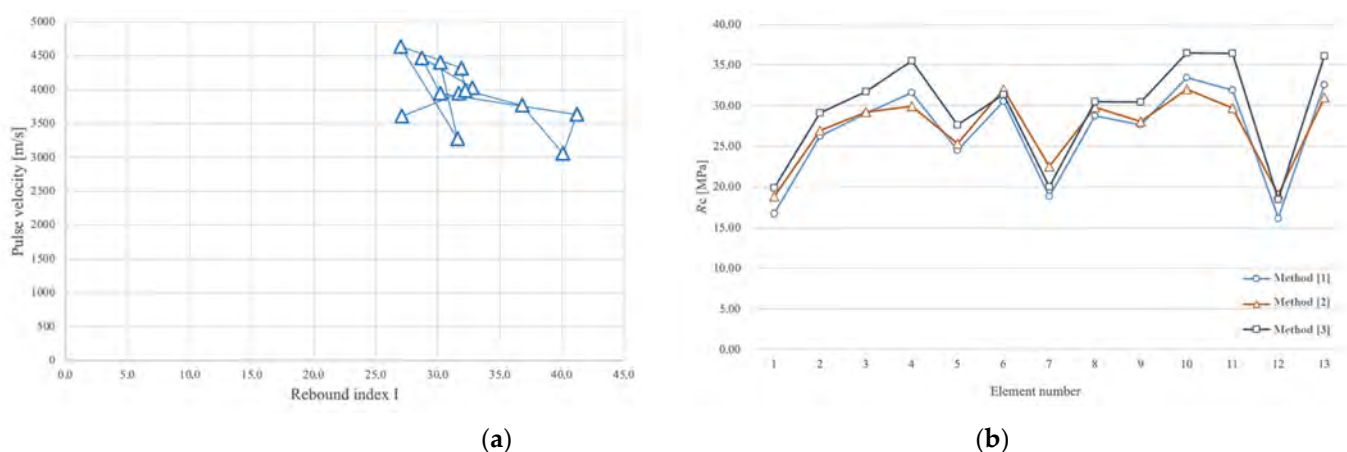
Figure 11a,b shows the results of the SONREB tests in graphical form. As can be seen, the values formed a rather definite cluster, which is generally an indication of a uniform material type.

**Figure 11.** (a) Diagram illustrating the values of the pulse velocities and rebound index; (b) SONREB results in terms of  $R_c$ .

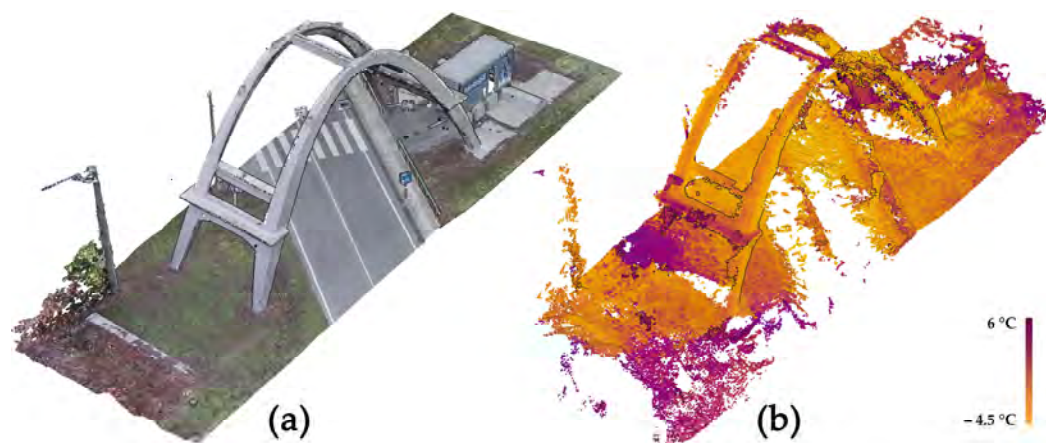
**Figure 14.** (a) Photogrammetric dense point cloud derived from the images acquired from the DJI Zenmuse XT2 visible sensor; (b) photogrammetric dense point cloud derived from the TIR images acquired from the DJI Zenmuse XT2 thermal sensor.

For these reasons, in many cases, the 3D reconstruction derived from the photogrammetric use of TIR images was characterized by a high level of noise and by the presence of numerous topological errors, gaps, or lack of information (Figure 14b). Often it is necessary to follow tailored strategies in order to optimize the results derived from the photogrammetric processing of the acquired thermal images. In most cases, a data fusion strategy is highly recommendable since it exploits the high spatial resolution of visible data (Figure 14a) in order to provide spatial referencing for the thermal information.
