Integrated 3D Mapping and Diagnosis for the Structural Assessment of Architectural Heritage: Morano's Parabolic Arch

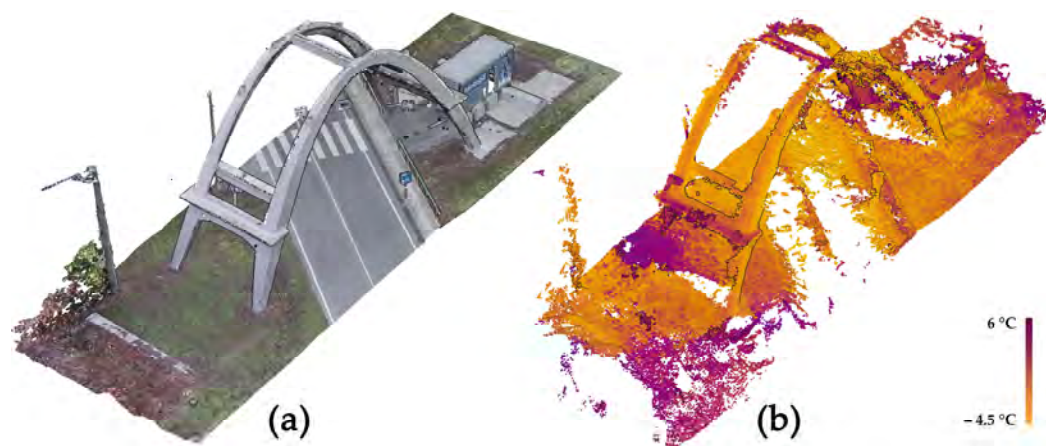
Figure 14. (a) Photogrammetric dense point cloud derived from the images acquired from the DJI Zenmuse XT2 visible sensor; (b) photogrammetric dense point cloud derived from the TIR images acquired from the DJI Zenmuse XT2 thermal sensor.

For these reasons, in many cases, the 3D reconstruction derived from the photogrammetric use of TIR images was characterized by a high level of noise and by the presence of numerous topological errors, gaps, or lack of information (Figure 14b). Often it is necessary to follow tailored strategies in order to optimize the results derived from the photogrammetric processing of the acquired thermal images. In most cases, a data fusion strategy is highly recommendable since it exploits the high spatial resolution of visible data (Figure 14a) in order to provide spatial referencing for the thermal information.

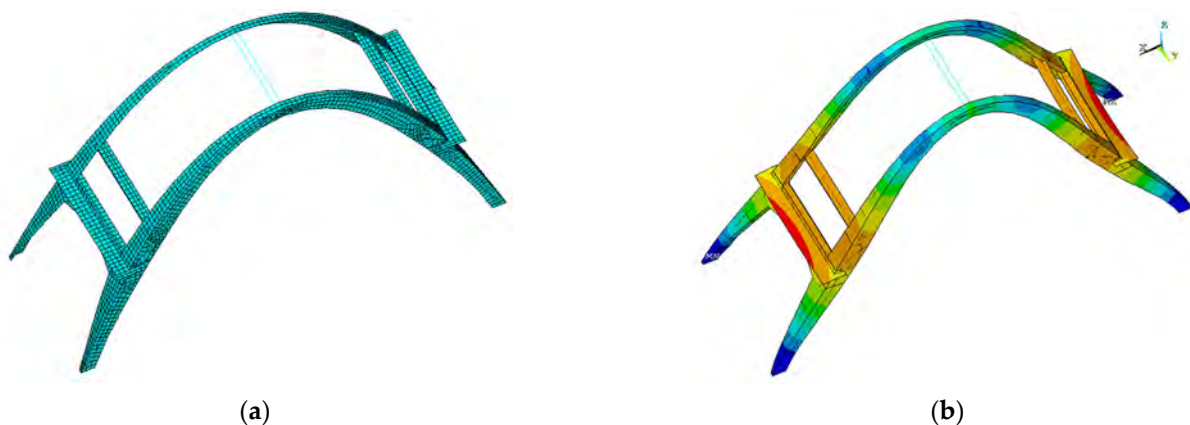
Figure 16a,b reports a view of the FE meshed model and the results of the static analysis, respectively. Overall, the distribution of deformations and stresses confirmed the substantial symmetry of the structure. The deformed shape of the structure indicated that the arch experienced its maximum deformation around the middle portion of the arches, in particular, at the joint with the beams.

Figure 16. (a) View of the 3D finite element modeling of the arch; (b) results of the static analysis that identified the static deformations of the structure (the scale goes to blue, deformations close to zero, to red, were the maximum deformations appear).
