Land reclamation at an opencast Italian asbestos mine: some problems recently faced

Land reclamation at an opencast Italian asbestos mine: some problems recently faced / Bergamini, M., Chiaia, B., Lovera, E., Manzone, G., Patrucco, M.. - 1:(2006), pp. 267-274. (Mine Planning and Equipment Selection (MPES 2006) Torino (ITALY) 20 - 22 settembre).

# Land reclamation at an opencast Italian asbestos mine: some problems recently faced

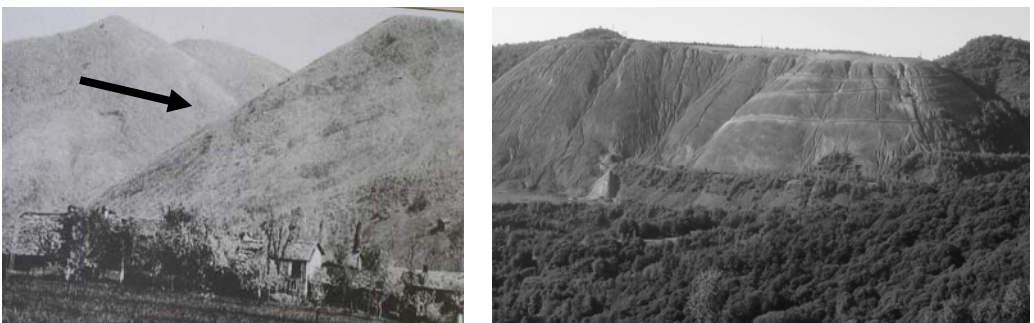
Figure 2. On the left, a 1945 picture of the Fandaglia Valley, the area destined to host the second dump of Balangero mine. On the right the same area as appears today, after a first stage of rehabilitation works.

A serious problem the Balangero mining company had to face was the dumping of both exploitation wastes and processing tailings. Huge volumes of material were involved and the result, in terms of landscape reshaping, is impressive (Fig. 2).

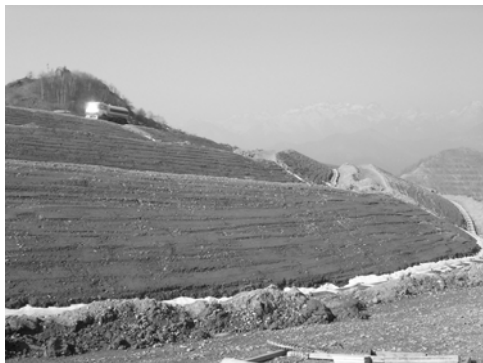
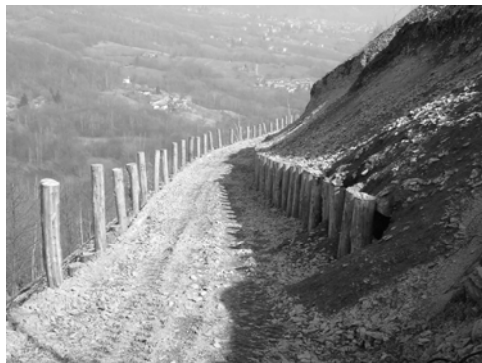
Figure 3. On the left, The reshaping of the upper part of the dump: the benches and the draining works are well visible. On the right, the berms created in the central part of the slope, to stabilize the dump body and intercept the run-off.

- reshaping of the upper part of the slope through the creation of 3 large benches (10 m height, 32° slope), and water control with draining channels (Fig. 3);
- run-off control in the central part of the slope through the creation of a number of little berms (3-4 m large) distant 30-40 m from each other (Fig. 3);
- reshaping of the toe of the slope and creation of a sedimentation basin where all the water drained along the slope has to be collected before reaching the Fandaglia river;
- starting the natural growing of vegetation through a first artificial planting.

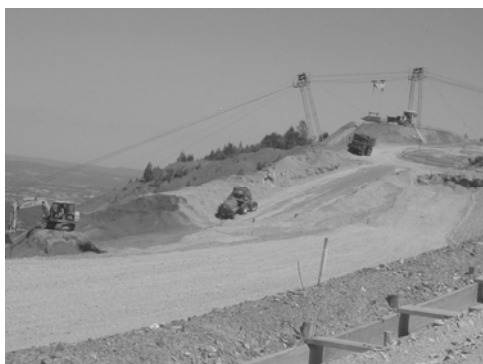
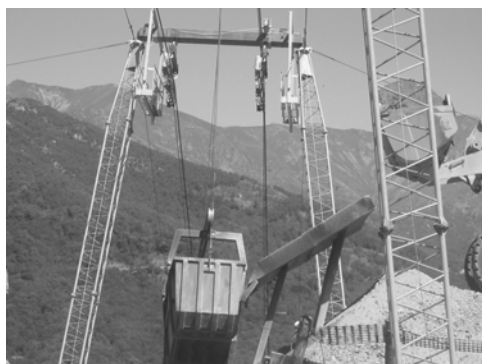
Figure 4. The earth-moving organization in the upper floor of the dump. On the right, a particular of the loading operation of one bucket of the ropeway.

A very critical phase of the work was the earthmoving, due to the topographic set and to the characteristic of the material to be moved. The final work organization resulted in (Fig. 4):

- a main transportation system based on a two-cable ropeway, with independent haulage ropes, single bucket capacity of 3 m<sup>3</sup>, capable of approx. 50 m<sup>3</sup>/h on a descent of 400 m;
- an earth moving organization on the upper part of the slope, based on a hydraulic excavator (bucket 0.8 m<sup>3</sup>), 2 trucks (capacity 12 m<sup>3</sup>), 1 wheel loader (bucket 0.8 m<sup>3</sup>).

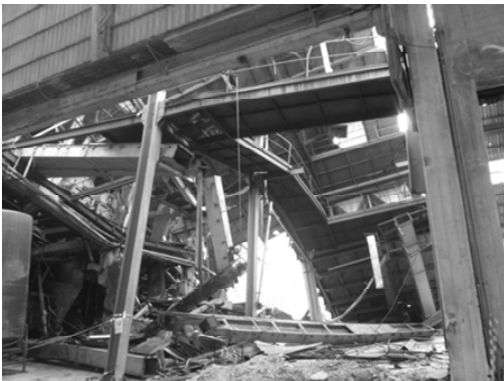
Figure 5. Partial collapse of the steel/reinforced concrete structures sustaining Building “A”.

The building fell down in the past and is not recoverable (Fig. 5). Moreover, previous actions were carried out to remove plants and part of the load-carrying steel members. However, damage is only partial and further sudden collapses cannot be excluded. Although the area is easily reachable from the ground level, the presence of plants and relicts fully impregnated of asbestos forces to choose a sequence of removal operations alternated with induced highly-controlled partial collapses.

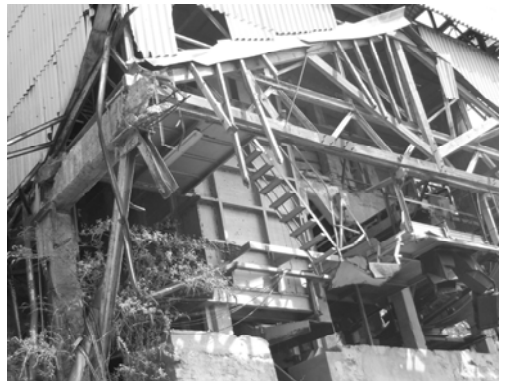
Figure 6. The state of building “B” showing the incipient risk for collapse.

The building is densely occupied with plants containing a high quantity of asbestos fibres. It is the remaining part of a larger building partially demolished during a wrong operation which did not take into account the static characteristics of the frames (Fig. 6). The base of the building, on the valley side, rests on the remaining parts of two cantilever beams (in the original static scheme they were beams supported at both sides), stiffened by means of diagonal steel members. These two beams are severely damaged in correspondence of the support on the columns, due to a combined shear-flexural effect due to the modification of the static scheme. Collapse of these beams would presumably provoke the collapse of the entire building due to domino effect.
