Land reclamation at an opencast Italian asbestos mine: some problems recently faced

Land reclamation at an opencast Italian asbestos mine: some problems recently faced / Bergamini, M; Chiaia, Bernardino; Lovera, E; Manzone, Giuseppe; Patrucco, Mario. - 1:(2006), pp. 267-274. (Mine Planning and Equipment Selection (MPES 2006) Torino (ITALY) 20 - 22 settembre).

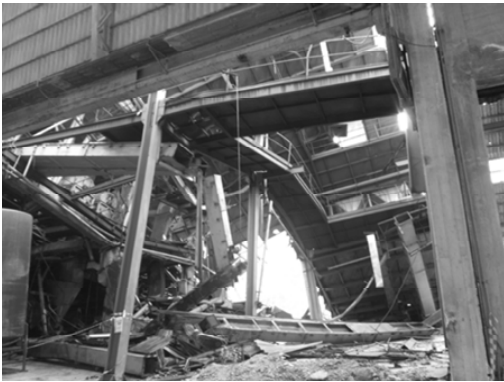
Figure 5. Partial collapse of the steel/reinforced concrete structures sustaining Building “A”.

The building fell down in the past and is not recoverable (Fig. 5). Moreover, previous actions were carried out to remove plants and part of the load-carrying steel members. However, damage is only partial and further sudden collapses cannot be excluded. Although the area is easily reachable from the ground level, the presence of plants and relicts fully impregnated of asbestos forces to choose a sequence of removal operations alternated with induced highly-controlled partial collapses.

Due to the highly dangerous and chaotic situation, controlled demolition shall be executed with the help of telescopic equipments remotely controlled, with a sequence of removal operations starting from the upper parts to the lower ones. The correct determination of the collapse kinematics appears of great importance, to avoid uncontrolled asbestos dispersion due to uncontrolled collapses. For the same reason, we suggest that, in any case, selective removal of relicts, although more time-demanding, should always be preferred to induced collapses.
