The Influence of the Climatic Factors on the Decay of Marbles: an Experimental Study

Paola Marini, Rossana Bellopede

DITAG – Dipartimento del Territorio, dell’Ambiente e delle Geotecnologie  
Politecnico di Torino – C.so Duca degli Abruzzi 24, 10129 - Torino, Italy

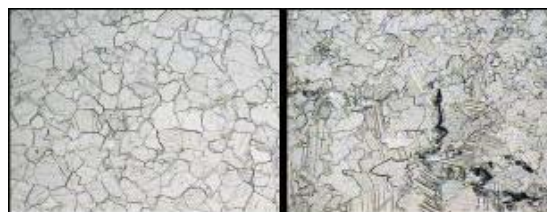
Fig. 2: Microphoto of a granoblastic marble (on the left) and a xenoblastic marble (on the right). Real dimensions 1,9x2,5 mm.

tendency to decay while xenoblastic (allotriomorphic habit) have lower (Fig. 2).

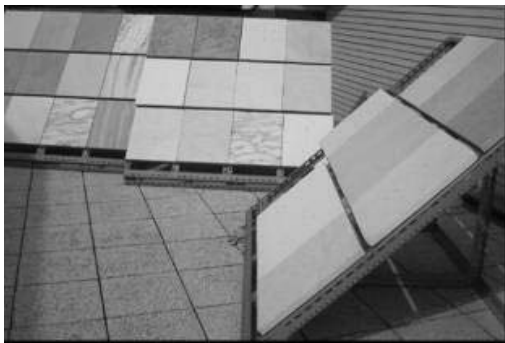
Fig. 4: Marble slabs toward West exposition. On the right of the picture the slabs exposed toward North.

Several marble slabs have been located on a large terrace of the Politecnico di Torino, free from covers and far from the ground, positioned toward the four main orientations and have been inserted in a metal structure with interposition of rubber prisms to insulate the metal structure from the slabs, in order to prevent transmitting of the UPV signal (Fig. 4).

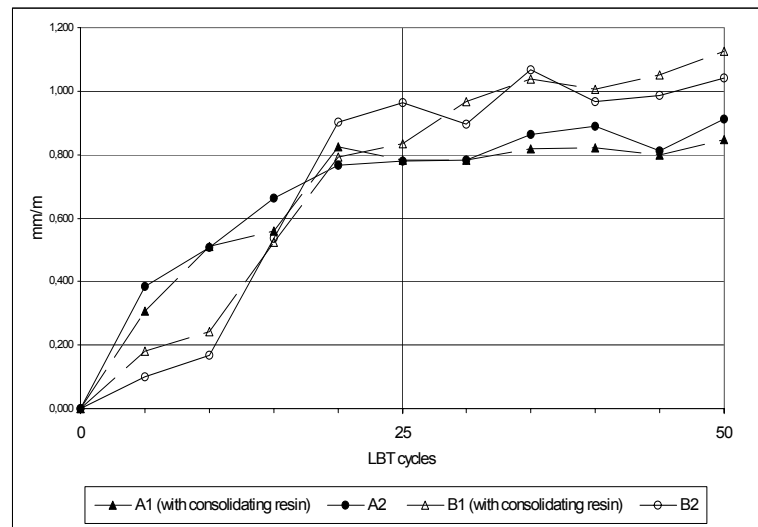
Fig. 13: Bowing measurements on specimens of Carrara marbles "A" and "B" after subsequent cycles of Lab - Bow Test.

In the figure 13 the data of bowing after Lab-Bow Test (LBT) on two different slabs of Carrara marbles (A and B) used on façade are reported.

The research highlights the bowing phenomenon as an evolutive mechanism and this is confirmed by the numerous artificially ageing cycles executed in laboratory. The slab A, that already bowed in situ, after 25 cycles decreases its trend to bowing (Fig. 13). The slab B, not already deformed in situ, reaches a higher bowing but shows the same trend o the slab A in the last 25 cycles. To confirm the bowing results, the UPV and flexural strength of slab B after 50 cycles hardly decrease compared to natural condition, while the
