The Influence of the Climatic Factors on the Decay of Marbles: an Experimental Study

Paola Marini, Rossana Bellopede

DITAG – Dipartimento del Territorio, dell’Ambiente e delle Geotecnologie
Politecnico di Torino – C.so Duca degli Abruzzi 24, 10129 - Torino, Italy

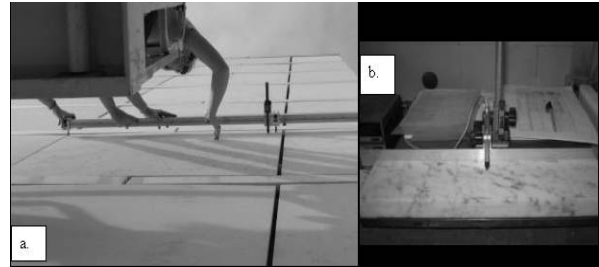
Fig. 3: a. In situ bow-meter - b. Laboratory bow-meter.

For the in situ measurements on the slabs a bow-meter designed and manufactured within the TEAM Project has been used, shown in Figure 3a. It is made of two aluminium elements that run along a graduated bar 168mm long. Along the bow-meter a digital calliper, with a precision of 0,01mm, is placed on a mobile track able to reach every point along the bow-meter and measure the size of bowing of the slab.

The laboratory measurements have been performed by means of a digital micrometer calliper on a reference plane where the specimen is placed (Fig. 3b). The value of bowing is given in mm/m.

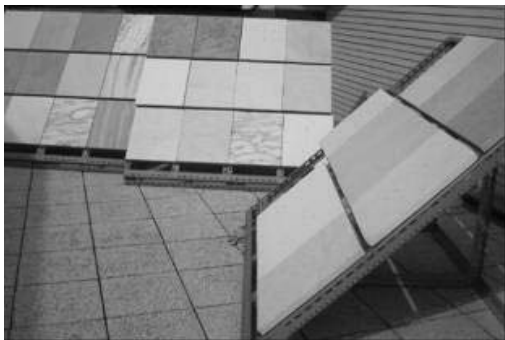
Fig. 4: Marble slabs toward West exposition. On the right of the picture the slabs exposed toward North.

Several marble slabs have been located on a large terrace of the Politecnico di Torino, free from covers and far from the ground, positioned toward the four main orientations and have been inserted in a metal structure with interposition of rubber prisms to insulate the metal structure from the slabs, in order to prevent transmitting of the UPV signal (Fig. 4).

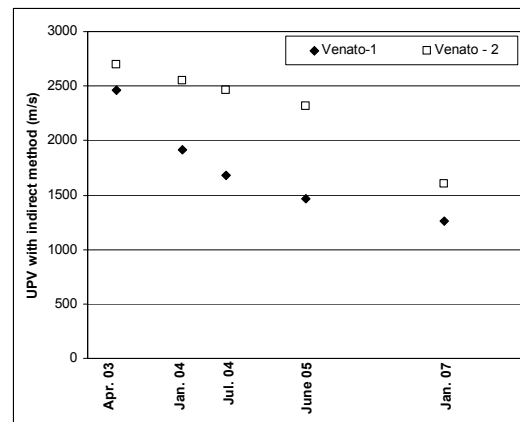
Fig. 5: UPV measurements (mean values) at different decay steps on two Venato marble slabs (West exposition).

The Venato marble shows a decreasing of UPV values already after 9 months of exposition and reaches -48% after 45 months of exposition (Fig. 5). The measurements of bowing after 45 months of exposition show a different behaviour for the two slabs: Venato 1 has a convex bowing of 0,44 mm/m while Venato 2 has a concave bowing of 0,62 mm/m, that is to say that both

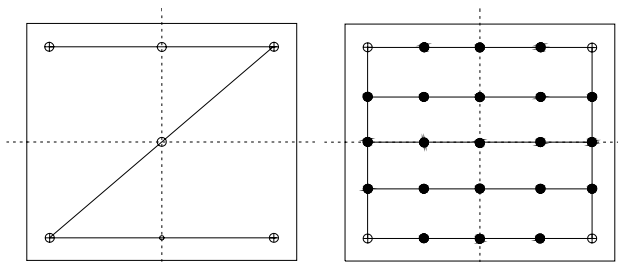
Fig 6: Measurement schemes of bowing in situ (on the left) and in laboratory (on the right). For the laboratory measurements the white circles indicate the points of support of bow-meter and the black one the points of measure.

The measurements of bowing by means of bow meter have been executed both in situ and in laboratory in accordance with the schemes reported in the Figure 6.

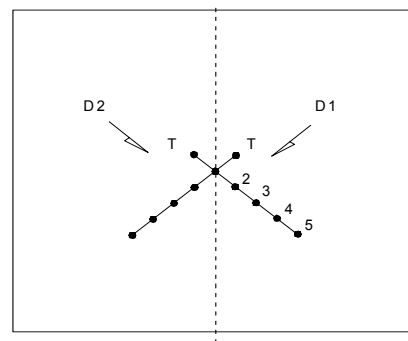
Fig. 7: Measurement scheme of UPV .

For the UPV measurements the points of measure have been positioned as in Figure 7 with a distance among them of 80mm.

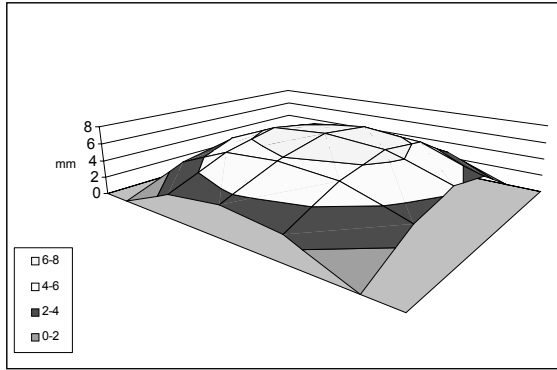
Fig. 8: Typical spherical bowing measured on S-E S-W exposed marble slabs of the modern building.

The slabs oriented to S-E and S-W show an high spherical bowing (76% of slabs tested $\geq 6\text{mm}$ -Fig. 8), those on a turret show cylindrical bowing of medium-low grade ($< 6\text{mm}$ - Fig. 9) and, finally near to zero was the bowing for the internal and sheltered slabs.

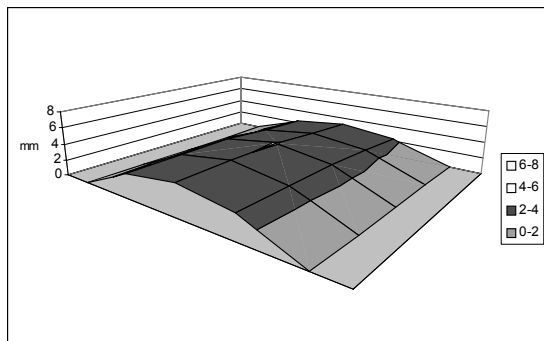
Fig. 9: Typical cylindrical bowing measured on marble slabs of the turret the modern building.

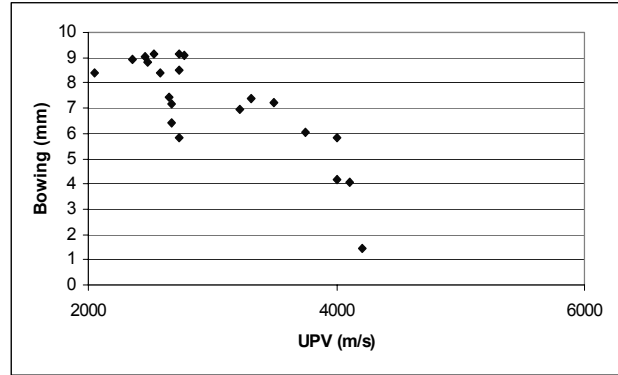
Fig. 10: Bowing versus UPV measurements for the marble façade slabs of a modern building exposed to S-E -S-W.

In the Figure 10 and 11 respectively the correlations Bowing - UPV and - Bowing-Wa for the façade slabs S-E S-W are reported. With the increasing of bowing the UPV values decrease and the Wa increase.

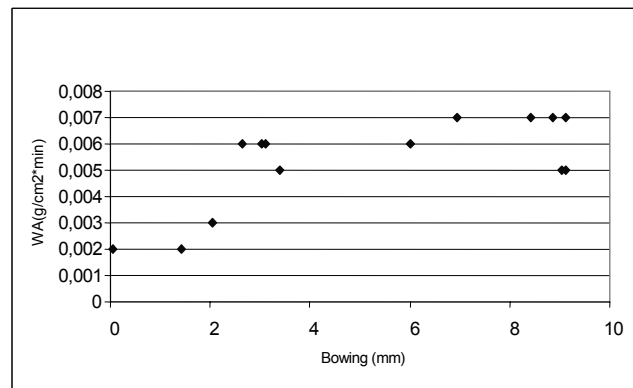
Fig. 11: Bowing versus Wa measurements for the marble façade slabs of a modern building exposed to S-E -S-W.

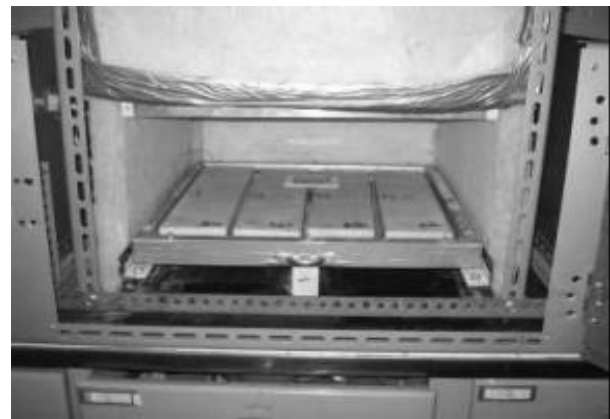
Fig. 12: Apparatus for the execution of the Lab Bow test.

To reproduce in laboratory the effects of water and temperature on the marble specimens the Lab- Bow Test has been carried out. It is a durability test and has been performed according to the North Test Method Build 499 2002 Cladding panels test for bowing (Fig.12). The specimens of dimensions 400x100x30mm positioned on a wet sand and their upper face is heated by means of infrared lamps. During the cycle the temperature increases from 20°C to 80°C in 4 hours, it is kept constant for 3 hours and then it decreases to 20°C in 18 hours. The relative bowing is measured every cycle till the 5 and then every 5 cycles. A maximum of 50 cycles have been performed on 4 specimens cut from 2 different slabs. In particular the specimens named A are cut from a slab showing 5,5mm of bowing in situ, while the specimens B are cut from a slab without bowing in situ.
