The Influence of the Climatic Factors on the Decay of Marbles: an Experimental Study

Paola Marini, Rossana Bellopede

DITAG – Dipartimento del Territorio, dell'Ambiente e delle Geotecnologie
Politecnico di Torino – C.so Duca degli Abruzzi 24, 10129 - Torino, Italy

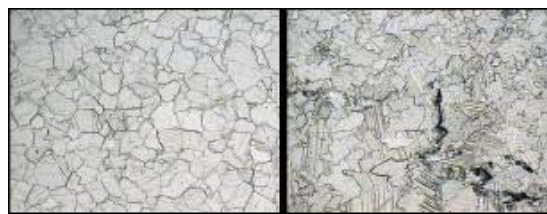
Fig. 2: Microphoto of a granoblastic marble (on the left) and a xenoblastic marble (on the right). Real dimensions 1,9x2,5 mm.

tendency to decay while xenoblastic (allotriomorphic habit) have lower (Fig. 2).

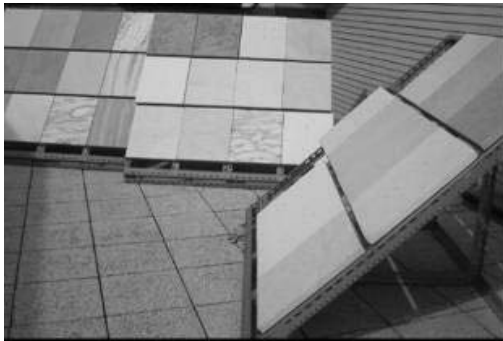
Fig. 4: Marble slabs toward West exposition. On the right of the picture the slabs exposed toward North.

Several marble slabs have been located on a large terrace of the Politecnico di Torino, free from covers and far from the ground, positioned toward the four main orientations and have been inserted in a metal structure with interposition of rubber prisms to insulate the metal structure from the slabs, in order to prevent transmitting of the UPV signal (Fig. 4).

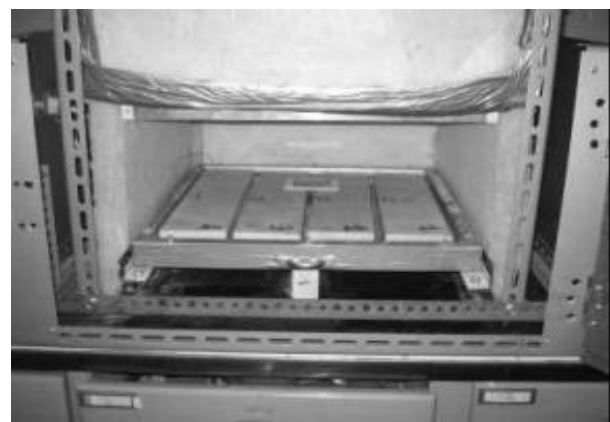
Fig. 12: Apparatus for the execution of the Lab Bow test.

To reproduce in laboratory the effects of water and temperature on the marble specimens the Lab- Bow Test has been carried out. It is a durability test and has been performed according to the North Test Method Build 499 2002 Cladding panels test for bowing (Fig. 12). The specimens of dimensions 400x100x30mm positioned on a wet sand and their upper face is heated by means of infrared lamps. During the cycle the temperature increases from 20°C to 80°C in 4 hours, it is kept constant for 3 hours and then it decreases to 20°C in 18 hours. The relative bowing is measured every cycle till the 5 and then every 5 cycles. A maximum of 50 cycles have been performed on 4 specimens cut from 2 different slabs. In particular the specimens named A are cut from a slab showing 5,5mm of bowing in situ, while the specimens B are cut from a slab without bowing in situ.
