Non contact wear measurement on pneumatic seals

G. Belforte, L. Mazza, C. Visconte

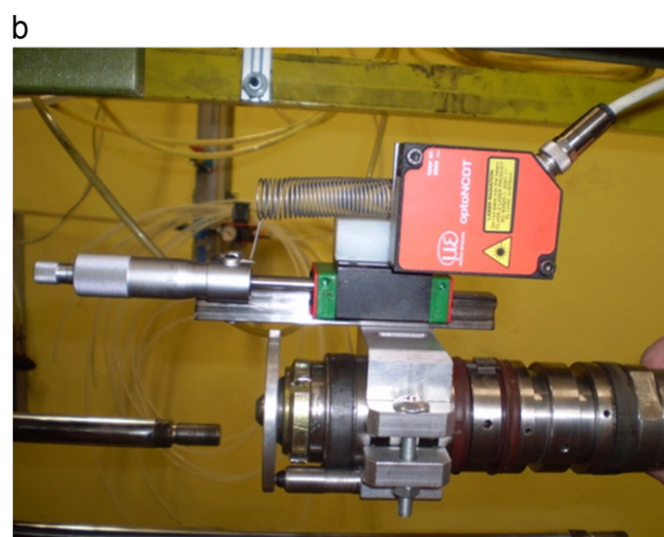
Fig. 2. Wear measuring device, equipped with a laser displacement sensor: (a) scheme; (b) manufactured equipment.

A scheme of the measuring device is shown in Fig. 2(a). Element (1) had the aim of centring the measuring device on the piston; a linear precision guide (2), actuated by a micrometric screw (3), drove the axial displacement of a laser sensor (4). Consequently, the laser beam (5), perpendicular to the piston axis, could investigate the seal lip surface at various axial positions. A dividing head (6) and a dowel pin (7) were provided in order to turn the centring element (1) about the piston, so as to perform circumferential measurements. This latter degree of freedom was provided to evaluate if a uniform wear profile could be detected around the seal lip. The laser displacement sensor had a beam diameter of 0.3 mm, a measuring range of 20 mm and a resolution of 4 μm .

Fig. 2(b) shows the manufactured measuring equipment, assembled on the piston during an experimental test.
