# 4. Analysis and monitoring of oval domes

# 4.1 Geometry and structural peculiarities of oval domes

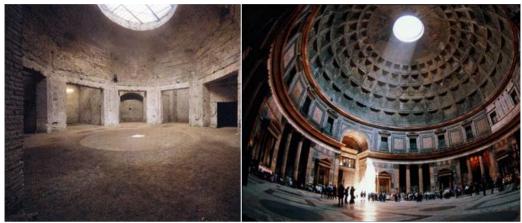
The Pantheon in Rome (Figure 4.1) is the first notorious example of dome: it is a very simple structure made of a cylinder (the Rotunda) and a hemispheric dome of the same diameter (around 43 m), though at the same time it is full of intuition and innovation [2]. From inside the dome is clearly a hemisphere where the meridians spring vertically from the cylinder itself. From the outside, the cylinder appears higher than from inside and the dome emerges from the cornice with a flatter shape. It is interesting to note

that the "steps" visible on the extrados of the dome are not an architectural choice but the consequence of the technique of pouring the concrete in subsequent rings. From outside, the cylinder appears as a big brick wall, containing within its thickness a series of arches which inside correspond to niches and empty spaces.

Figure 4.1 - Dome of the Octagonal room (left), Pantheon (right).

The first examples of domes date back to 4000 BC in Mesopotamia, realised by cantilevering layers of masonry from a circular or oval plant and achieving the top of the building. These domes were of the type that nowadays we refer to as "false domes". Few examples of domes can be found in Egyptian and Greek architecture [1]. In fact it is only during the Roman age that the concept of arch and dome were explored and used in any type of application. The arch has probably been the most important innovation in the history of architecture, transforming, thanks to the curvature associated with the thrust at the springs, bending moments in compression forces, even if a certain bending strength is indispensable to maintain a stable shape. Spatial vaults (usually with circular, square or polygonal bases) are a development of the arch concept. Their particularly satisfactory behaviour is due to the double curvature and mainly to the hoop effect of horizontal rings. As previously stated, the first real domes arise and develop with the Romans and the dome of the Octagonal Room in the Domus Aurea (I century) is the first important example (Figure 4.1).

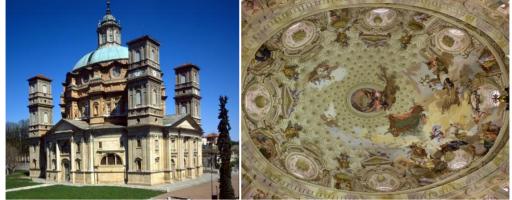
The Sanctuary of Vicoforte, near Mondovi (Cuneo, Italy), is a building of great historical, architectural, and structural significance, owing its fame primarily to the great masonry elliptical dome (Figure 4.12), which is the biggest in the world of this shape in terms of overall dimensions (internal axes 37.23 by 24.89 m).

Figure 4.12 - The Sanctuary of Vicoforte (left). The interior of the dome (right).

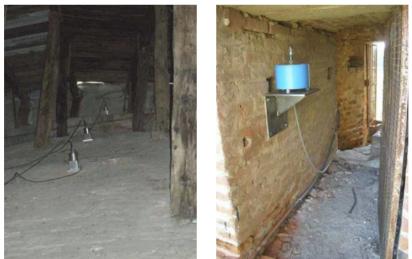
Figure 4.17 - Examples of accelerometers and geophones placement: (a) on the top of the dome and (b) on a column.

The data acquisition campaign at the Sanctuary of Vicoforte was performed by Eucentre, Pavia, in June 2008 [29]. The tests were executed by means of 4 Lennartz 3D/5s triaxial geophones with a sensitivity of 400 V/m/s and 5 PCB 393B31 ICP piezoelectric accelerometers with a sensitivity of 10 V/g. The signals of the transducers have been digitalized through a multiplexer SCXI1140 and an A/D PCI National Instruments converter with a resolution of 16 bit. Different sampling frequencies were used in the acquisitions.

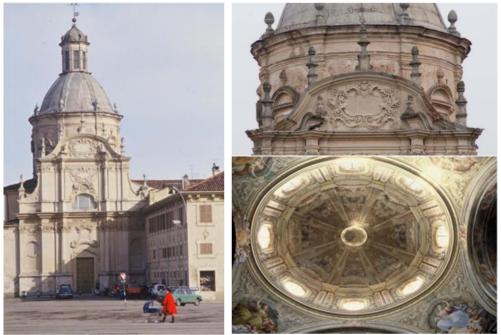
The dome presents a slender lantern 5 m tall which recalls the structure of the dome; in fact it has 8 pilasters, one for each buttress. The roof of the lantern is again a little masonry dome. The richly decorated Baroque façade has a jut which exceeds the height of the church body of 6 m.

The old choir has dimensions in plant of 10 m by 22 m and it is covered by a barrel vault, reinforced through the use of regularly distanced round arches in correspondence of the pilasters and by using metal chains.

Figure 4.30 - Santa Caterina in Casale Monferrato.

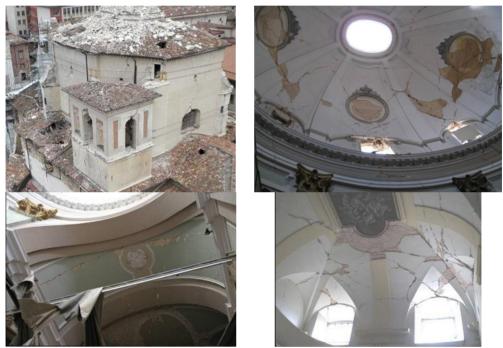
Figure 4.36 - Damage due to the 2009 earthquake: (a) Lantern completely destroyed, the damage on the tiburio and on the bell tower, (b) Damage on the dome's groins, (c) detachment between the main body and the dome, (d) Vault of the sacristy.

The earthquake of April 2009 has severely damaged the church. In accordance with the Directive PCM a survey of the damage has been conducted by Prof. Lagomarsino and his team [41]. The whole structure suffered heavy damage by the earthquake but, in particular, the lantern was completely destroyed by the earthquake (see figure 4.36a). The roofing of the lantern was rebuilt during the 80s using steel trusses and an edge beam in concrete to connect it to the masonry structure.

Other damage mechanisms were also activated: the façade shows the initiation of a tilting mechanism and several cracks are present in the apse, the presbytery and in the lateral chapels. The annexed bodies were heavily damaged too, such as in the case of the sacristy vault and its walls.
