# Terrestrial Laser Scanning and Settled Techniques: a Support to Detect Pathologies and Safety Conditions of Timber Structures

**Keywords:** Cultural Heritage, Wood dome, Structural assessment, Digital Photogrammetry, Laser survey, Orthophoto.

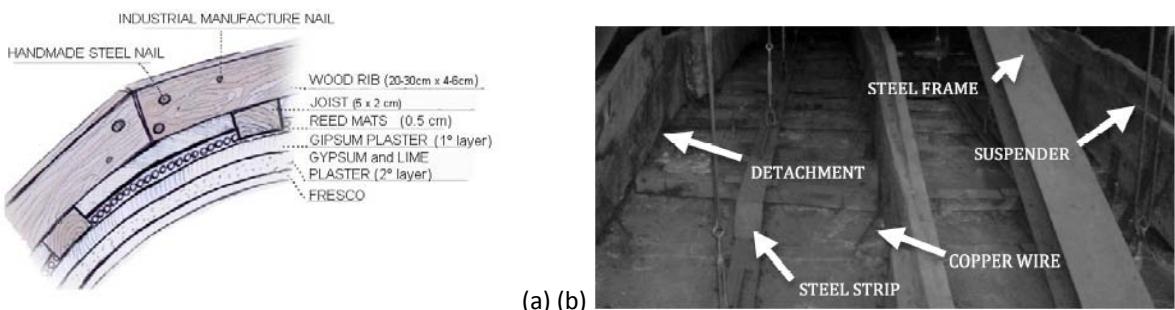
Figure 1: Scheme of "camorcanna" layers [5] (a), extrados of the Hall of Honor (b) of the Valentino Castle.

The principal structure is the above wood rib frame (Fig. 1a) that rules the curved shape of the dome. Each rib is obtained joining together two or more shaped planks with steel nails. The wood planks are 3 – 6 cm thick, 20 – 40 cm wide, and usually 2 – 3 m long. The rib spacing is around 0.7 m. The ribs are connected with steel nails to the underlying orthogonal wood joists. Joist section is 5 cm wide and 2 cm height. The joist spacing is around 25 cm. The continuous reed mat is hanging on the joists, and realizes the surface for the subsequent layers of plaster and stucco for the frescoes.

recently the roof structure was renewed and a steel frame structure was placed above the dome, and connected, with vertical suspender cables, to iron strips that were screwed to the little wood carpentry. (Fig. 1b) Nowadays, a survey revealed that the suspender cables above the vault in the region close to the abutments have lost their tension. This may indicate an increase of the vault deformation; therefore a structural assessment of the dome is mandatory.

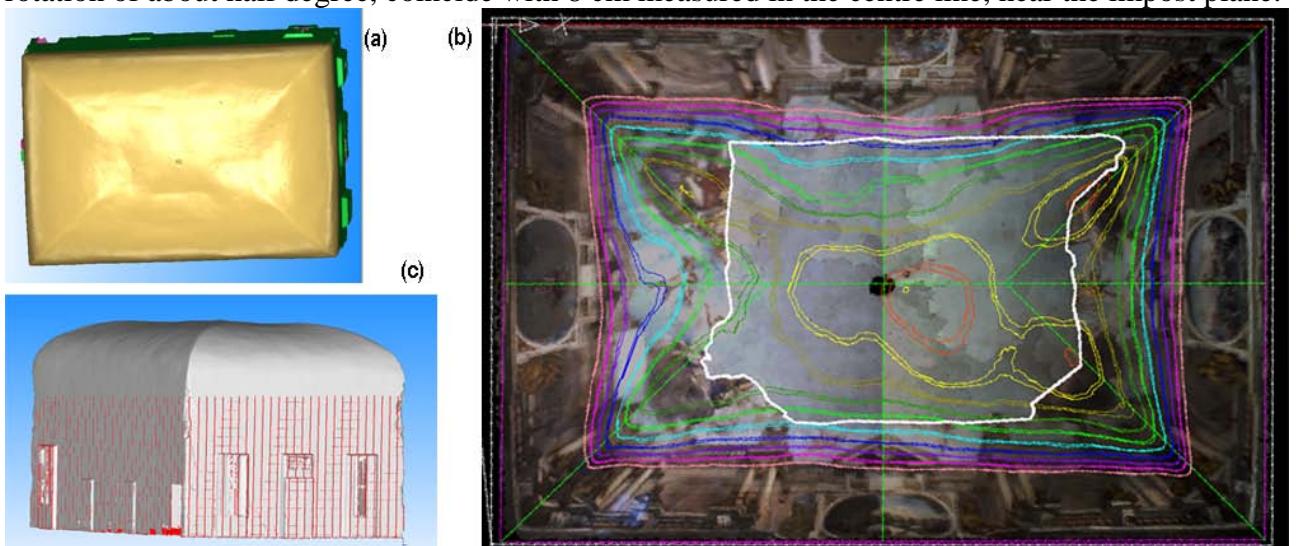
Figure 2: A nadiral view of the mesh model of dome for visual control of subsidence (a); the final orthophoto of the dome intradox, obtained by a mosaic of projected photograph with the superimposition of the section profiles and the signs of prior restorations (b) Total mesh model and sections profiles on walls.(c)

For the clear pavilion surface of the Hall of Honor, which is decorated by rich frescos and not by plastic ornamental elements, we performed the laser survey acquisition using a phase based scanner (LEICA HDS6100 [7] The points model, after processes that fulfilled the complete cleaning and optimization of surface accuracy, describes the only interesting surfaces: floor, walls and vault. From laser model a large number of revealing profiles belonging to multiple section planes have been detected with the aim of analyzing the curves trends and spotting the anomalies and subsidence of the vault. Some irregularities are visually observable in the mesh model. (Fig 2a)

Furthermore the points model have been used to derive a Digital Elevation Model (DEM) useful for the orthophoto generation. In fact, the metric image texturing has been faced by a digital photogrammetry project; 8 images organized in two stripes have been acquired by self calibrated camera (Canon EOS 1Ds), then they have been oriented using a bundle adjustment process and projected using the DEM. In this way we obtained the complete removal of the huge chandelier encumbrance. The final orthophoto enable to detect the exact location and extension of restoration signs on vault frescos. The surface contours of the vault are computed with an equidistance of 5 cm and pertain horizontal planes: they present an high level of geometrical aberration. The location of height anomalies obtained from the laser model, and the shape of the frescos abrupton outlined in the orthophoto, are in good agreement; it is observable because results are reported to the same reference system (Fig. 2b).

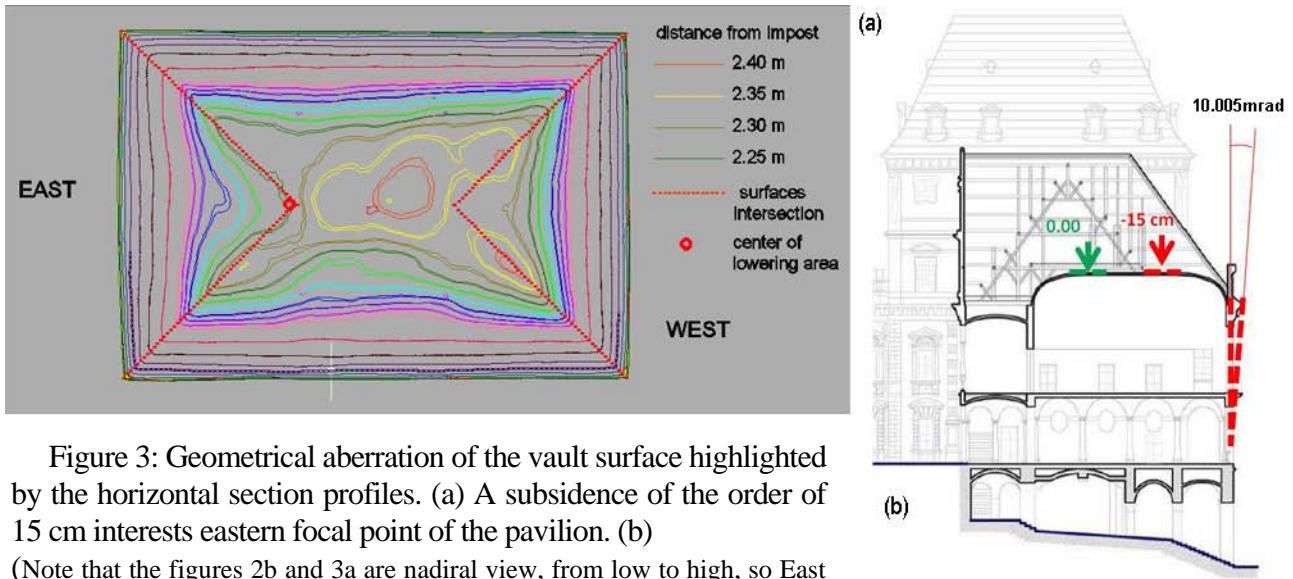
Figure 3: Geometrical aberration of the vault surface highlighted by the horizontal section profiles. (a) A subsidence of the order of 15 cm interests eastern focal point of the pavilion. (b) (Note that the figures 2b and 3a are nadiral view, from low to high, so East is in the left and west is on the right).

We can estimate the greater loss of the original geometrical shape in the subsiding area near eastern point of intersection of the cylinders of pavilion (red spot in Fig. 3a). Adding to the XXth restorations, this asymmetric subsidence may be related to a general rotation of eastern perimeter wall, that we observed and measured by means of the section profiles on walls (Fig. 2c and 3b). The rotation of about half degree, coincide with 8 cm measured in the centre line, near the impost plane.

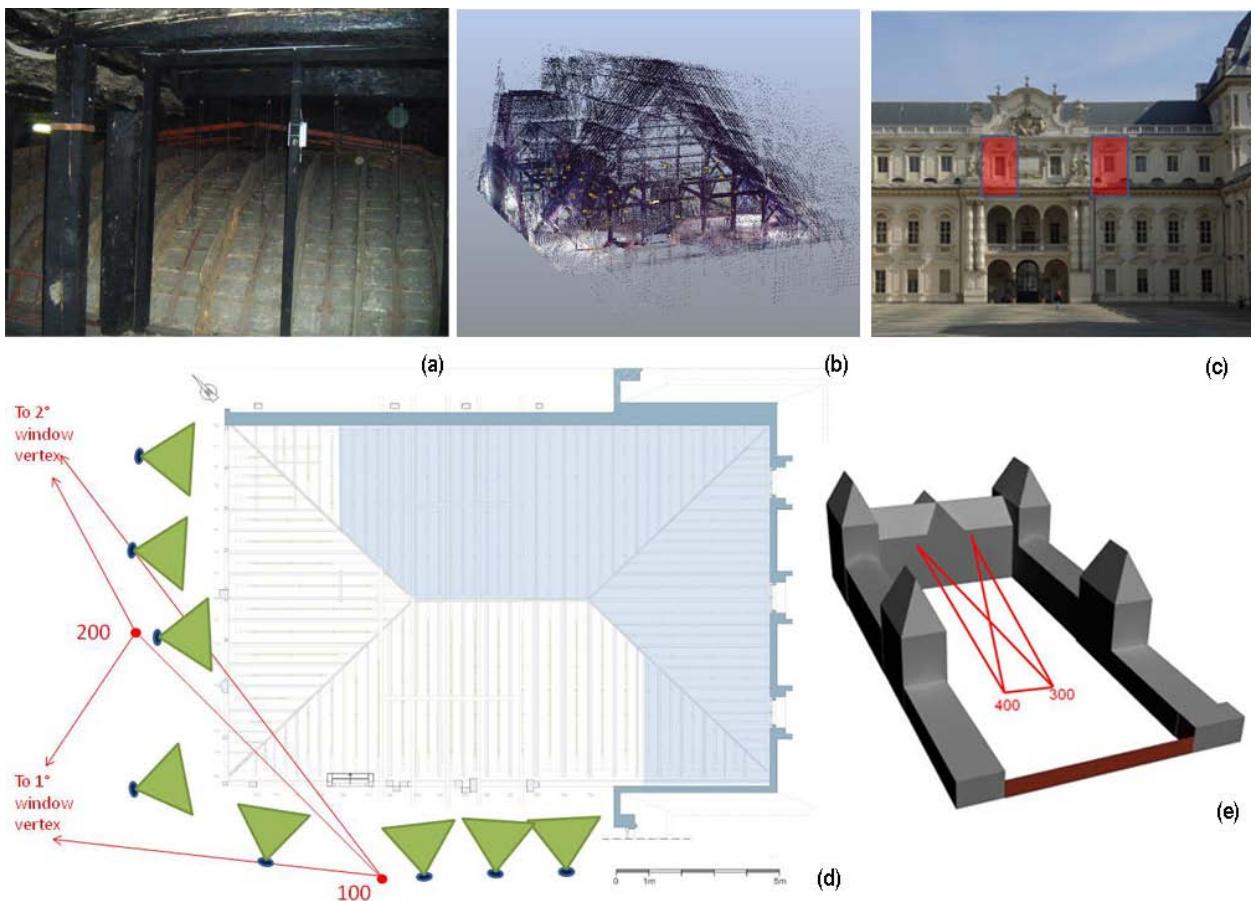
Figure 4: A view of the extrados with the wooden planking over it (a); a view of the registered points cloud (b); the position of windows enabling topographical intersections (c); a plan of the extrados with the scheme of scan positions and topographical measured directions (in red) on vertexes located on attic floor (n° 100 and 200) and near the windows (d), the scheme of topographical intersections connecting the vertexes in the attic, with the ones in the honor court(e).

The laser survey of vault extrados has been more complex than the lower, because of the encumbrances of the roof carpentry and since a wooden planking is placed over the vault (Fig. 4a)

Moreover the northern side is unreachable for the presence of a bearing wall, and obviously the curvature makes the measurable portion very reduced (in the Fig. 4d, the light blue points out the unmeasurable portion of the vault).

8 scans have been acquired (green triangle in Fig. 4d) and they have been registered with the support of about 25 plane targets, measured by topographical method. For the estrados survey we used the Focus 3D scanner (Faro Cam2) with portable and handy characteristics. The range of scan distances is variable from 0.6 to 120 m for reflective surfaces ( $> 90\%$ ), the error in linear distances is equal to  $\pm 2$  mm at 10 m and 25 m for reflectivity of 10% and 90%. [8] The results of registration are excellent (about half a centimeter for each residual) and obviously the cloud cleaning had to be totally manually managed in order to remove carpentry. Even the topographical measures performed with the aim to connect lower and upper models had been hard-working. Many portions of the castle have been surveyed by topographical, photogrammetrical and by TLS method, so a georeferenced topographical network (UTM WGS84 system) stands near the castle. [9]

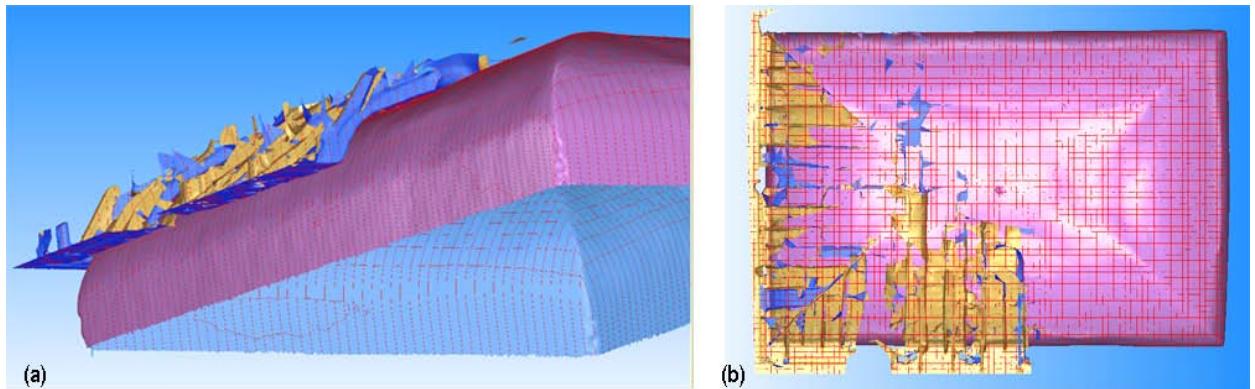
Figure 5: Two views of the combination of the upper and lower mesh models for the determination of the thickness of the vault. (a) (b).

**Thickness and Profile Analysis.** By means of the combined study of the extrados and intrados laser models (Fig. 5), it is possible to obtain an extensive mapping of the dome thickness and a precise analysis of local deformations. The analysis of section profiles, set in the horizontal or vertical planes and compared with the hypothetical original bending arcs, has enabled the chance to ascertain several localized deformation of the vault, in the order of some centimeters, that must be considered in the structural assessment of the vault. (A study on geometrical scheme of dome generation has been performed and we recognized that the hypothetical original bending arcs are very close to the constructive principles concerning the “*Cherche r’alongée*” recommended by P. Delorme in his essay: “Le Premier Tome de l’Architecture”. [10])

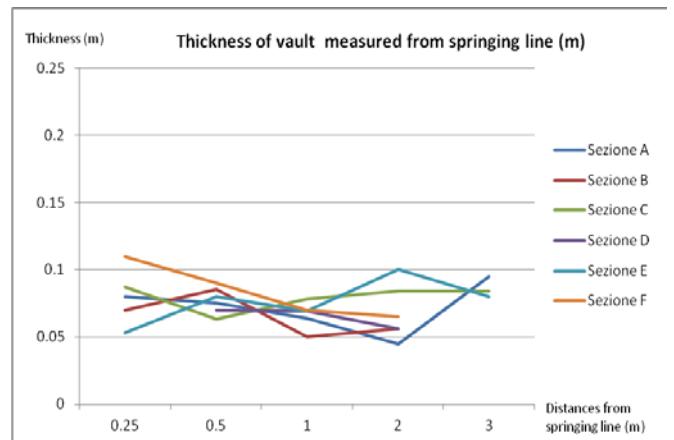
Figure 6: The thickness has been measured along some radii, interpolating arcs derived from Delorme geometrical scheme. Some sample vertical sections (A, B, C, D, E, F, about 1.5 m distant from each other) have been located in the measurable portion of

upper model, and they have been inspected and measured.

The maximum thickness is 0.22 m at the springing line. At the range distance between 0.5 m to 1m in plan from the walls, the average thickness decreases and becomes rather equal to 0.10 m. At the reins the thickness is minimum, and rather equal to only 0.06 m. In the central part of the dome the thickness is about 0.11 m, probably due to restorations and material additions. (Fig. 6-7)

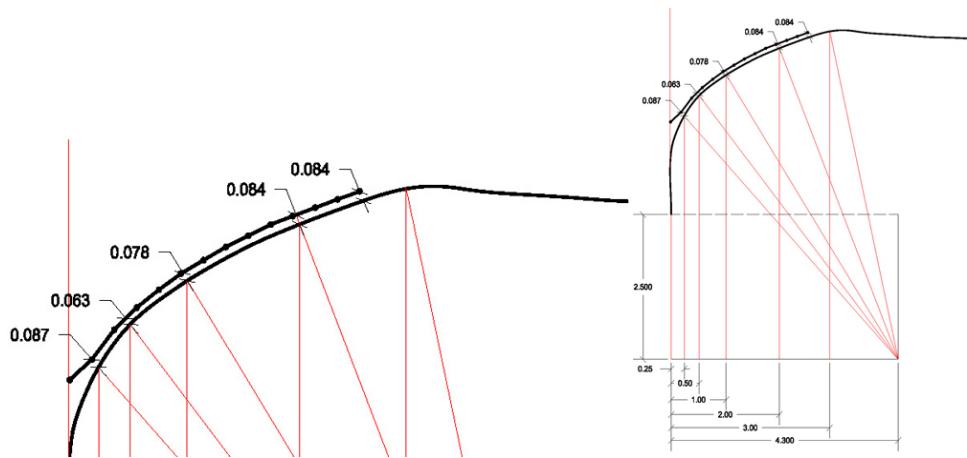
Figure 7: A sample section derived with the aim to examine the thickness of the vault.

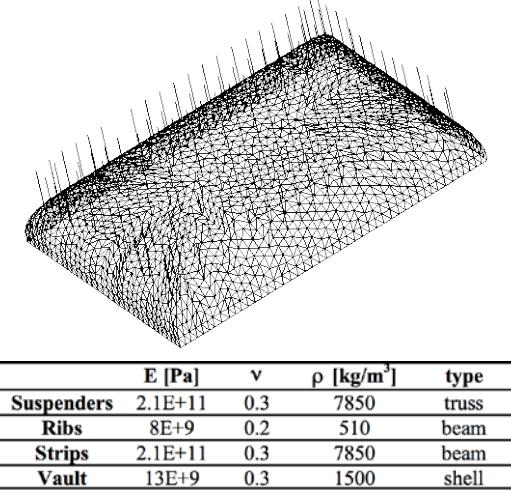
Figure 8: Mesh of the model (*above*); mechanical parameters of the model (*below*).

The shell represents the behaviour of the plaster, of the reed mat and of the wood joists in a single equivalent layer. The linear analysis has been carried out with the finite element program DIANA [11]. The overall mesh of the model is shown in Fig. 8a, while the table in Fig. 8b reports the basic mechanical assumption. The model is subjected to the only action of dead load due to gravity. At the present stage, the nonlinear behaviour of the materials has not been considered yet. Therefore, the model can provide only preliminary information about the structural behaviour of the dome. Nevertheless, the obtained deformed shape, shown in figure 9, is in agreement with the anomalies measured by the laser-scanning survey. In particular, the annular region around the big chandelier appears to be the most prone to displacements. On the other side, the suspenders, which are located in the outer region of the vault, are not elongated at all. This corresponds well with the evidence of the survey, which reveals that many of them have actually lost their tension (Fig. 10).

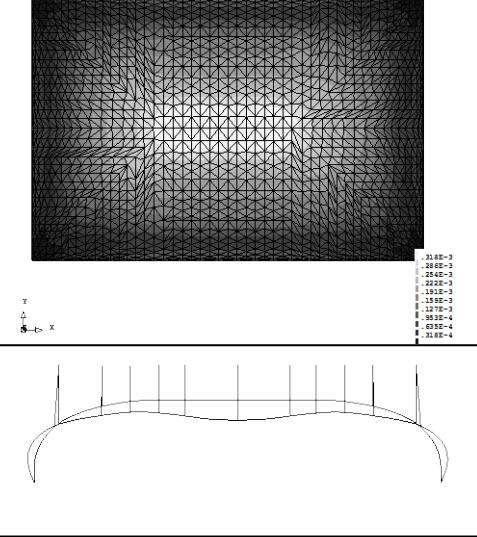
Figure 9: Contour plot of vertical displacements (*above*); transverse section with vertical displacements (*below*).

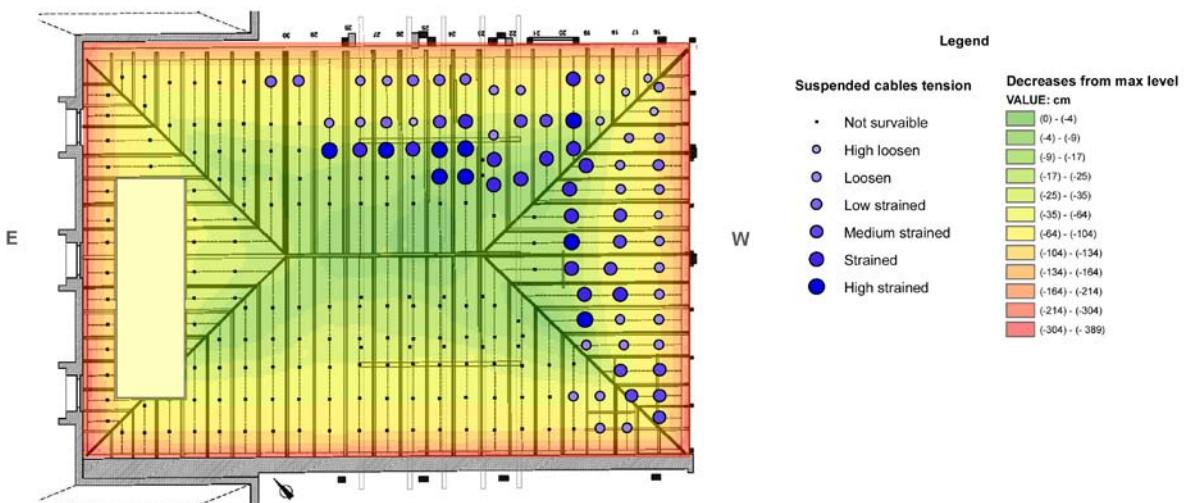
Figure 10: The survey representation of the state of tension in the suspenders is metrically referenced to the intrados Dem by GIS tools. The nadiral view is from low to high.
