# Terrestrial Laser Scanning and Settled Techniques: a Support to Detect Pathologies and Safety Conditions of Timber Structures

Clara Bertolini-Cestari<sup>1, a</sup>, Filiberto Chiabrando<sup>1, b</sup>, Stefano Invernizzi<sup>2, c</sup>,  
Tanja Marzi<sup>1, d</sup> and Antonia Spanò<sup>1, e</sup>

**Keywords:** Cultural Heritage, Wood dome, Structural assessment, Digital Photogrammetry, Laser survey, Orthophoto.

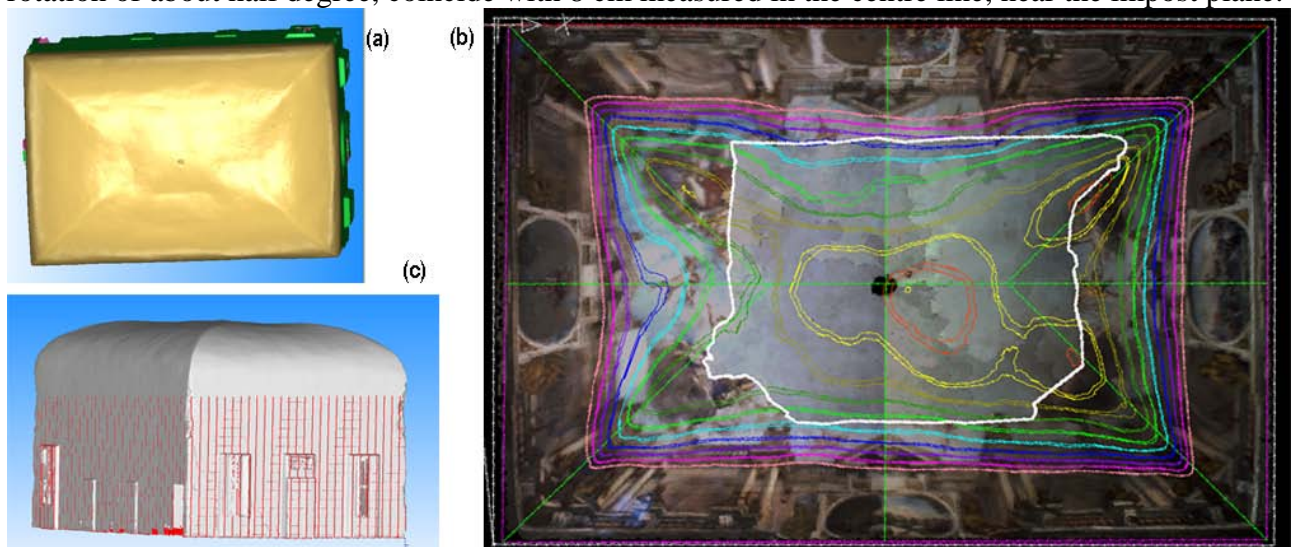
For the clear pavilion surface of the Hall of Honor, which is decorated by rich frescos and not by plastic ornamental elements, we performed the laser survey acquisition using a phase based scanner (LEICA HDS6100 [7]) The points model, after processes that fulfilled the complete cleaning and optimization of surface accuracy, describes the only interesting surfaces: floor, walls and vault. From laser model a large number of revealing profiles belonging to multiple section planes have been detected with the aim of analyzing the curves trends and spotting the anomalies and subsidence of the vault. Some irregularities are visually observable in the mesh model. (Fig 2a)

Furthermore the points model have been used to derive a Digital Elevation Model (DEM) useful for the orthophoto generation. In fact, the metric image texturing has been faced by a digital photogrammetry project; 8 images organized in two stripes have been acquired by self calibrated camera (Canon EOS 1Ds), then they have been oriented using a bundle adjustment process and projected using the DEM. In this way we obtained the complete removal of the huge chandelier encumbrance. The final orthophoto enable to detect the exact location and extension of restoration signs on vault frescos. The surface contours of the vault are computed with an equidistance of 5 cm and pertain horizontal planes: they present an high level of geometrical aberration. The location of height anomalies obtained from the laser model, and the shape of the frescos abruption outlined in the orthophoto, are in good agreement; it is observable because results are reported to the same reference system (Fig. 2b).

Figure 2: A nadiral view of the mesh model of dome for visual control of subsidence (a); the final orthophoto of the dome intrados, obtained by a mosaic of projected photograms with the superimposition of the section profiles and the signs of prior restorations (b) Total mesh model and sections profiles on walls.(c)

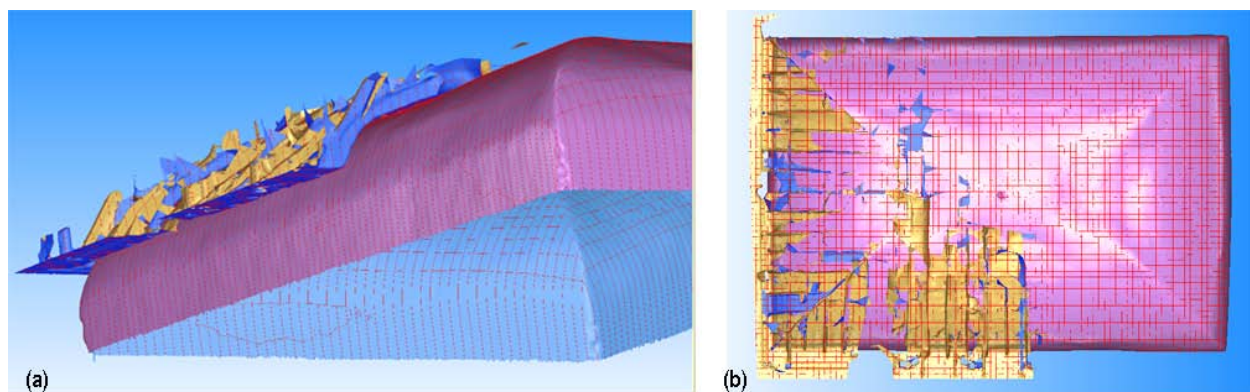
**Thickness and Profile Analysis.** By means of the combined study of the extrados and intrados laser models (Fig. 5), it is possible to obtain an extensive mapping of the dome thickness and a precise analysis of local deformations. The analysis of section profiles, set in the horizontal or vertical planes and compared with the hypothetical original bending arcs, has enabled the chance to ascertain several localized deformation of the vault, in the order of some centimeters, that must be considered in the structural assessment of the vault. (A study on geometrical scheme of dome generation has been performed and we recognized that the hypothetical original bending arcs are very close to the constructive principles concerning the “*Cherche r’alongée*” recommended by P. Delorme in his essay: “*Le Premier Tome de l’Architecture*”. [10])

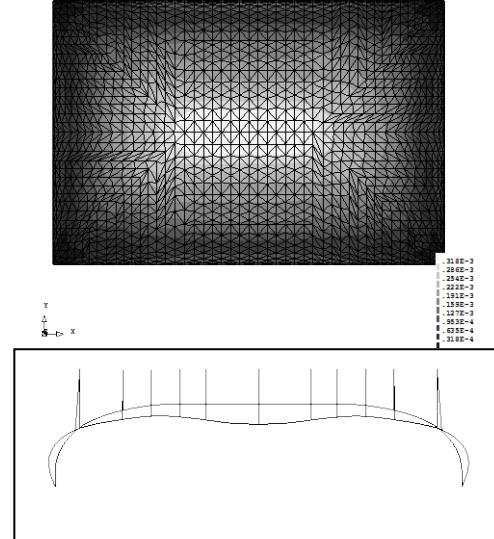
Figure 9: Contour plot of vertical displacements (*above*); transverse section with vertical displacements (*below*).

The shell represents the behaviour of the plaster, of the reed mat and of the wood joists in a single equivalent layer. The linear analysis has been carried out with the finite element program DIANA [11]. The overall mesh of the model is shown in Fig. 8a, while the table in Fig. 8b reports the basic mechanical assumption. The model is subjected to the only action of dead load due to gravity. At the present stage, the nonlinear behaviour of the materials has not been considered yet. Therefore, the model can provide only preliminary information about the structural behaviour of the dome. Nevertheless, the obtained deformed shape, shown in figure 9, is in agreement with the anomalies measured by the laser-scanning survey. In particular, the annular region around the big chandelier appears to be the most prone to displacements. On the other side, the suspenders, which are located in the outer region of the vault, are not elongated at all. This corresponds well with the evidence of the survey, which reveals that many of them have actually lost their tension (Fig. 10).
