Terrestrial Laser Scanning and settled techniques: a support to detect pathologies and safety conditions of timber structures

Terrestrial Laser Scanning and Settled Techniques: a Support to Detect Pathologies and Safety Conditions of Timber Structures

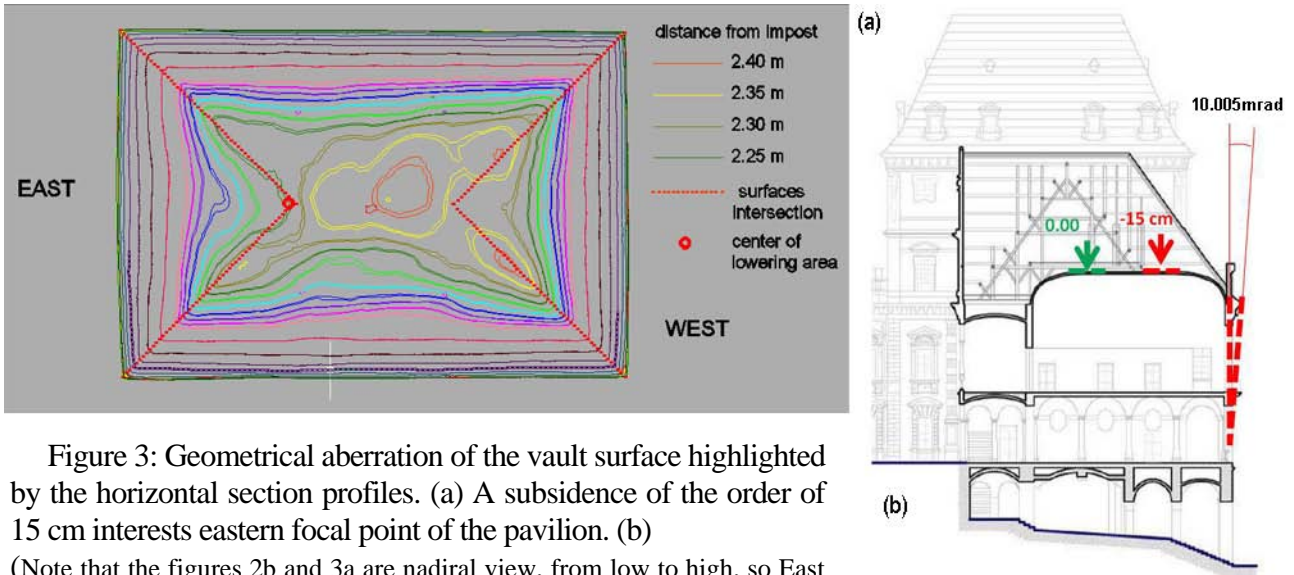
Figure 3: Geometrical aberration of the vault surface highlighted by the horizontal section profiles. (a) A subsidence of the order of 15 cm interests eastern focal point of the pavilion. (b) (Note that the figures 2b and 3a are nadiral view, from low to high, so East is in the left and west is on the right).

We can estimate the greater loss of the original geometrical shape in the subsiding area near eastern point of intersection of the cylinders of pavilion (red spot in Fig. 3a). Adding to the XXth restorations, this asymmetric subsidence may be related to a general rotation of eastern perimeter wall, that we observed and measured by means of the section profiles on walls (Fig. 2c and 3b). The rotation of about half degree, coincide with 8 cm measured in the centre line, near the impost plane.

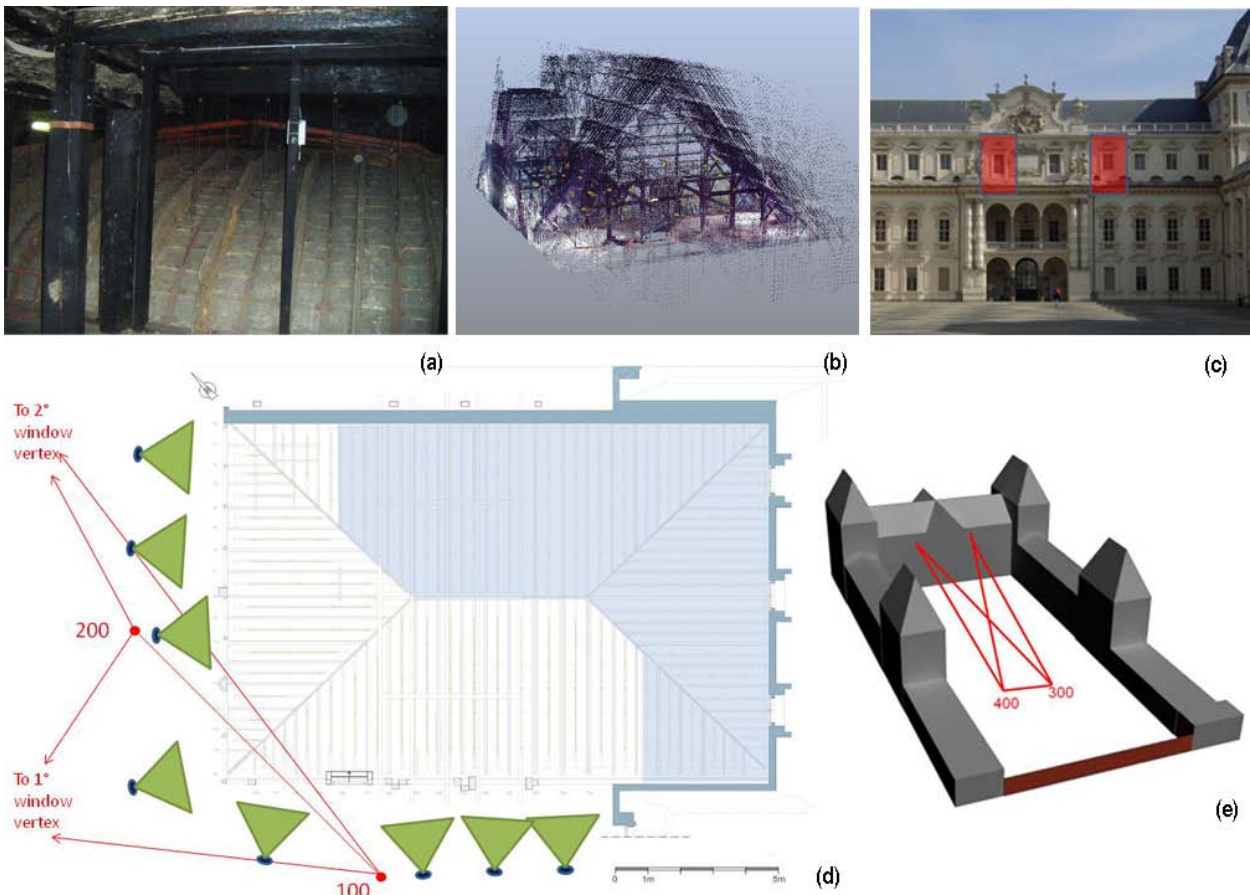
Figure 4: A view of the extrados with the wooden planking over it (a); a view of the registered points cloud (b); the position of windows enabling topographical intersections (c); a plan of the extrados with the scheme of scan positions and topographical measured directions (in red) on vertices located on attic floor (n° 100 and 200) and near the windows (d), the scheme of topographical intersections connecting the vertices in the attic, with the ones in the honor court(e).

The laser survey of vault extrados has been more complex than the lower, because of the encumbrances of the roof carpentry and since a wooden planking is placed over the vault (Fig. 4a)

Moreover the northern side is unreachable for the presence of a bearing wall, and obviously the curvature makes the measurable portion very reduced (in the Fig. 4d, the light blue points out the unmeasurable portion of the vault).

8 scans have been acquired (green triangle in Fig. 4d) and they have been registered with the support of about 25 plane targets, measured by topographical method. For the estrados survey we used the Focus 3D scanner (Faro Cam2) with portable and handy characteristics. The range of scan distances is variable from 0.6 to 120 m for reflective surfaces (> 90%), the error in linear distances is equal to ± 2 mm at 10 m and 25 m for reflectivity of 10% and 90%. [8] The results of registration are excellent (about half a centimeter for each residual) and obviously the cloud cleaning had to be totally manually managed in order to remove carpentry. Even the topographical measures performed with the aim to connect lower and upper models had been hard-working. Many portions of the castle have been surveyed by topographical, photogrammetrical and by TLS method, so a georeferenced topographical network (UTM WGS84 system) stands near the castle. [9]

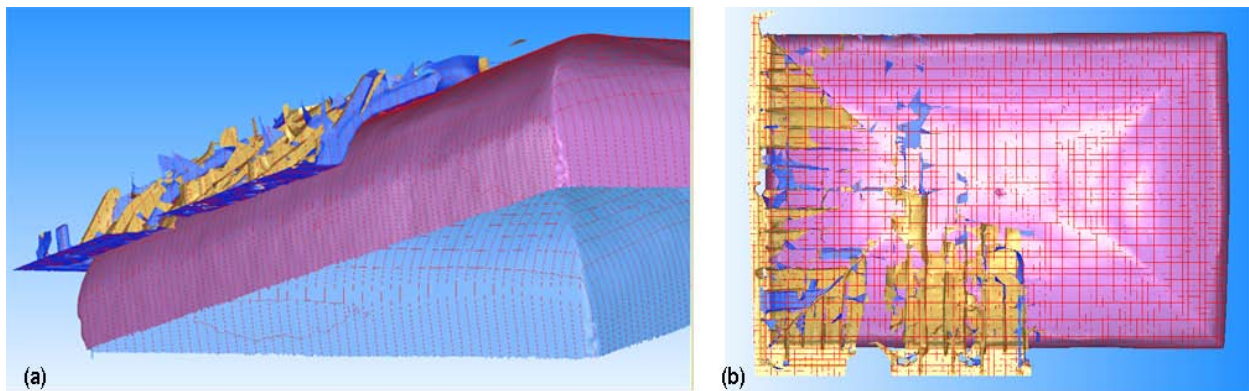
Figure 5: Two views of the combination of the upper and lower mesh models for the determination of the thickness of the vault. (a) (b).

Thickness and Profile Analysis. By means of the combined study of the extrados and intrados laser models (Fig. 5), it is possible to obtain an extensive mapping of the dome thickness and a precise analysis of local deformations. The analysis of section profiles, set in the horizontal or vertical planes and compared with the hypothetical original bending arcs, has enabled the chance to ascertain several localized deformation of the vault, in the order of some centimeters, that must be considered in the structural assessment of the vault. (A study on geometrical scheme of dome generation has been performed and we recognized that the hypothetical original bending arcs are very close to the constructive principles concerning the “*Cherche r’alongée*” recommended by P. Delorme in his essay: “*Le Premier Tome de l’Architecture*”. [10])

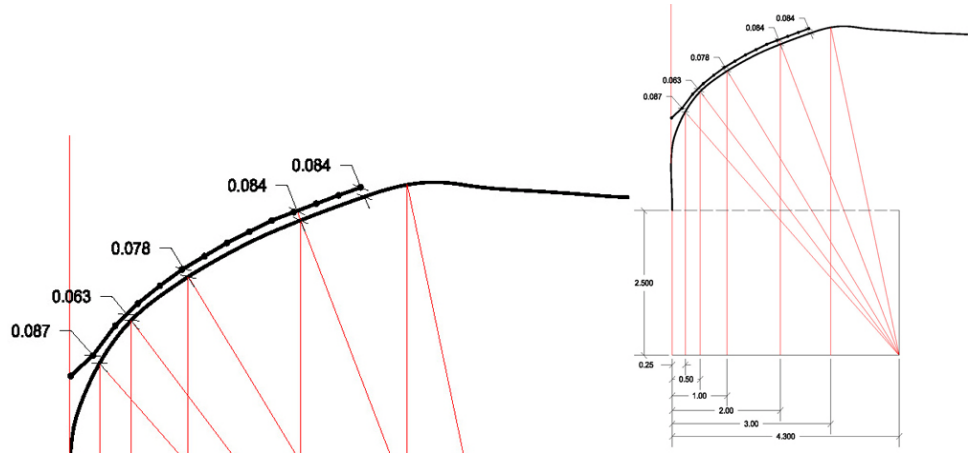
Figure 7: A sample section derived with the aim to examine the thickness of the vault.

The maximum thickness is 0.22 m at the springing line. At the range distance between 0.5 m to 1m in plan from the walls, the average thickness decreases and becomes rather equal to 0.10 m. At the reins the thickness is minimum, and rather equal to only 0.06 m. In the central part of the dome the thickness is about 0.11 m, probably due to restorations and material additions. (Fig. 6-7)

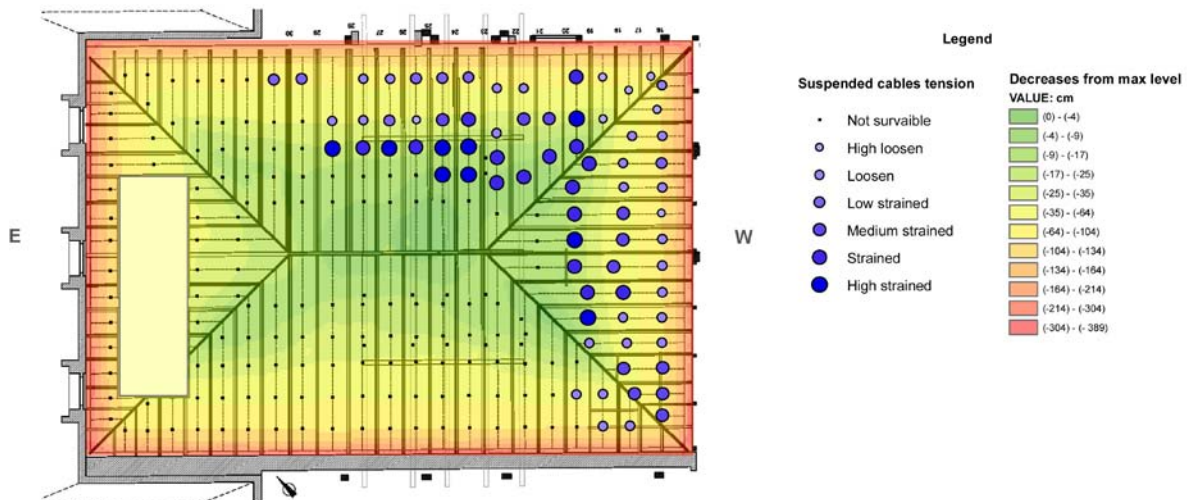
Figure 10: The survey representation of the state of tension in the suspenders is metrically referenced to the intrados Dem by GIS tools. The nadiral view is from low to high.

The shell represents the behaviour of the plaster, of the reed mat and of the wood joists in a single equivalent layer. The linear analysis has been carried out with the finite element program DIANA [11]. The overall mesh of the model is shown in Fig. 8a, while the table in Fig. 8b reports the basic mechanical assumption. The model is subjected to the only action of dead load due to gravity. At the present stage, the nonlinear behaviour of the materials has not been considered yet. Therefore, the model can provide only preliminary information about the structural behaviour of the dome. Nevertheless, the obtained deformed shape, shown in figure 9, is in agreement with the anomalies measured by the laser-scanning survey. In particular, the annular region around the big chandelier appears to be the most prone to displacements. On the other side, the suspenders, which are located in the outer region of the vault, are not elongated at all. This corresponds well with the evidence of the survey, which reveals that many of them have actually lost their tension (Fig. 10).

The preliminary finite element model is confirmed as far as the deformed shape is concerned, and also the loosen suspenders can be localized. The suggestion is not to provide tightening to the loosen suspenders [1, 12].
