AE monitoring and structural modelization of the Asinelli Tower in Bologna

# AE monitoring and structural modelization of the Asinelli Tower in Bologna

*Keywords:* Acoustic emission, finite element method, structural assessment.

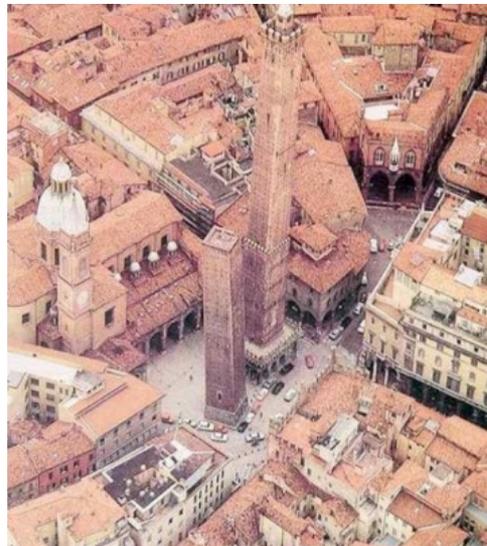
Figure 1. The Asinelli Tower and the Garisenda Tower in the city center of Bologna.

The Asinelli Tower rises to a height of 97.30 m above the ground. It has a square cross-section, tapering along its height, the sides measuring ca 8.00 m at the base and 6.50 m at the top. From the structural standpoint, the tower can be subdivided into four segments, depending on type of masonry. The thickness of the walls varies from 3.00 m at the foundations to 1.00 m at the top. The first segment, at the base of the tower, is made entirely of selenite blocks. It starts at a depth of ca 1.70 m below ground level and rises to 3.00 m above ground. The substructure of the tower is nearly square, with sides approx. 10.50 m long. The second segment, with sides tapering from 8.15 m to 7.70 m, rises to a height of 34.20 m. The third segment, which constitutes the upper part of the tower and contains the merlons added in the fifteenth century, has sides that gradually decrease in size to ca 6.50m at a height of 81.25 m above ground level. The masonry of the second and third segments is a sacco, i.e., consists of an outer and an inner face, 90 cm and 45 cm thick respectively, enclosing a mixture of rubble, bricks and mortar – and is characterised by an overall thickness of 2.80 m. At the base, up to a height of 8.00 m, the tower is surrounded by an arcade built at the end of the fifteenth century.

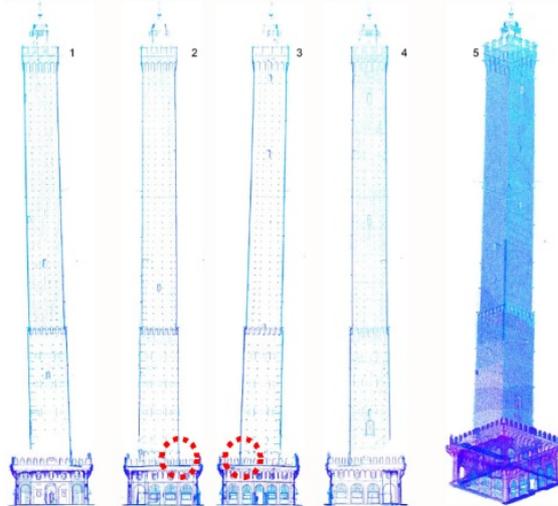
Figure 2. Front views and axonometric view of the Torre degli Asinelli. These views, supplied by the Municipality of Bologna, are taken from the measurements of the exterior of the structure made by Prof. Alessandro Capra by laser scanning. Faces (1) South; (2) East; (3) North; (4) West; (5) Axonometric view. The transducers were applied to the north-east corner of the tower, in the zones marked with a circle.

The studies conducted in the early twentieth century by F. Cavani [8] revealed that the Asinelli Tower leaned westward by 2.25 m; this is the reason why it is known as the tallest leaning tower in Italy. The latest measurements, made in 2009 by Prof. A. Capra by laser scanning, on behalf of the municipality, showed an overall inclination of 1.51 degrees and a deviation from verticality of 2.38 m. Thus we find that the deviation increased by 13 cm in the course of approx. one century, that is to say at an average rate of 1.30 mm/year. Figure 1 shows the Asinelli Tower and the adjacent Garisenda Tower in the city center of Bologna. Figures 2 and 3 show the front elevations and the cross-section of the Asinelli Tower and a plan view indicating the zone of application of the AE sensors.

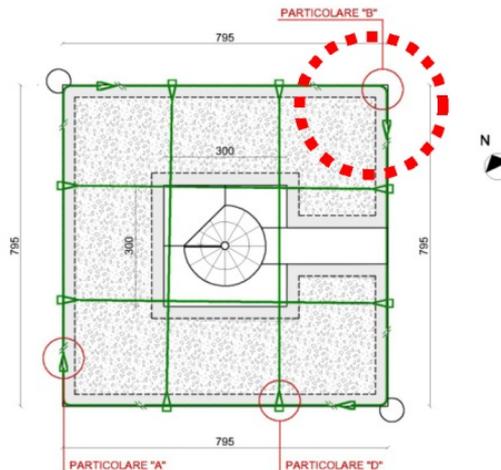
Figure 3. Cross-section of the tower at a height of ca 10 m above ground. Drawing supplied by the Municipality of Bologna. The corner where the sensors were applied is marked with a circle.

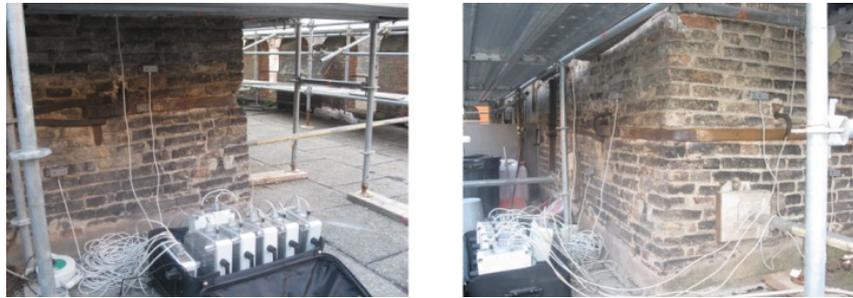
Figure 4. Photos of the AE data acquisition system on the monitoring site.

Only a limited number of sensors were available and hence the AE devices were positioned in a zone that would be both significant for monitoring purposes and easy to reach. In particular, six AE sensors were applied to the northeast angle of the tower at an average height of ca 9.00 m above ground level, immediately above the terrace atop the arcade. In this area, the double-wall masonry has an average thickness of ca 2.45 m (see Figs. 2 and 3). AE monitoring began on 23 September 2010 at 5:40 PM, and ended on 28 January 2011 at 1:00 PM. It was carried on for ca 2915 hours, corresponding to 122 consecutive days. The arrangement of the AE sensors, shown in the photos in Fig. 4, corresponds to the scheme illustrated in Fig. 5. The sensors were glued to the outer surface of the masonry with cold set silicone based adhesives, selected on account of their good ultrasound signal transmission capacity, resulting in reduced damping at the interface between the masonry and the sensors.

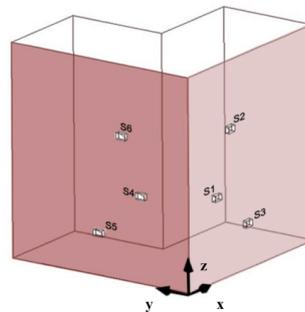
Figure 5. Axonometric scheme of the points of application of the AE sensors at the north-east corner of the tower.

The coordinates of the sensor application points are given in Table 1. The origin of the coordinate system of reference, as can be seen in Fig. 5, is at the bottom corner of the masonry at the intersection with the outer surface of the terrace surrounding the tower.

Sensors	x	y	z
S1	51.50	0.00	98.00
S2	78.00	0.00	171.0
S3	110.00	0.00	53.00
S4	0.00	63.50	102.00
S5	0.00	121.06	50.00
S6	0.00	89.00	167.00

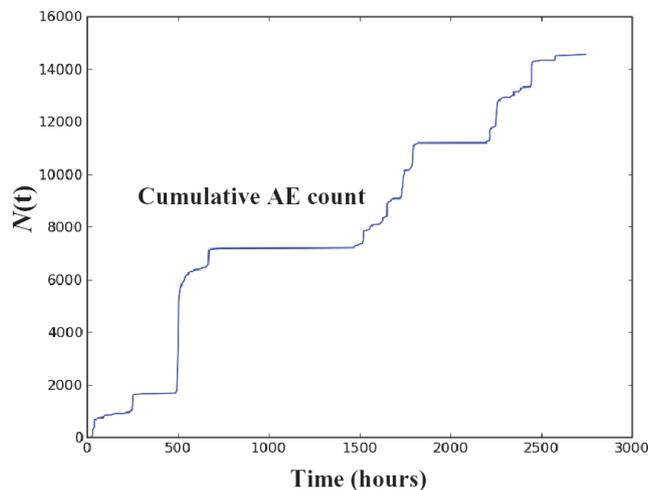
Figure 6 shows a plot of the cumulative AE count obtained on the basis of the number of events detected per monitoring day. The curve was plotted starting from the date of application of the sensors to the time the sensors were permanently removed. Throughout the monitoring period, the threshold level for the detection of the input signals coming from the PZT transducers was kept at 100 mV. Based on the authors' experience, in fact, this level is the most significant for the detection of AE signals from damage processes in non-metallic materials such as concrete and masonry [1,2,5,9].

From the curve in Fig. 6 it can be seen that the masonry is actually undergoing a damage process. The plot of the cumulative AE count, in fact, is characterized by jumps reflecting sudden increases in  $N$  that are seen to occur at certain time intervals. The discontinuities in the cumulative AE count curve denote the critical moments during which the release of energy from the microcrack formation process is greatest.

Figure 6. Cumulative AE count based on the data collected at the northeast corner of the tower, from 5:40 PM of 23 September 2010, to 1:00 PM of 28 January 2011.

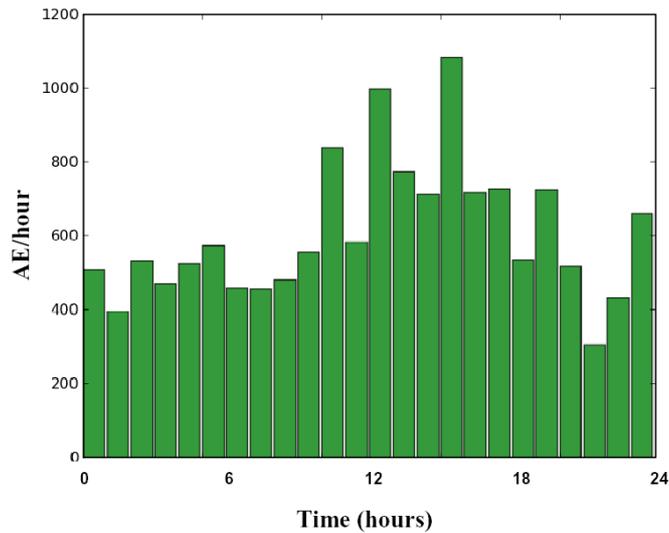
The AE count hourly distribution chart over a 24 hour time span, as determined for the entire monitoring period, is shown in Fig. 7.

Figure 7. AE count hourly distribution chart over a 24 hour time span, as determined for the entire monitoring period.

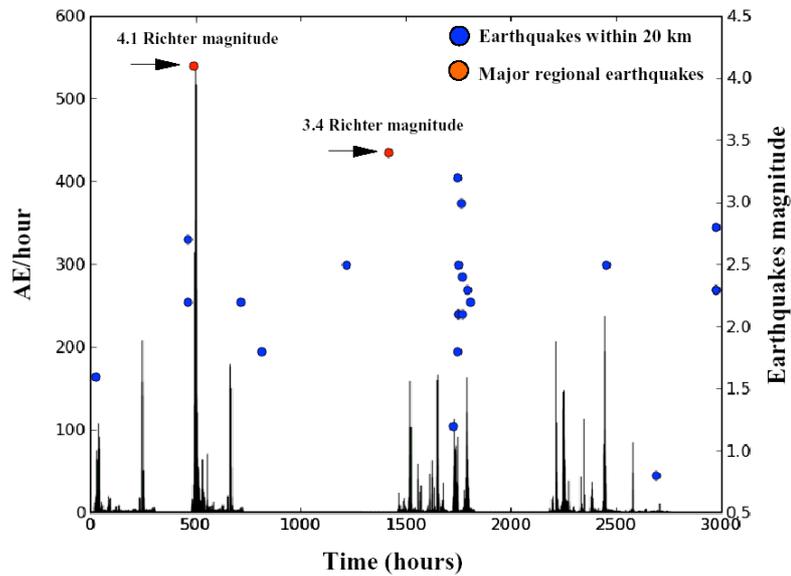
The chart in Fig. 8 shows the AE count rate per hour, the earthquakes recorded within a 20-km radius from the city center, and the two strongest quakes that hit the region. All the quakes, the two most important ones (denoted with red dots) and the weaker ones (blue dots), are shown as a function of time of occurrence and magnitude.

Fig. 8 reveals a *correlation between the AE events recorded experimentally and the seismic events*. As can be seen, in fact, the energy peaks measured through the AE count rate almost invariably occurred during a seismic event. In particular, the highest AE count peak (ca 500) was detected on 13 October, at 11:43 PM, when the Rimini area was hit by the 4.1 magnitude quake. Hence, this seismic event is the pulse phenomenon that resulted in the highest damage effect on the tower.

The second strongest earthquake, i.e., the 3.4 magnitude quake that hit the Modena Apennines on 21 November at 4:10 PM, does not introduce any significant change to the chart shown in Fig. 8, since the AE activity detected during this event was rather limited.

Figure 8. Historic series of the AE differential count and the earthquakes detected within a 20-km radius from the Bologna city center. The chart also shows the two strongest regional earthquakes, which occurred in Rimini area and in the Modena Apennines. This chart refers to the entire monitoring period.

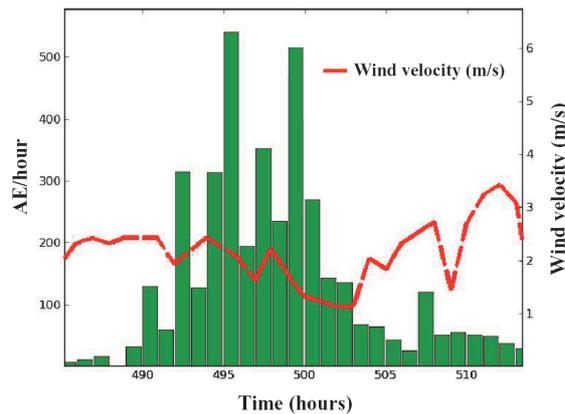
Figure 9: AE rate and wind velocity measurements during the monitoring period in a time window of 30 hours just after the earthquake of 13 October 2010.

In the chart of Fig. 9 are represented in detail the AE count rate and the wind velocity in a time window of 30 hours just after the earthquake that hit the Rimini area on 13 October 2010. The graph shows that the peaks in the AE count rate do not correspond with those of the wind velocity.

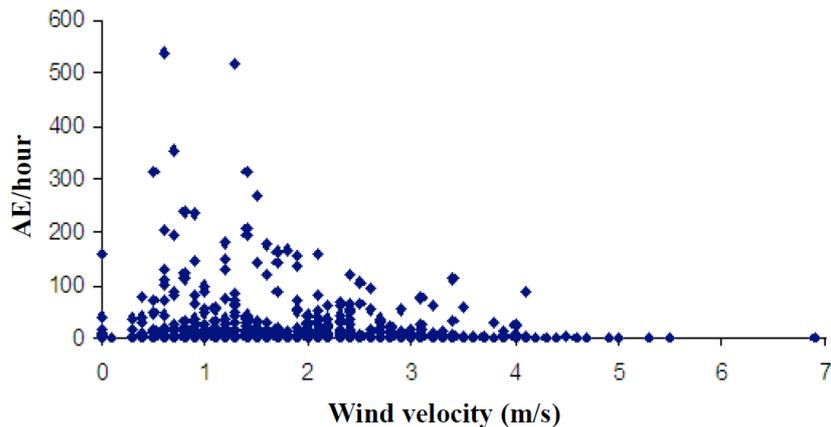
Moreover, the chart of Fig 10 relates the wind velocities and the AE count rate obtained during all the monitoring period (2915 hours). This graph makes clearer that the two phenomena are completely statistically unrelated.

Figure 10: Chart relating the wind velocity and the AE count rate during all the monitoring time, the two time series seem to be statistically unrelated.

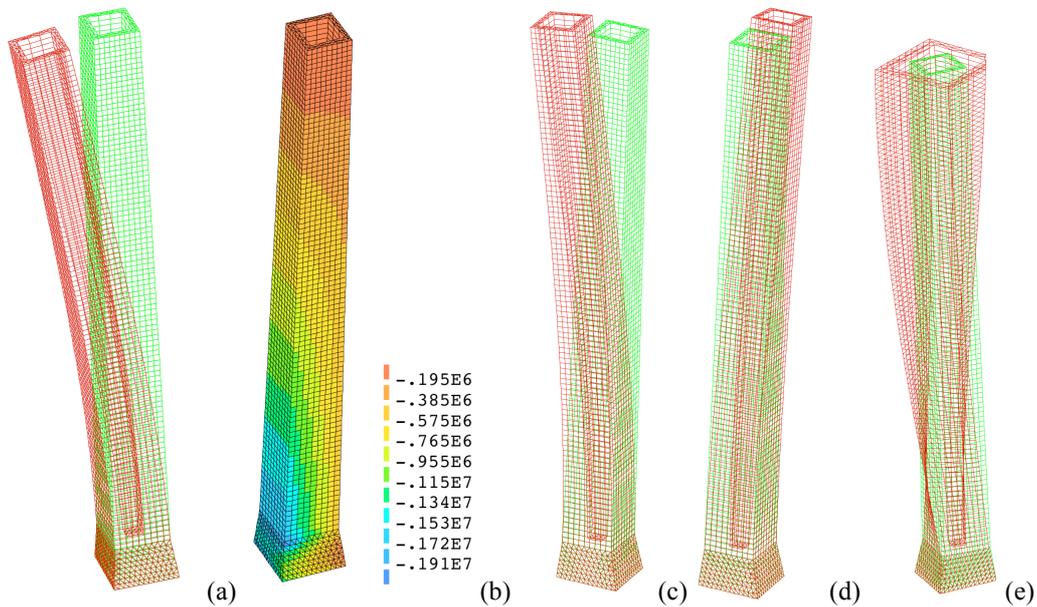
The preliminary linear elastic analysis considered only the self-weight of the tower (Fig. 11a). It was possible to assess that the elastic deformation of the tower is about 8 cm, which is about 1/30 of the present total deviation from verticality.

The level of stress in the masonry of the tower (Fig. 11b) is generally low, although in proximity of the monitored area, the level of vertical stress approach 2.1 Mpa, which can be critical in case of very poor masonry.

The preliminary modal analysis showed that the first mode is bending in the west-east plane, with a resonance frequency of 0.357 Hz (Fig. 11c). The second mode is bending in the orthogonal plane, with an eigen-frequency equal to 0.365 Hz (Fig 11d). The third eigen-frequency is 1.75 Hz, and the fourth is 1.78 Hz. The fifth mode is torsional (Fig. 11e) with an eigen-frequency of 3,07 Hz. Those results agree quite well with more detailed dynamic analyses carried out by other Authors [11].

The maximum vertical stress in the tower is compatible with the acquire rate of acoustic emissions from the monitored region. The fact that the first modal shape tends to increase the stress in the same area agrees well with the increase of acoustic emissions connected with seismic events.

Figure 11. Deformation due to the effect of gravity (a); vertical stress expressed in MPa (b); first modal shape (c); second modal shape (d); fifth modal shape (e).
